# *LIMITED ASBESTOS INSPECTION*

**7844 Old Pearsall Rd. #2  
San Antonio, TX**

**for  
Pape-Dawson Engineers  
Mr. Phil Pearce**

**ASBESTOS INSPECTION**  
**7844 Old Pearsall Rd. #2**  
**San Antonio, Texas**  
**for**  
**Pape-Dawson Engineers**

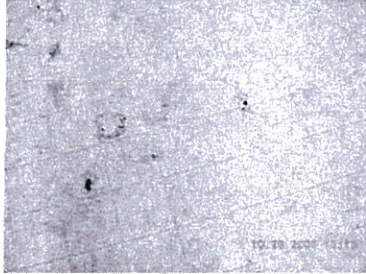
**#2 Tan Sheet Flooring**

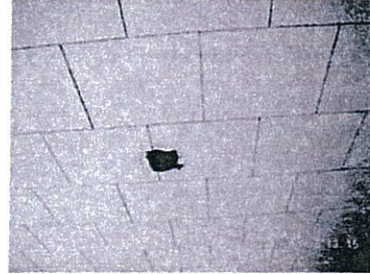
**#3 Ceiling Tile**

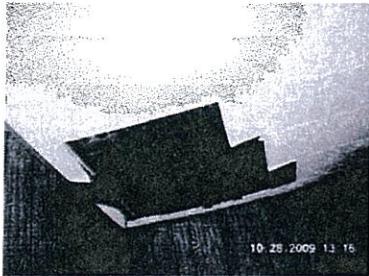
**#4 Ceiling Tile**

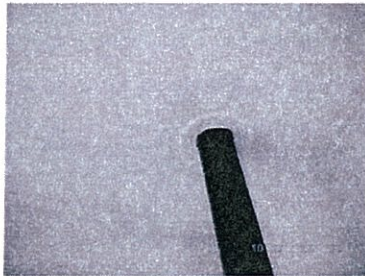
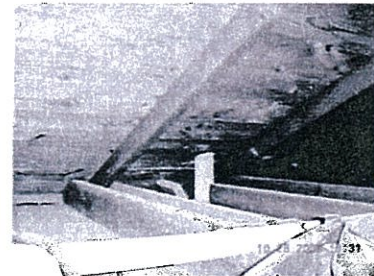
6.4. The cementitious water heater pipe that goes thru the attic and roof is presumed ACM.

7.2. **Non-Friable Materials.** Cementitious water heater pipe approximately 4 linear feet .

**#5 Water Heater Exhaust**

**#6 Water Heater Exhaust**

8.2. The cementitious water heater pipe should be abated (removed) prior to demolition.

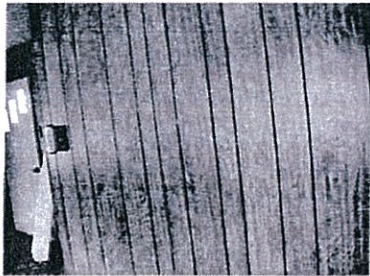
**#7 Paneling**

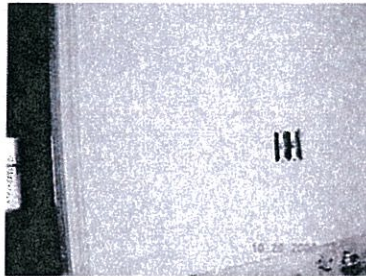
6.3. The laboratory results indicated "NAD – No Asbestos Detected" for all submitted samples except the float mud which contained <1%Chrysotile Asbestos. The float mud was point counted in accordance with paragraph 5.3.2.1 above, with the result of 0.025% Chrysotile Asbestos; therefore, the float mud is considered not to contain asbestos.

**#8 Wallboard and Float Mud**

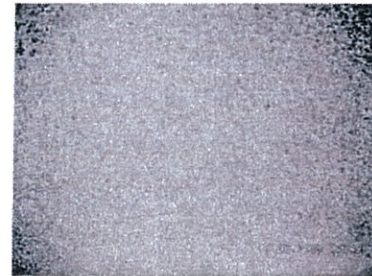
**#9 Ceiling Stipple**

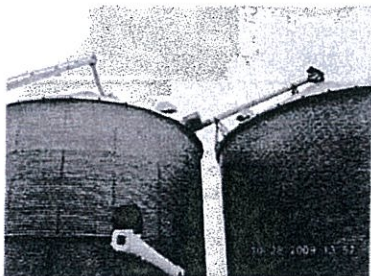
**#10 Grain Silo**

- 4.1. The residence contains bedrooms, living room, kitchen, bath, hall and a laundry.
- 4.2. The two grain storage bins are metal construction without any suspect ACM.

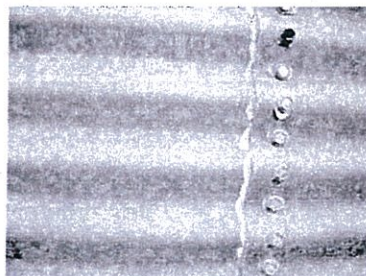
**#11 Grain Silo Caulking**

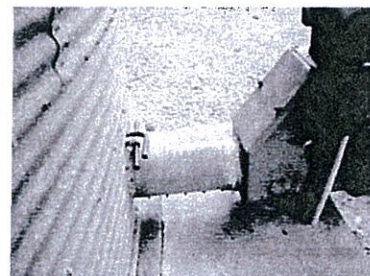
**#12 Grain Silo Motor**
