**SUBSURFACE UTILITY ENGINEERING**  
**QUALITY LEVEL - A: Test Hole Data Information**  
 SAM, Inc. Project Number: 31151-31

**TEST HOLE NUMBER: 1**  
 Date: July 8, 2011  
 Client: C P & Y, Inc.  
 Project: Leon Creek Interceptor

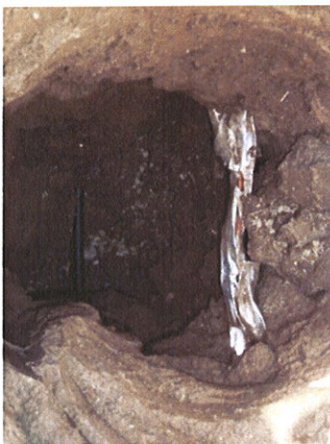
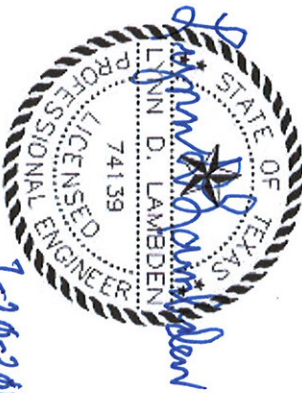
**TEST HOLE PICTURE**

Surface Material: **Natural ground**  
 Surface Elevation: **520.50**  
 Thickness & Condition: **Dry**  
 Trench Material: **Black clay**  
 Utility Bedding Material: **Black clay**  
 Utility Found: **1/2" direct bury Fiber Optic line**  
 Utility Condition: **Good**  
 Utility Depth (Top): **3.3'**

1. SAM, Inc. located Test Hole # 1 by records and utility locator for the fiber optic line prior to air/vacuum excavation of the utility.
2. No additional utilities were found within Test Hole # 1 excavation.
3. All excavation was performed with air/vacuum excavation equipment.
4. The Test Hole was backfilled with excavated material.
5. The picture depicts the existing fiber optic line.

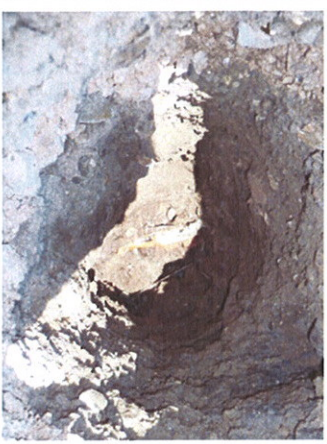
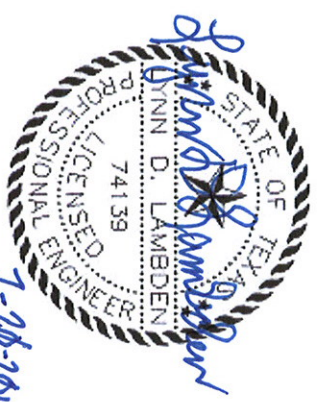
**TEST HOLE PICTURE**

Project Location:	San Antonio, Texas	Surface Material:	Natural ground
Utility Location:	Leon Creek Wastewater Plant	Surface Elevation:	527.68
Utility Sta./Offset:	N/A	Thickness & Condition:	Dry
Record Utility:	Fiber Optic line	Trench Material:	Rocky black clay
Utility Owner:		Utility Bedding Material:	Rocky black clay
Contact/Phone:		Utility Found:	1/2" direct bury fiber optic line
Address:		Utility Condition:	Good
Field Crew:	Gabe Johnson and Miller Pipeline	Utility Depth (Top):	2.6'
Field Conditions:	Off roadway

1. SAM, Inc. located Test Hole # 2 by records and utility locator for the fiber optic line prior to air/vacuum excavation of the utility.
2. No additional utilities were found within Test Hole # 2 excavation.
3. All excavation was performed with air/vacuum excavation equipment.
4. The Test Hole was backfilled with excavated material.
5. The picture depicts the existing fiber optic line.

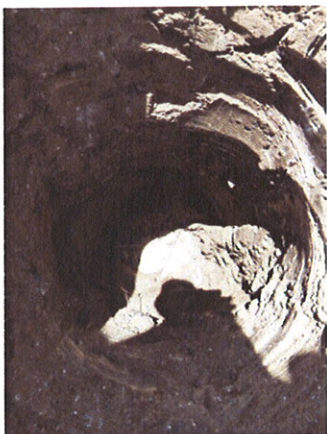
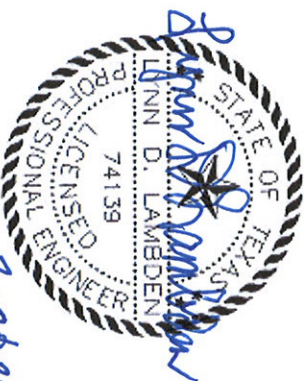
**TEST HOLE PICTURE**

Surface Material: **Natural ground**  
 Surface Elevation: **527.89**  
 Thickness & Condition: **Dry**  
 Trench Material: **Rocky black clay**  
 Utility Bedding Material: **Rocky black clay**  
 Utility Found: **16" poly pipe with tracer wire**  
 Utility Condition: **Good**  
 Utility Depth (Top): **3.5'**

1. SAM, Inc. located Test Hole # 3 by records and utility locator for the water line prior to air/vacuum excavation of the utility.
2. No additional utilities were found within Test Hole # 3 excavation.
3. All excavation was performed with air/vacuum excavation equipment.
4. The Test Hole was backfilled with excavated material.
5. The picture depicts the existing water line.

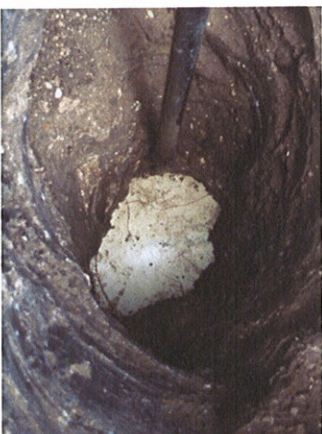
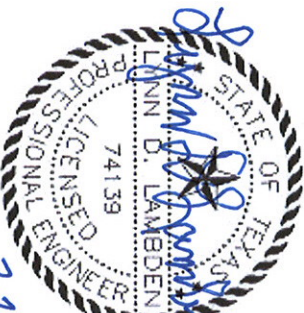
**TEST HOLE PICTURE**

Utility Found: **16" poly pipe without tracer wire**  
 Utility Condition: **Good**

1. SAM, Inc. located Test Hole # 4 by utility records for the water line prior to air/vacuum excavation of the utility.
2. No additional utilities were found within Test Hole # 4 excavation.
3. All excavation was performed with air/vacuum excavation equipment.
4. The Test Hole was backfilled with excavated material.
5. The picture depicts the existing water line.

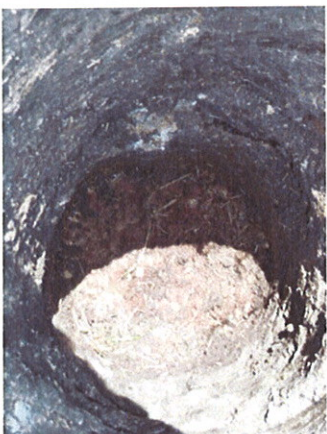
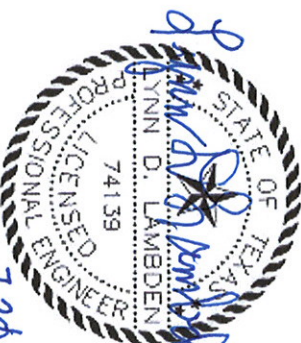
**TEST HOLE PICTURE**

Surface Material: **Natural ground**  
 Surface Elevation: **527.19**  
 Thickness & Condition: **Dry**  
 Trench Material: **Black clay**  
 Utility Bedding Material: **Black clay**  
 Utility Found: **24" concrete conduit**  
 Utility Condition: **Good**  
 Utility Depth (Top): **2.5'**

1. SAM, Inc. located Test Hole # 5 by records and utility locator for the electric line prior to air/vacuum excavation of the utility.
2. No additional utilities were found within Test Hole # 5 excavation.
3. All excavation was performed with air/vacuum excavation equipment.
4. The Test Hole was backfilled with excavated material.
5. The picture depicts the existing conduit.
