CONDITION REMEDIATION ALTERNATIVES ANALYSIS

Project Scoping Report

Multiple Sewershed Package 12

PREPARED FOR: San Antonio Water System

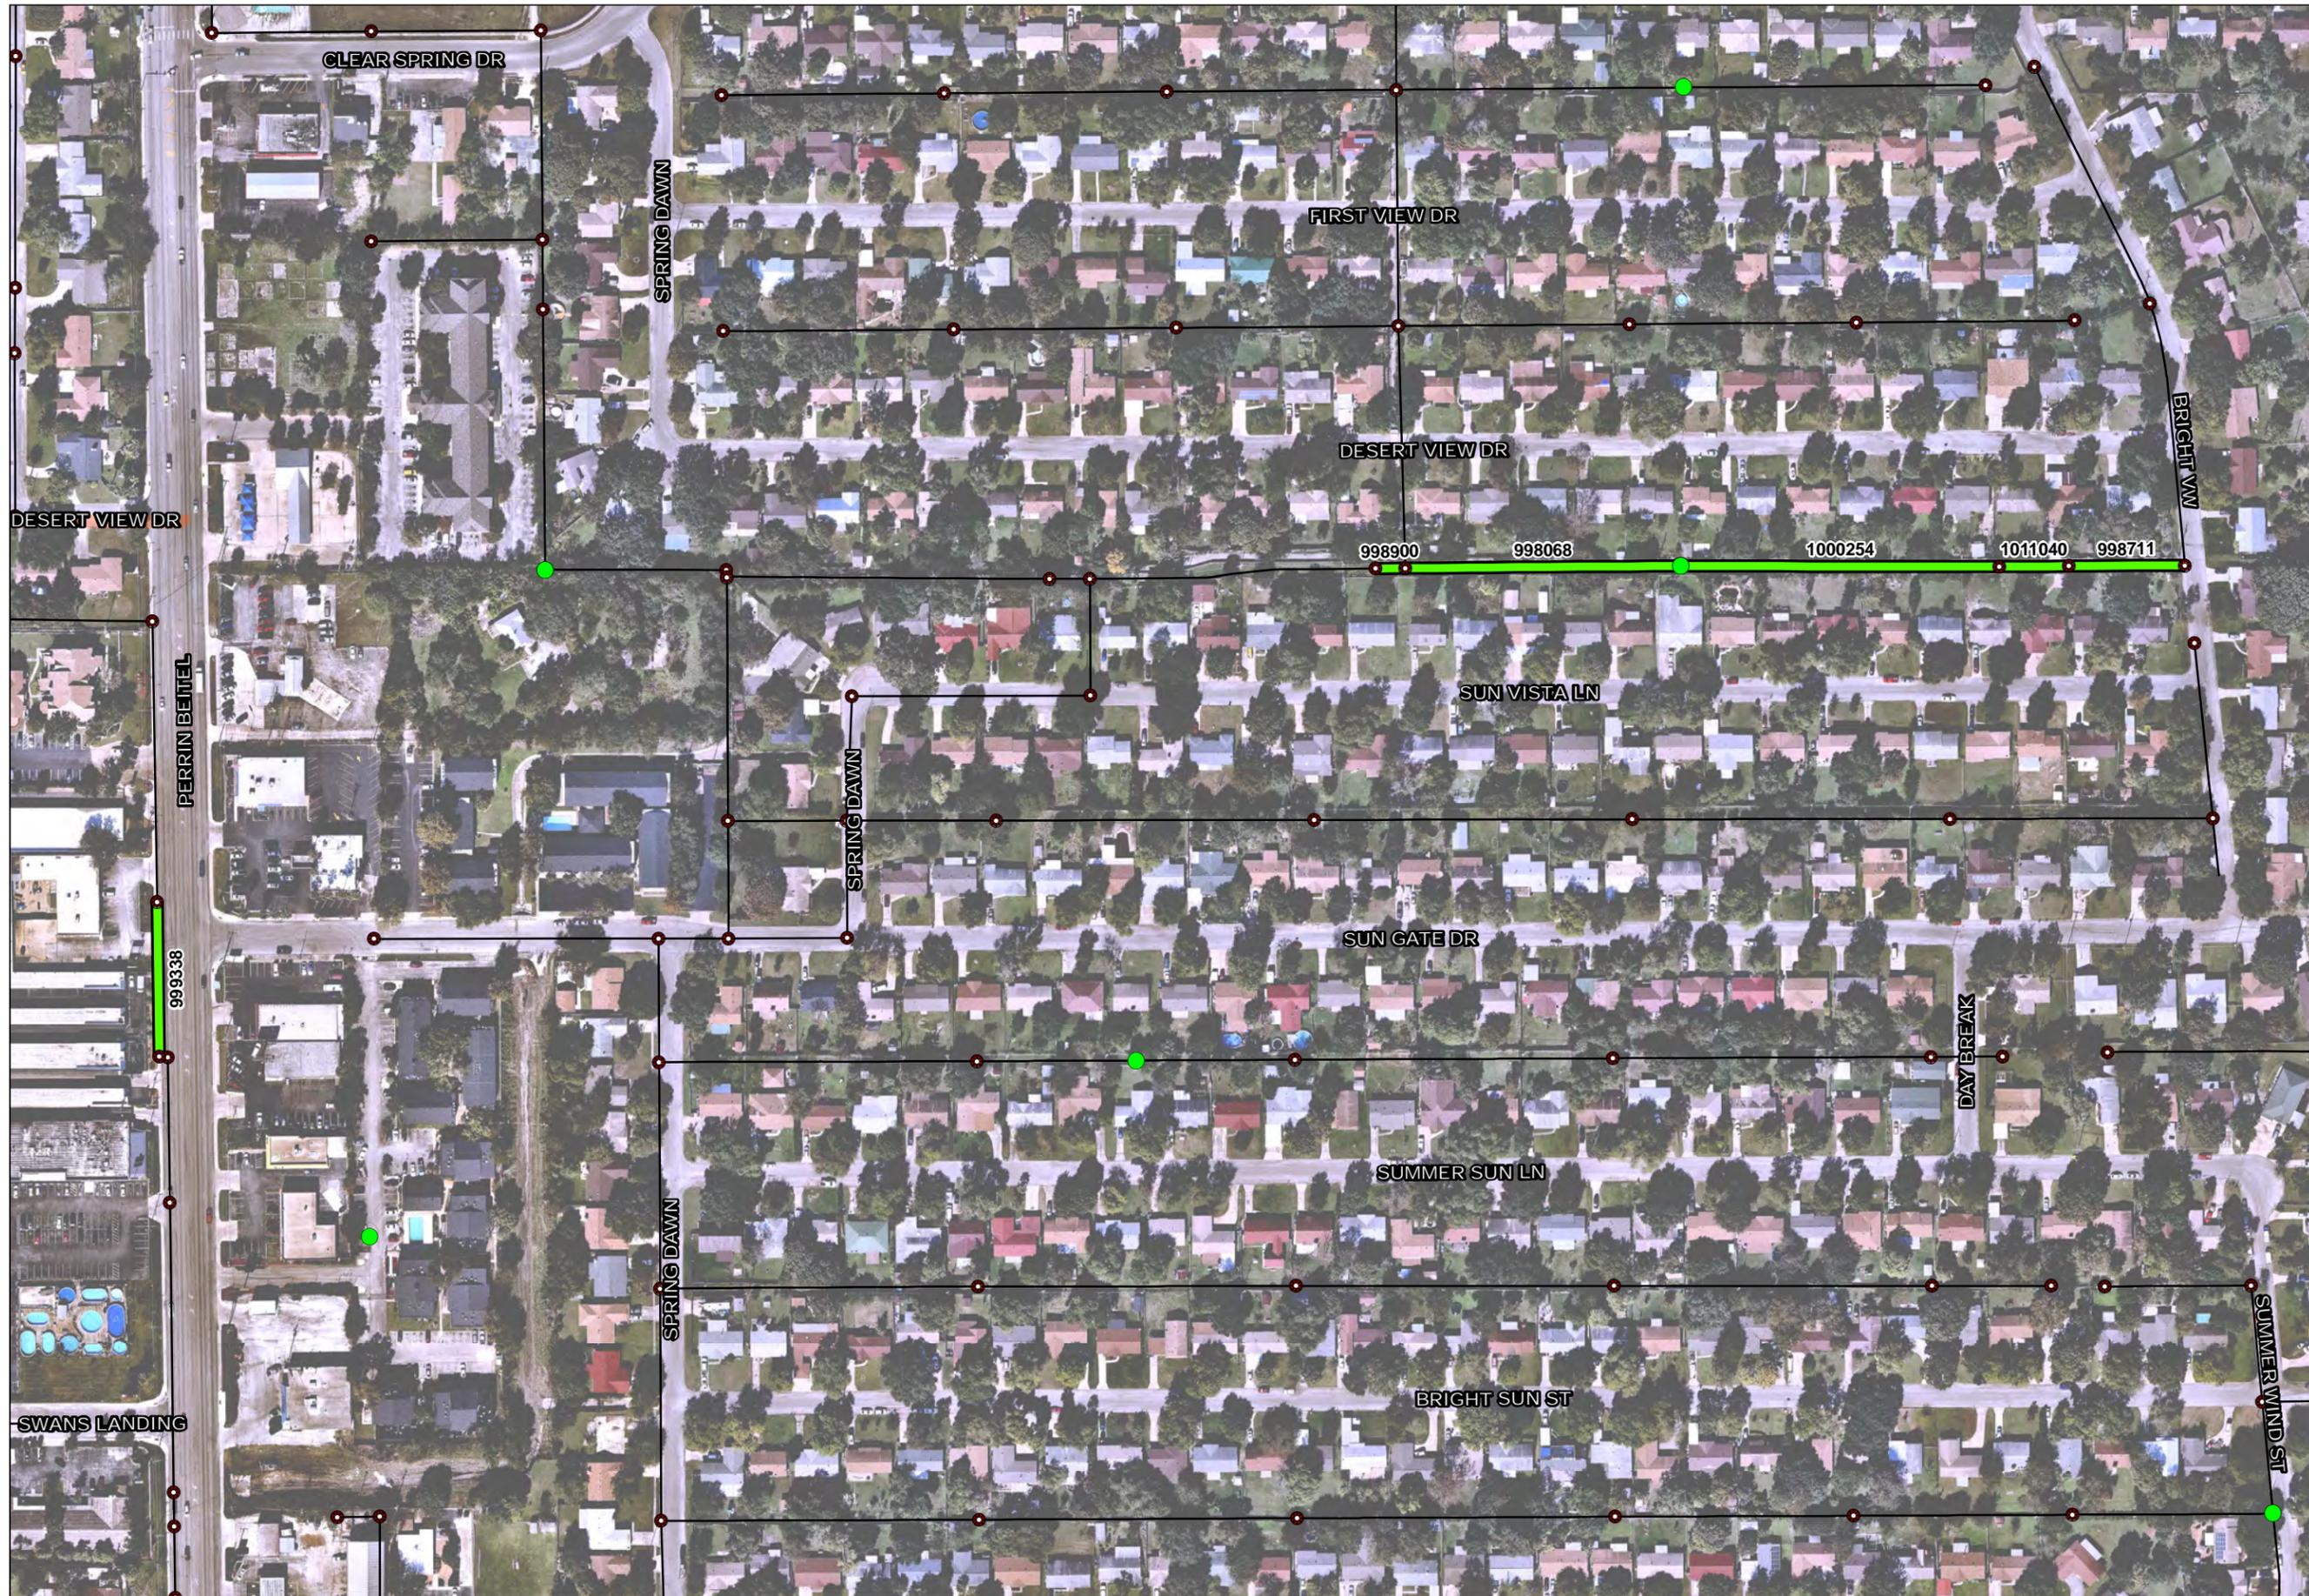
Sheet AM45

Index Page	Compkey	As-built No.	Block Map No.	Install Year	Dia. (in.)	Material	Avg. Depth (feet)	Length (feet)	Verified Cond. Rating	Preliminary Remediation Method	Decision Notes and Design Considerations
AM45	999338	DJ-3221	186614	1967	10	CP	8	181	E	Replace	This asset was included in a previous package. The consultant recommended replacement due to utility conflicts.
AM45	998900	79-02	188616	1979	8	CP	6	46	E	Replace	This asset was included in a previous package. The consultant recommended replacement due to gas line conflicts.
AM45	998068	DJ-4074	188616	1965	8	CP	6	354	E	Replace	This asset was included in a previous package. The consultant recommended replacement due to gas line conflicts.
AM45	1000254	DJ-4074	188616	1965	8	CP	5	400	D	Replace	This asset was included in a previous package. The consultant recommended replacement due to gas line conflicts.
AM45	1011040	DJ-4074	188616	1965	8	CP	6	87	E	Replace	This asset was included in a previous package. The consultant recommended replacement due to gas line conflicts.

AM45	998711	DJ-4074	188616	1965	8	CP	7	143	E	Replace	This asset was included in a previous package. The consultant recommended replacement due to gas line conflicts.

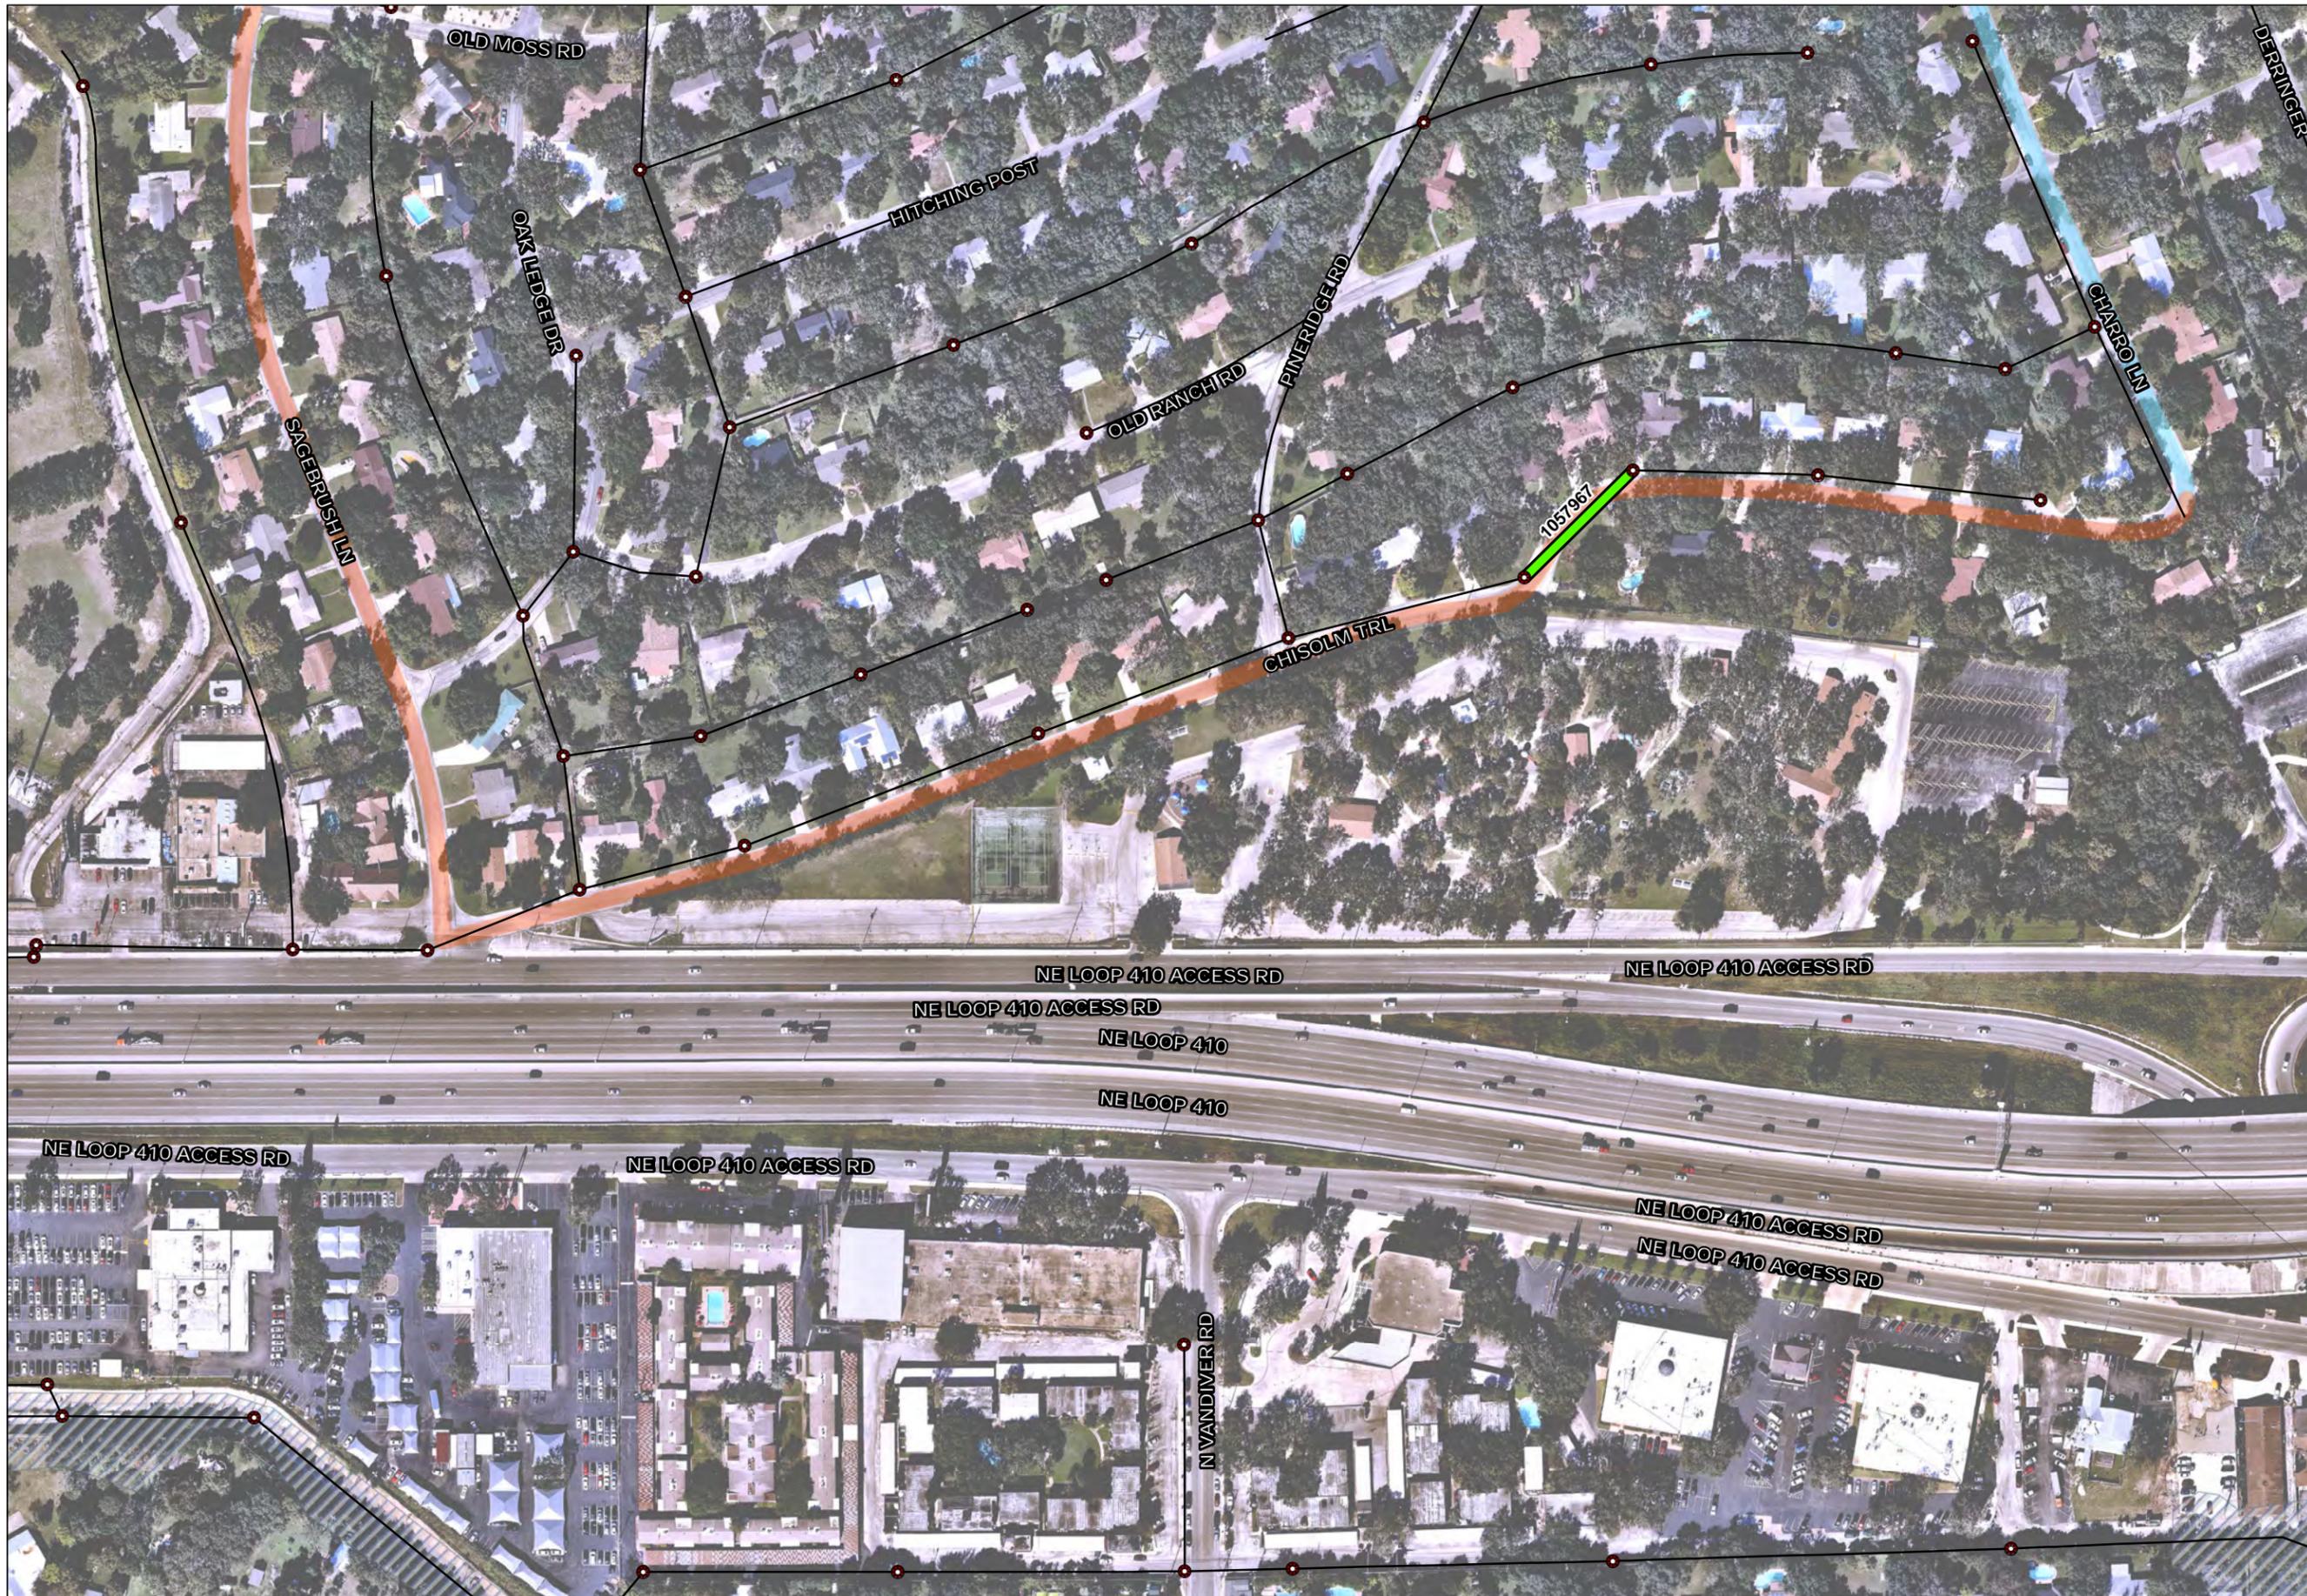
Sheet AO41

Index Page	Compkey	As-built No.	Block Map No.	Install Year	Dia. (in.)	Material	Avg. Depth (feet)	Length (feet)	Verified Cond. Rating	Preliminary Remediation Method	Decision Notes and Design Considerations
AO41	1057967	OM-4844	176612	1958	8	CP	4	167	D	Replace	This asset was included in a previous package. The consultant recommended replacement due to the depth of line.
AP43	1000092	DJ-1095	182610	1963	8	DIP	10	630	E	Replace	The majority of the survey is missing. An additional manhole may be needed.
AT42	997434	OM-2711	178600	1952	8	CP	7	228	E	Replace	The pipe includes projecting aggregate and missing pipe. There is also a possible sag.
AY40	976999	OM-4334	172592	1927	8	CP	9	305	E	Replace	There are several sections of crushed pipe. Based on SAWS review, the pipe is under a home.
BE29	2758473	OM-186	142580	1950	8	CP	8	10	E	Replace	There is large void behind the missing pipe.
BE31	1048481	OM-2238	148580	1928	8	CP	6	485	E	Replace	The pipe includes projecting aggregate, missing pipe, and roots. The pipe is close to (or under) buildings.

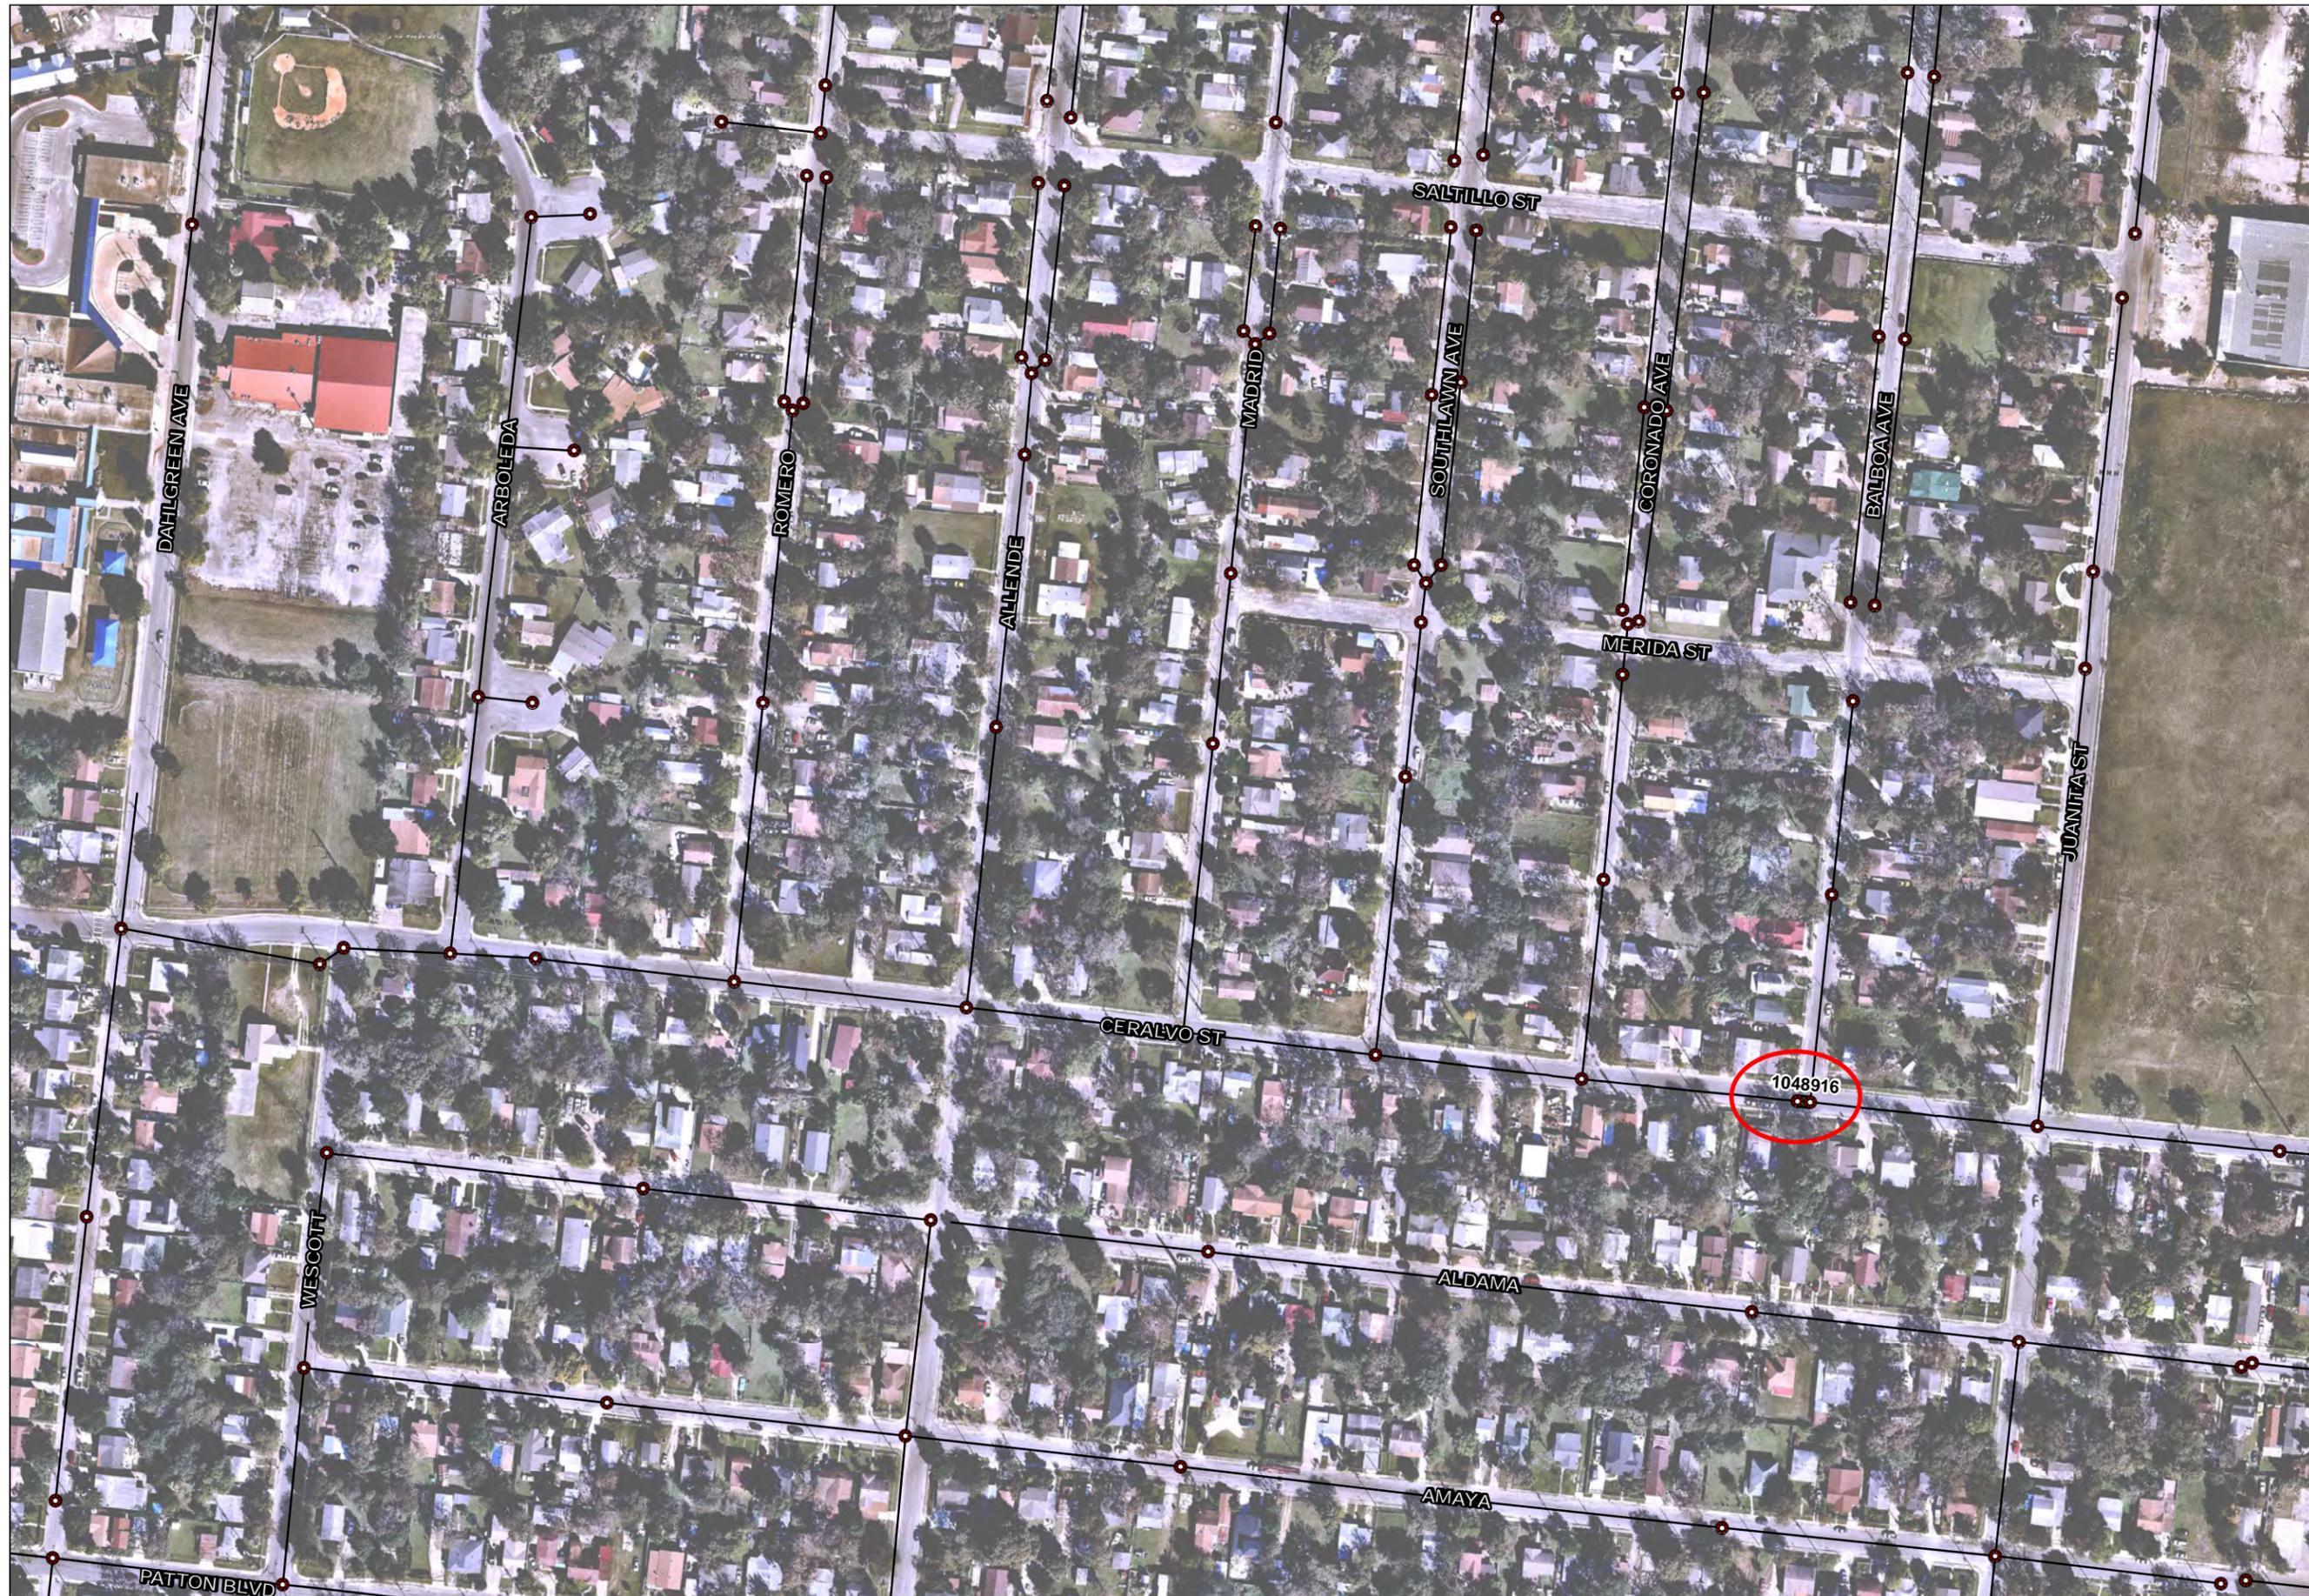
Sheet BH28

BH28	1048916	OM-753	140572	1956	12	CP	7	7	E	Replace	There are voids behind the missing pipe.
BN31	975893	OM-507	146560	1951	8	CP	5	237	E	Replace	The line segment may require a relocation due to a building above the pipe.
BP30	973088	OM-5008	144558	1935	12	CP	6	224	E	Replace	The line segment may require a relocation due to a building above the pipe.
