CAPACITY, MANAGEMENT, OPERATION, AND MAINTENANCE ALTERNATIVES ANALYSIS

Project Scoping Report

2022 CMOM Central East Small Diameter Sewershed Project

PREPARED FOR: San Antonio Water System

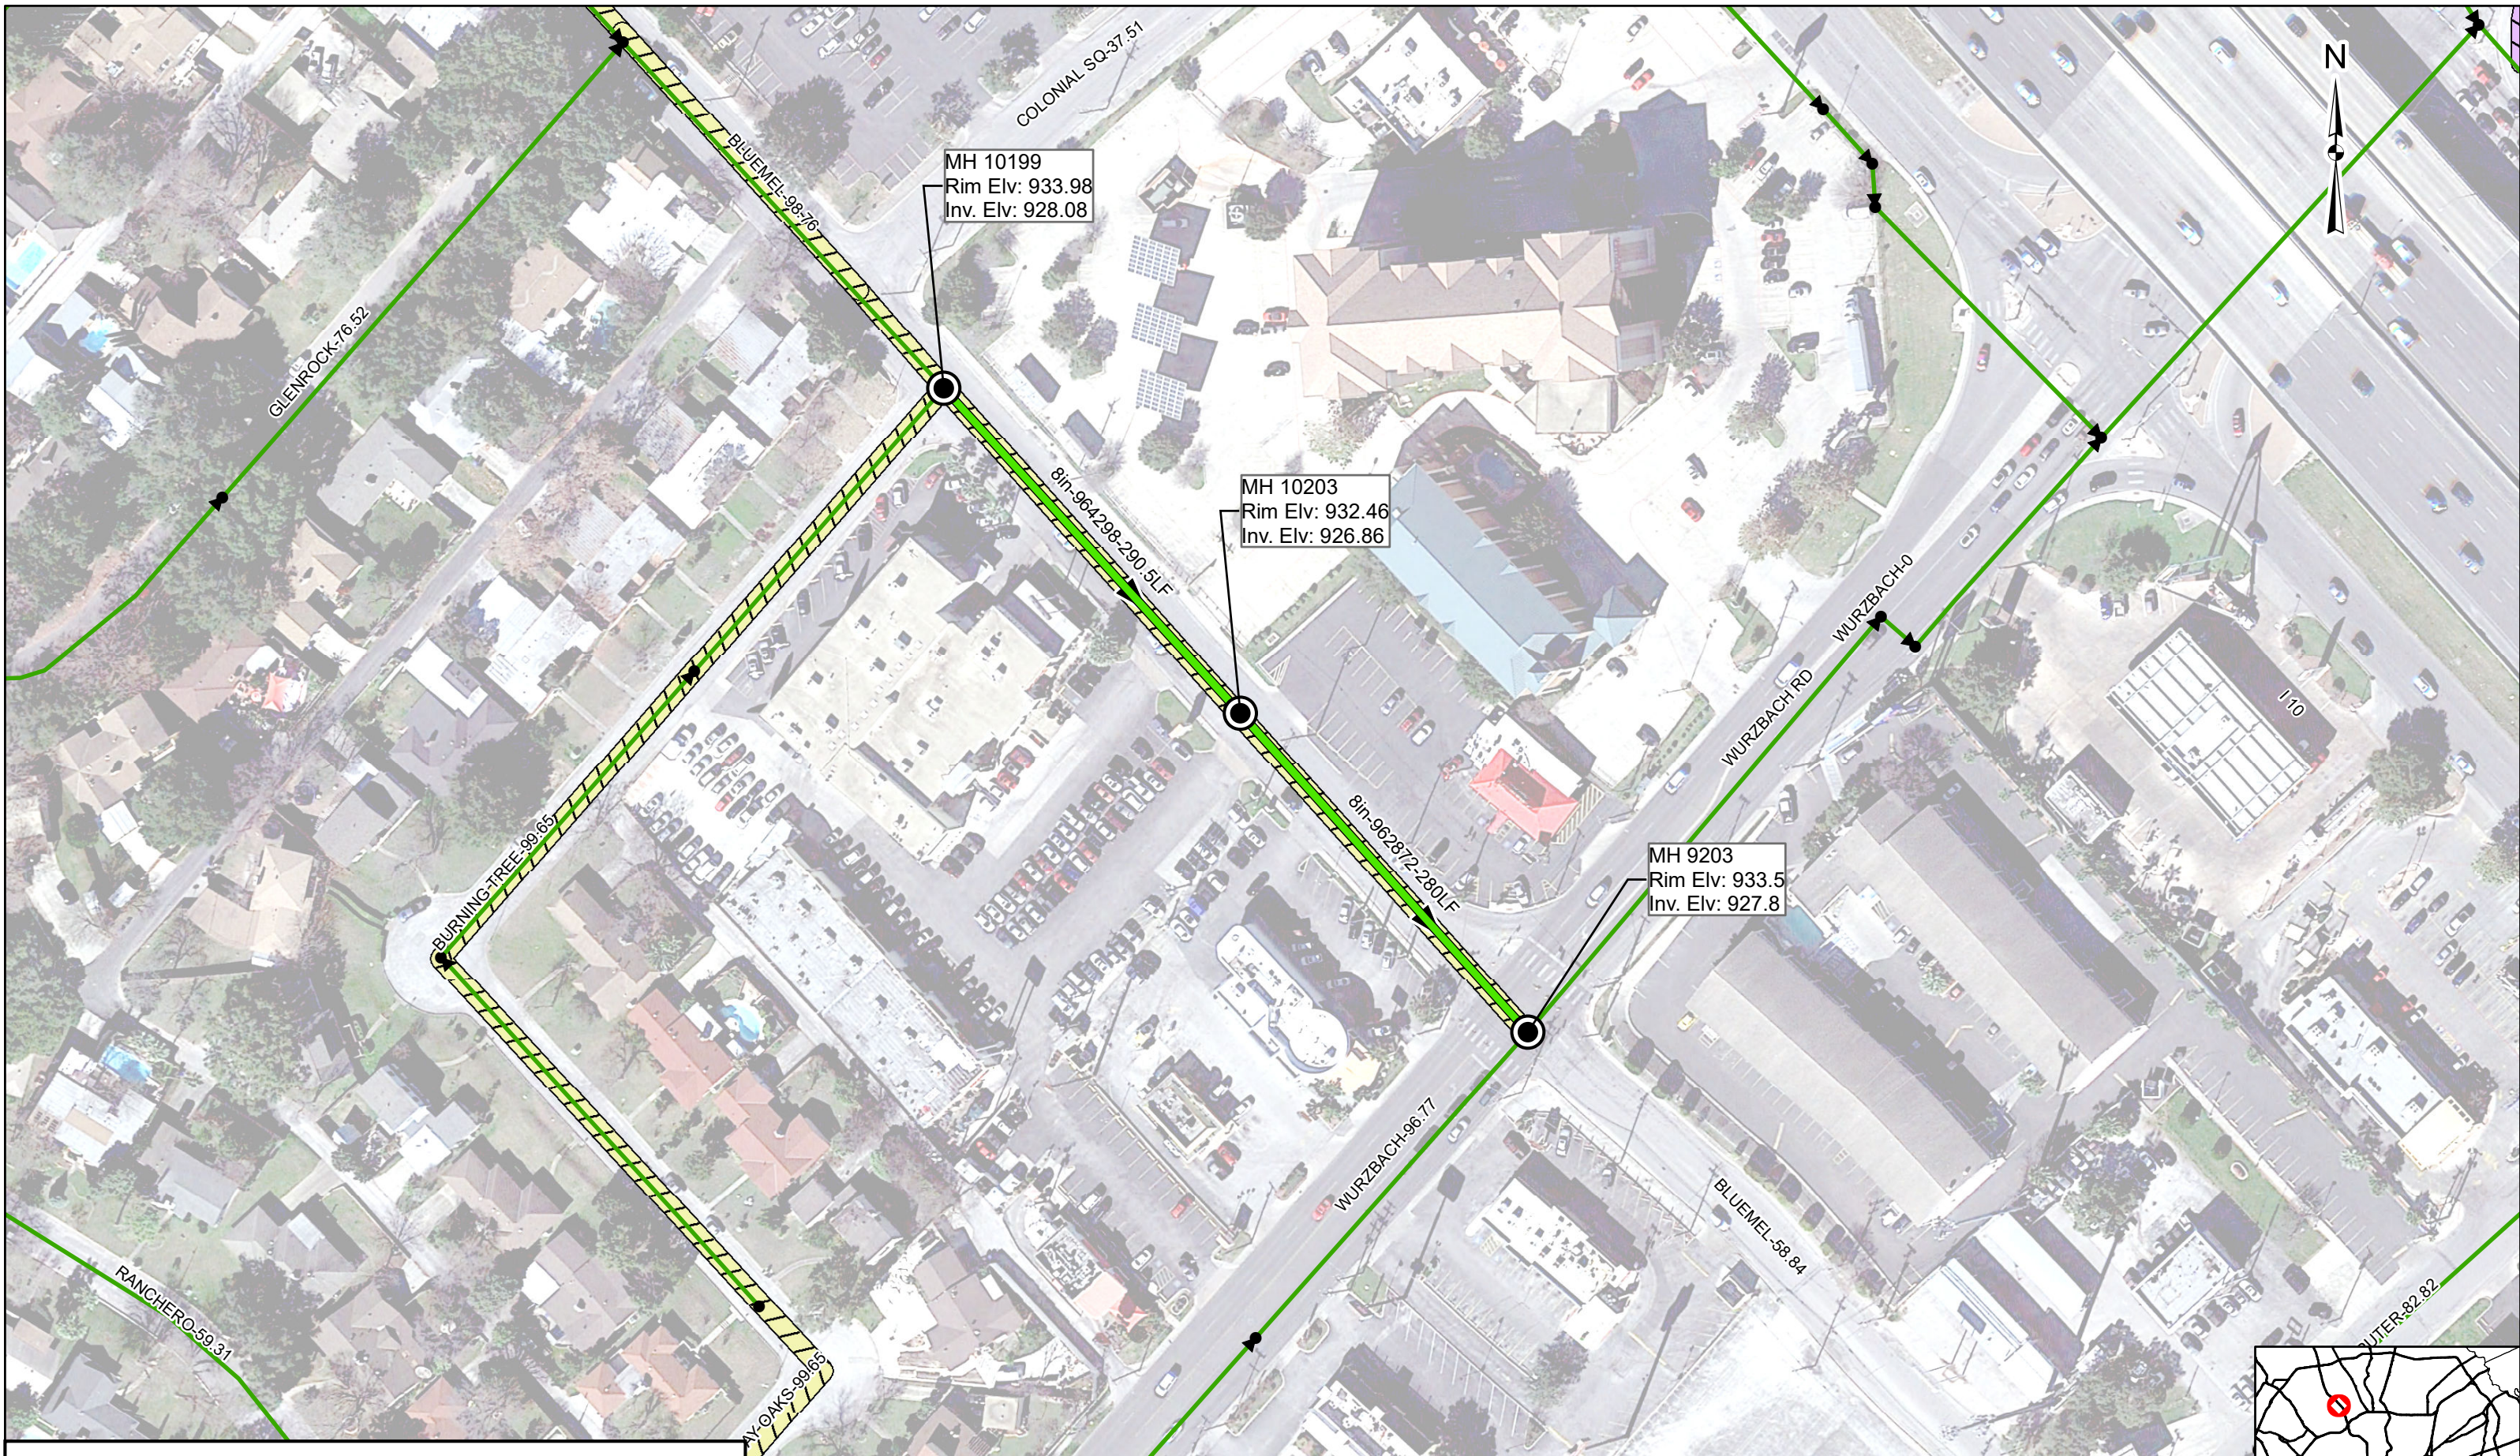
Map No.	Pipe ID	Preliminary Rehabilitation Actions	Diameter	Length	Material	Install Year	Comments
10	964298	OPEN CUT	8	290.5	VCP	1967	DS CCTV from 2021 includes MH to MH coverage. Pipe has surface aggregate missing and sags. 2 laterals identified in the CCTV. Main appears to cross a gas main and is parallel to/in line with a 8" water main. Segment is a C-rated opportunity main located upstream of an E-rated main, but its condition is declining, and sag should be addressed. Propose Open Cut due to condition and proximity to E-rated main proposed for Open Cut.
10	962872	OPEN CUT	8	280	VCP	1967	DS CCTV from 2021 includes 248ft of segment length and stops due to missing pipe within the flow line. Recent US CCTV not available. Pipe is in fair condition until 165ft from the USMH where the pipe begins to have sections of missing pipe and voids. DS CCTV from 2018 includes MH to MH coverage and also shows sections of missing pipe and voids. 3 laterals identified in the CCTV. Main appears to cross a gas main, OHE, and a 20" water main near DSMH and is parallel to/in line with a 8" water main. 2 SSOs reported at the lateral associated with the Pizza Hut in 2018 & 2021. SAWS WO #2038019 indicates a point repair will be made on this line. Consultant to follow-up with SAWS on the status of this WO and any available post CCTV during design. Propose Open Cut due to pipe condition.

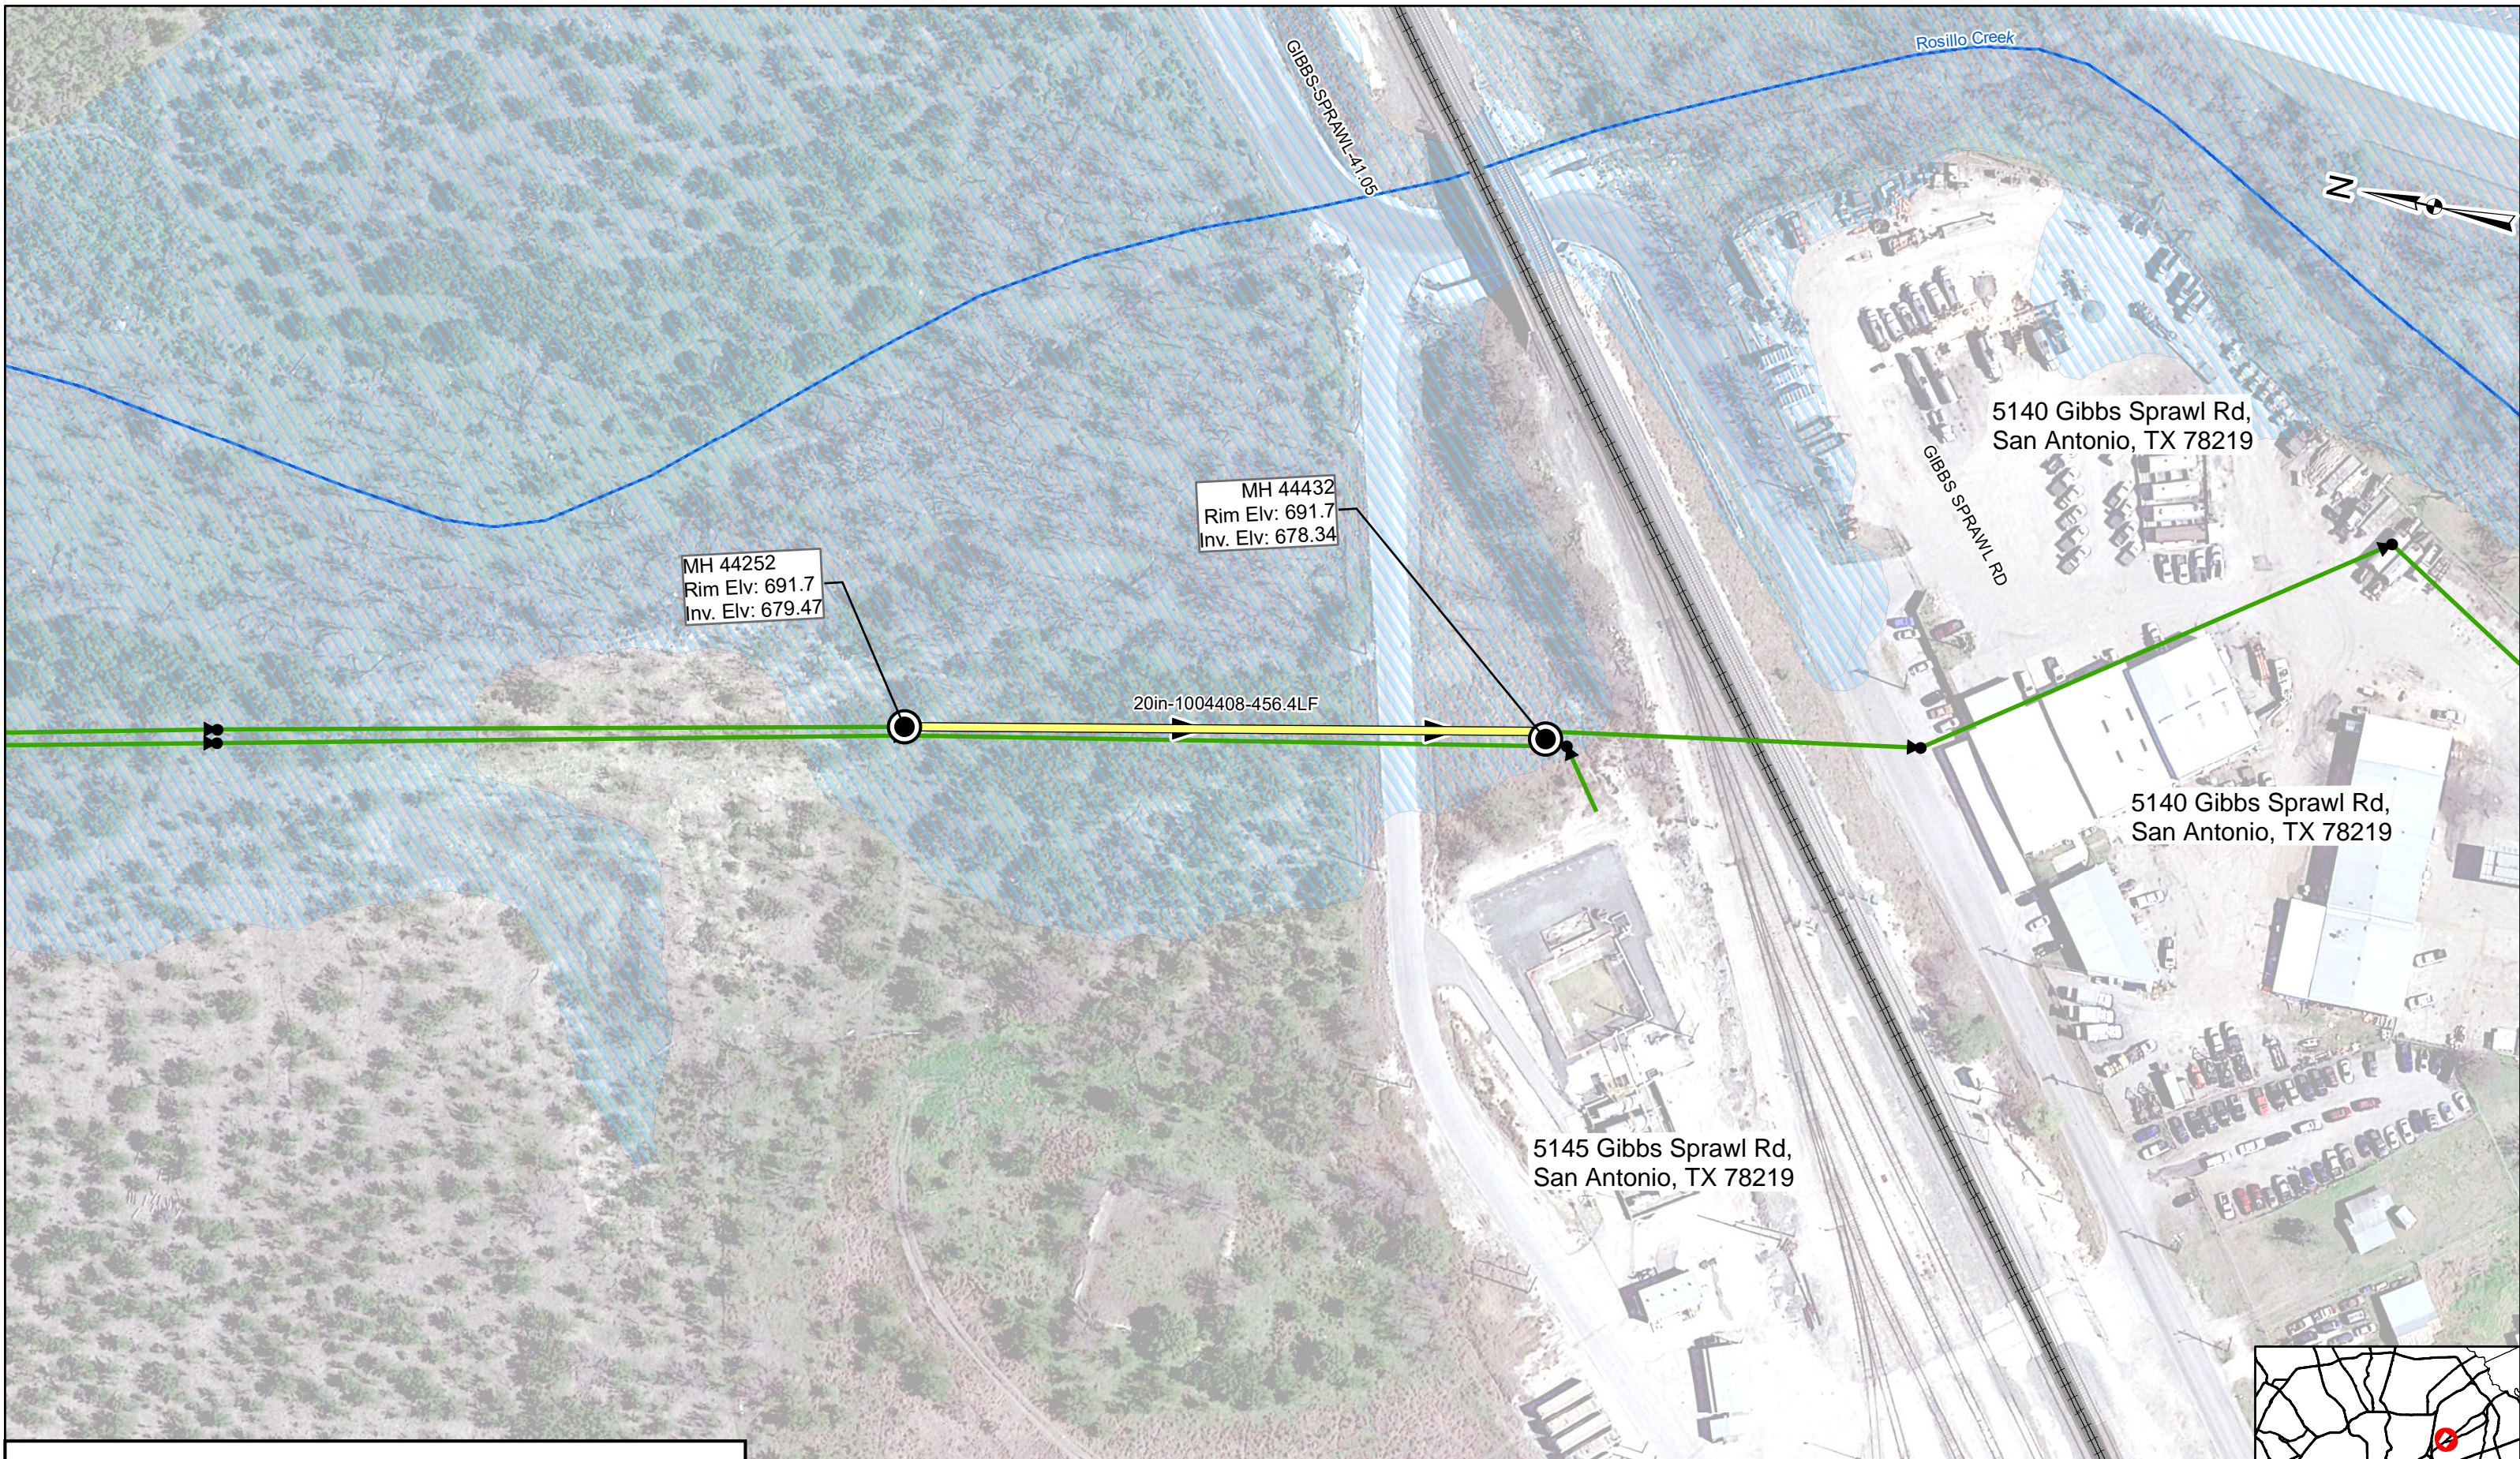
20in-1004408-456.4LF

12	1004408	PIPEBURST	20	456.4	DIP	1991	US CCTV from 2021 includes MH to MH coverage. Pipe material appears to be RCP, not DI. Surface aggregate visible, some reinforcement is visible, and there are a couple of intruding sealing rings hanging. The main has some sags, but they do not appear to be deep sags and there are no reported SSOs. As-builts indicate that the sewer main and the parallel 15" sewer main are located in a 25' easement. Consultant to confirm easements. Propose Pipe Bursting due to pipe condition and location.

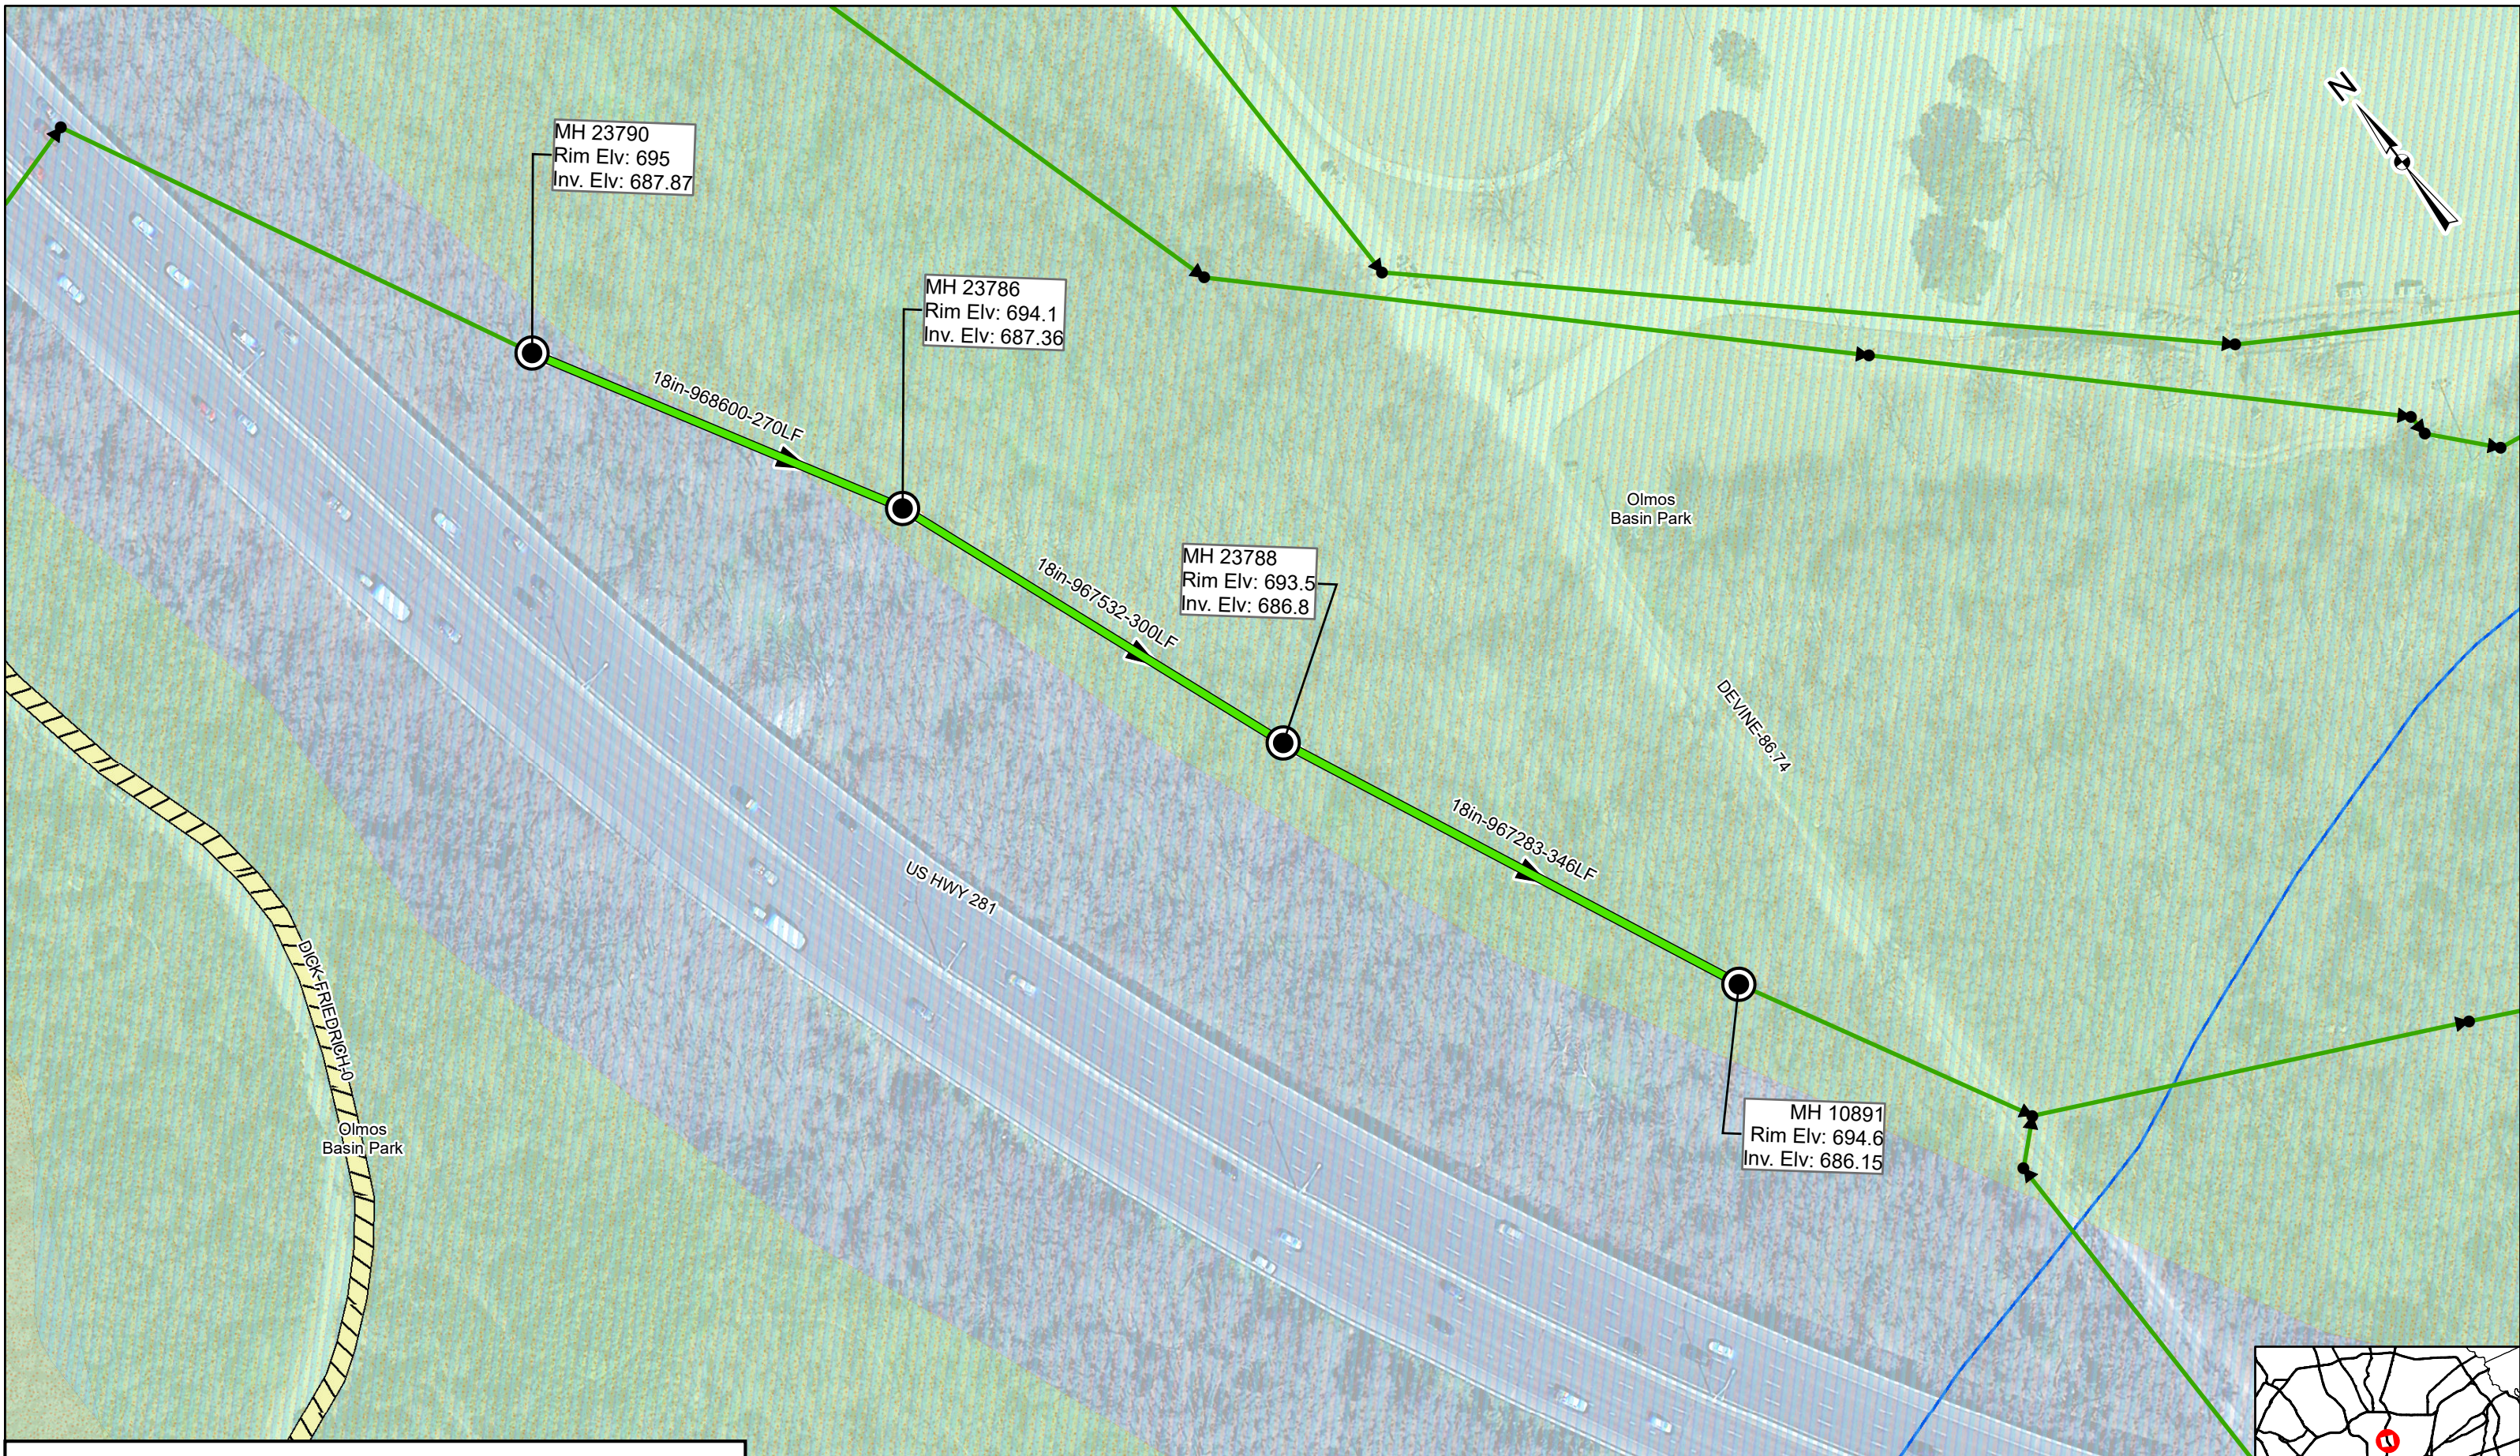
18in-968600-270LF

Map No.	Pipe ID	Preliminary Rehabilitation Actions	Diameter	Length	Material	Install Year	Comments
13	968600	OPEN CUT	18	270	VCP	1964	US CCTV from 2022 includes 102ft of segment length and stops at an offset joint. The first 80ft of pipe from the DSMH is PVC before it changes to VCP. The VCP pipe televised in US CCTV has multiple fractures, areas of broken pipe, and a void in the crown of the pipe. DS CCTV from 2022 stops at 10.8ft because of broken piece of pipe obstructing the crawler. There is a large void from 12oclock to 3 o'clock where this broken piece of pipe was previously located. As-builts do not indicate that the sewer main is within an easement. Consultant to investigate easements. Propose Open Cut due to known pipe defects and unknown pipe condition from unavailable CCTV coverage.
13	967532	OPEN CUT	18	300	VCP	1964	US CCTV from 2022 includes 28ft of segment length and stops because CCTV crawler cannot pass transition from VCP to PVC PR. US CCTV recorded multiple areas of broken pipe prior to material change. DS CCTV from 2022 stops at 3ft due to heavy silt in the pipe. As-builts do not indicate that the sewer main is within an easement. Consultant to investigate easements. Propose Open Cut due to areas of broken pipe and unknown pipe condition from unavailable CCTV coverage.

13	967283	OPEN CUT	18	346	VCP	1964	US CCTV from 2021 includes 61.5ft of segment length and stops due to large rag ball. Based on US CCTV from 2015, there is a large offset joint at that location that likely contributed to the rag ball. DS CCTV from 2021 stops at 3.5ft but it is unclear why CCTV crawler could not continue because of the high-water level. Camera zooms in on DS pipe and it appears there may be a pipe collapse. As-builts do not indicate that the sewer main is within an easement. Consultant to investigate easements. Propose Open Cut due to known pipe defects and unknown pipe condition from unavailable CCTV coverage.
14	974185	OPEN CUT	8	380	CP	1950	DS CCTV from 2022 includes 30ft of segment length and stops at missing pipe with cavity. Pipe is PVC up to the missing pipe, and the pipe appears to be concrete past the cavity. US CCTV from 2021 includes 25ft of segment length and stops at sag; rocks were visible in the line. US CCTV showed the pipe to be PVC going into the sag. CCTV from 2013 shows the main to be CP and VCP prior to the PVC Point Repairs, but complete CCTV was not available back then due to the already poor condition of the main. In 2013, the pipe was missing pipe wall and had cavities; it also had slight horizontal bends in the line. The main is located in an alley with a gas main and OHE. Smart MH located on the USMH. Propose Open Cut due to pipe condition. Consideration is need in regard to the depth of the line (10-14ft) and the space within the alley.
