GRAYSON ARMATURE WORKS
LARGE MOTOR DIVISION
 1910 JASMINE - PASADENA, TX 77503
 713-473-3231 FAX: 713-473-4201

SAN ANTONIO WATER SYSTEMS

GRAYSON SHOP JOB NUMBER 036108	ESTIMATED REPAIR COST
CUSTOMER PO# 201355	DATE RECEIVED 3/15/2013
EQUIPMENT ID	RFQ/WO

MANUFACTURER SIEMENS	HP/KW 3000	STYLE	TEMP. RISE C	PHASES 3	SF/PF 1.15
MODEL NUMBER 145	VOLTAGE 4000	RPM 3590	TYPE: RGWS	MOUNTING HORIZONTAL	
FRAME 8012	AMPS 370	SERIAL 1-5141-50198-1-3		ENCLOSURE

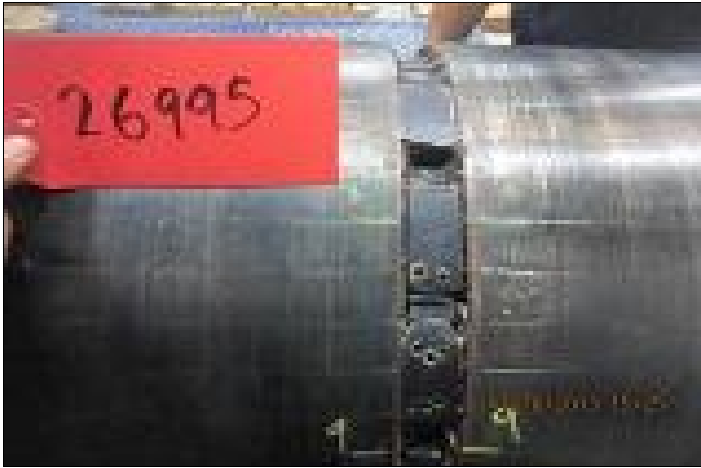
Center balance weight from SAWS original pictures

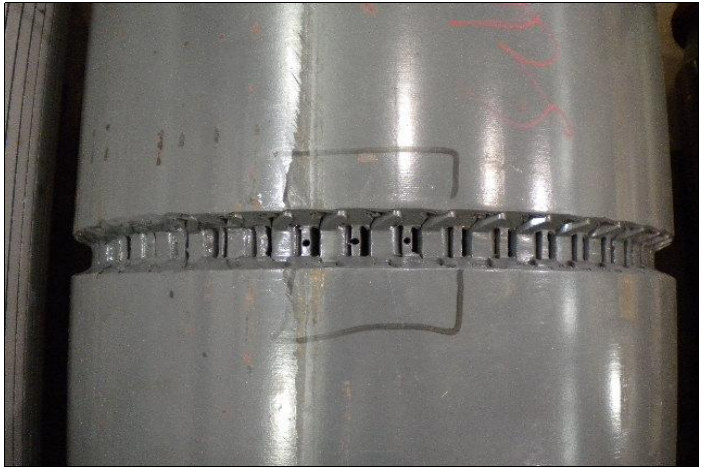
The center balance weight in the middle of the rotor is missing. This is part of a Siemens design that improves the balance of the rotor. This was probably done in the factory. All shaft fits, bearings and seals are worn.

Center balance weight is missing
This weight needs to be there

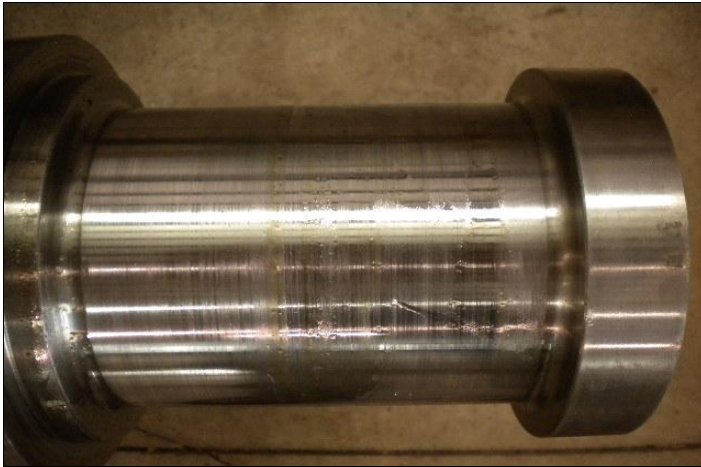
Outboard bearing journal is in rough condition

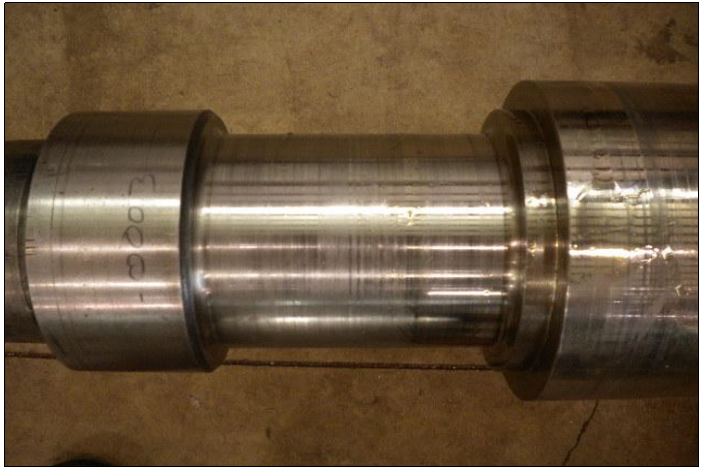
Inboard bearing journal is rough condition
Probe areas are scratched

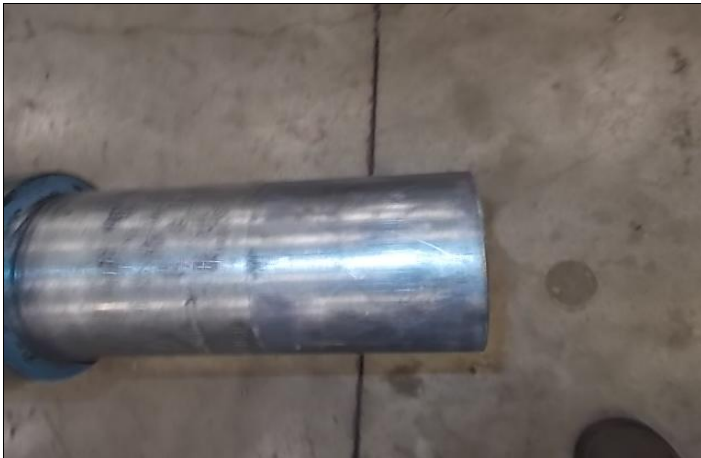
Coupling fit has visible damage

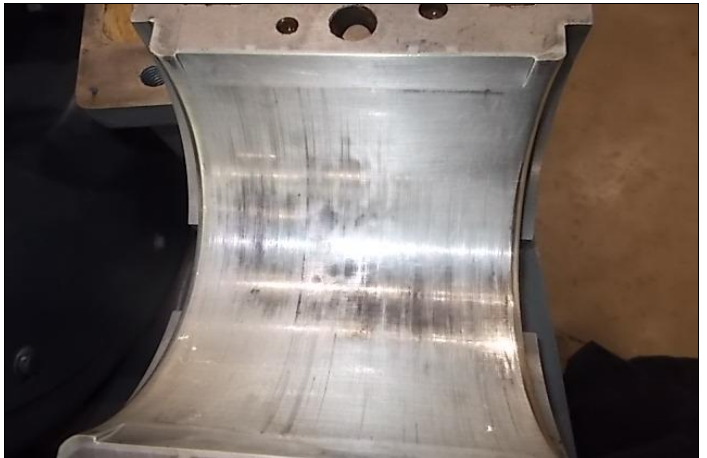
Bearings are oversized and have bad wear patterns

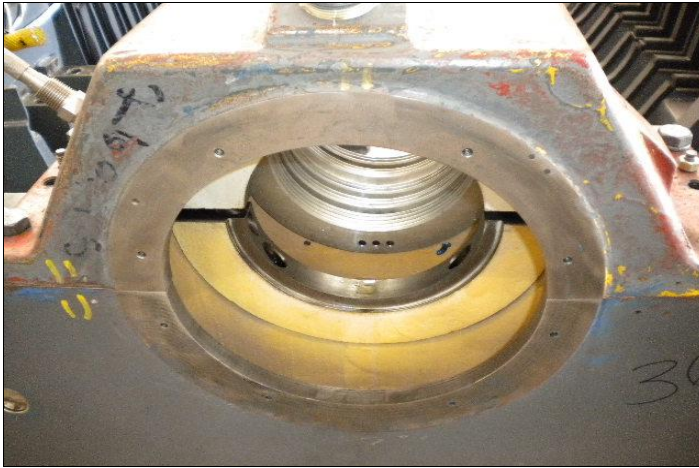
Bearing housings are oversized

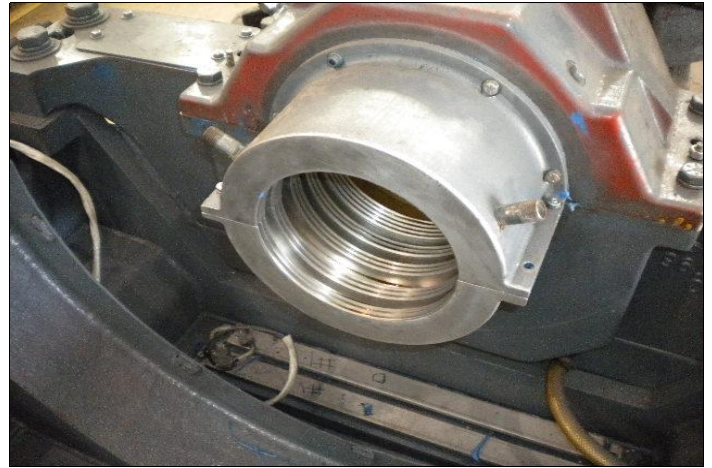
Seals are oversized

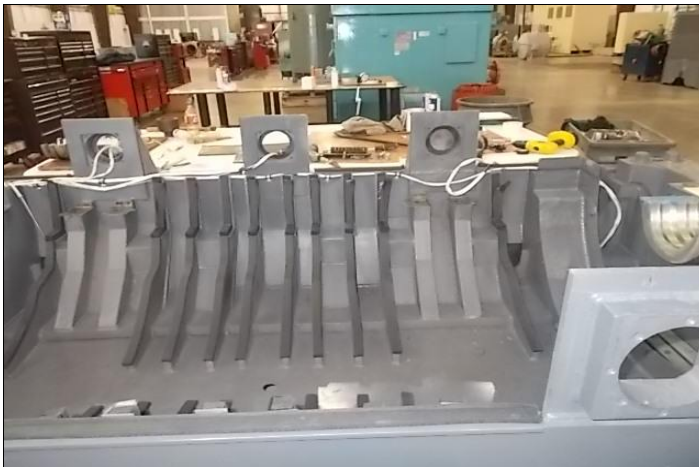
Bottom plate in frame is bent

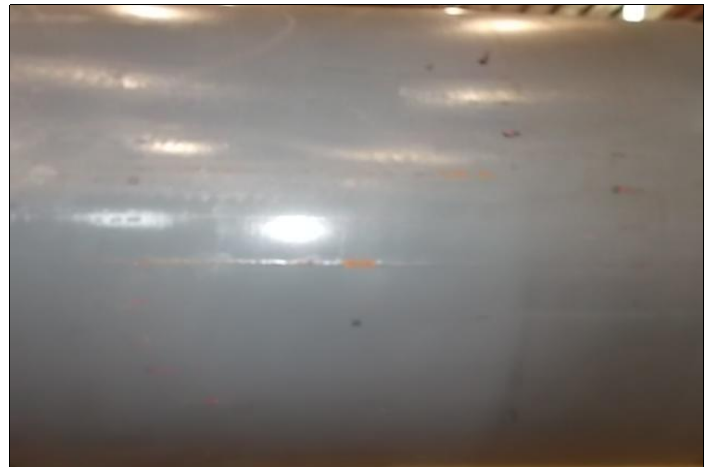
Bars are raising up in rotor.
Minor core penetration

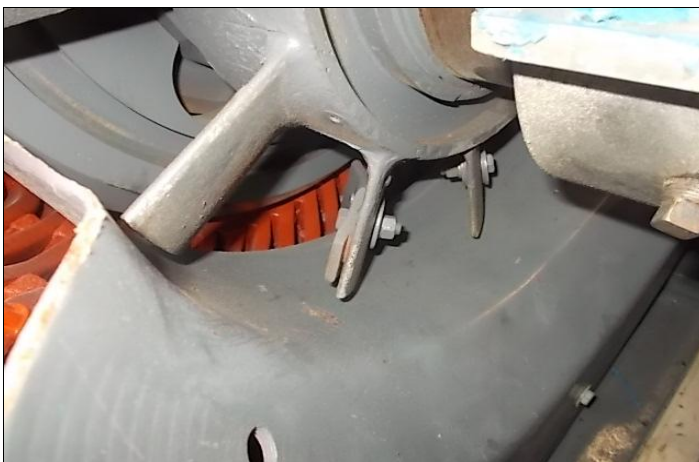
Excessive balance on internal fan blades

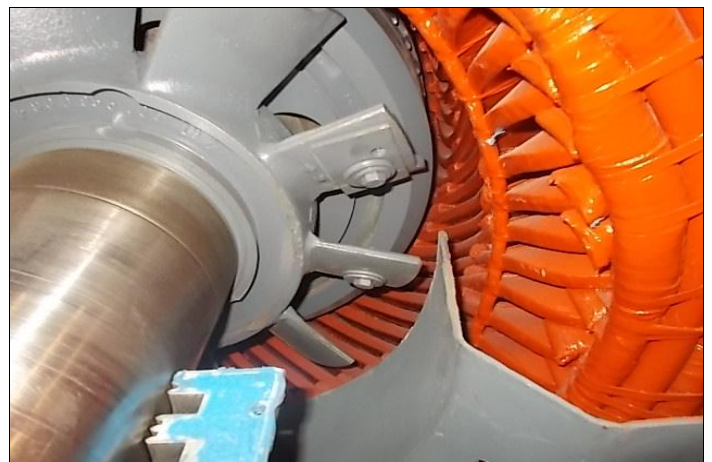
Excessive weight on internal fan blades
