# TEST HOLE SUMMARY REPORT

Project Name: SAWS Carrizo - NACO Pump Sta.

SAM - 31270-31 Prepared By: Alan Horton Client: Tetra Tech Date: 11/22/2011

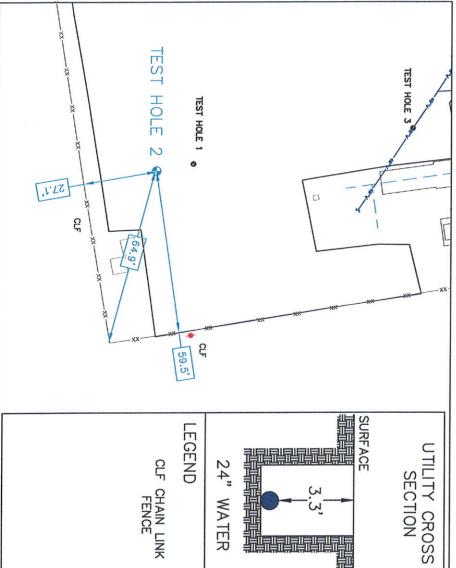
- 1. SAM, Inc. located Test Hole # 2 by No additional utilities were found within Test electronically designating the water line prior to air/vacuum excavation of the utility. Hole # 2 excavation.
- 3 All excavation was performed with The Test Hole was backfilled with air/vacuum excavation equipment.
- excavated material and asphalt patch.
- The picture depicts the existing water line surveying designated water line. Parking lot was resurfaced prior to

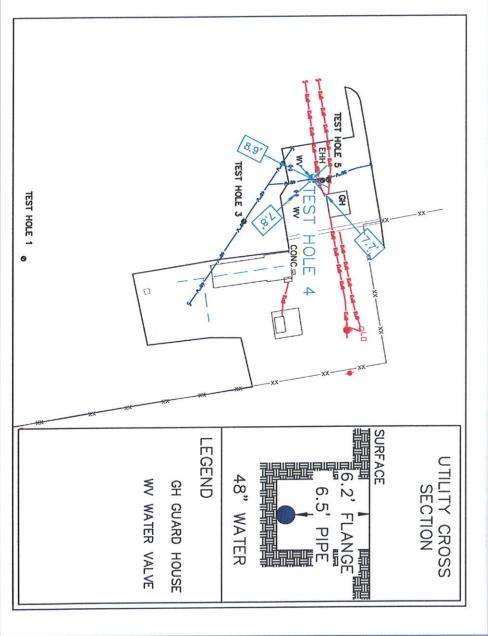
- 1. SAM, Inc. located Test Hole # 4 by No additional utilities were found within Tes-Hole # 4 excavation. prior to air/vacuum excavation of the utility electronically designating the water line
- All excavation was performed with The Test Hole was backfilled with air/vacuum excavation equipment
- excavated material.
- The picture depicts the existing water line.

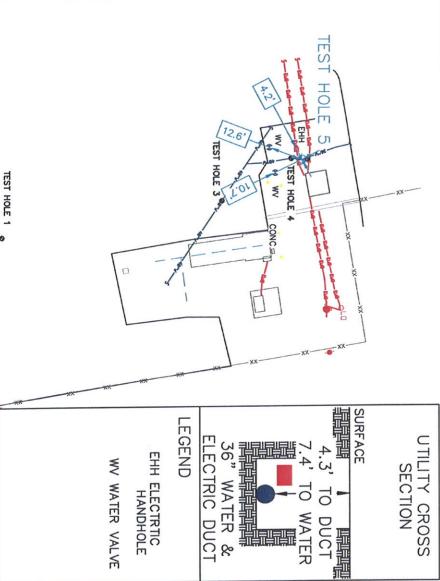
- SAM, Inc. located Test Hole # 5 by record air/vacuum excavation of the utility. information for the water line prior to
- All excavation was performed with A concrete electric duct 2' north of pipe was also found within Test Hole #5 excavation.
- The Test Hole was backfilled with air/vacuum excavation equipment
- excavated material.
- The picture depicts the existing water line.

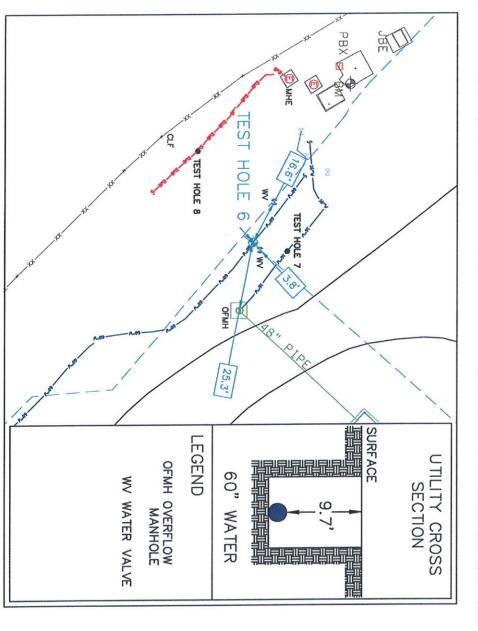
- SAM, Inc. located Test Hole # 6 by electronically designating the water line Hole # 6 excavation. No additional utilities were found within Test prior to air/vacuum excavation of the utility.
- 3 All excavation was performed with air/vacuum excavation equipment
- excavated material. The Test Hole was backfilled with
- The picture depicts the existing water line

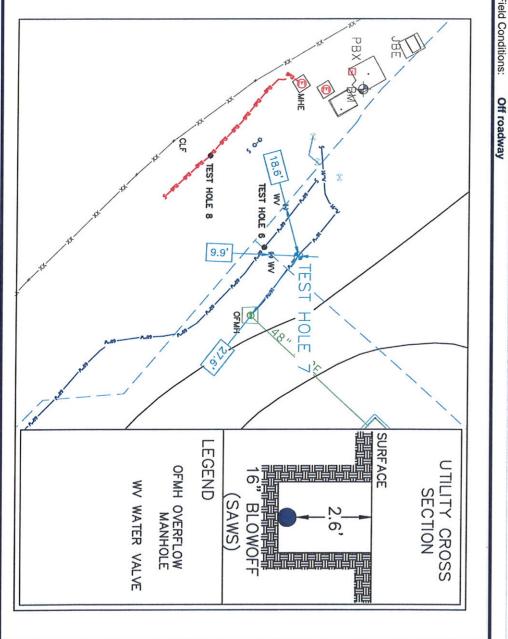
The picture depicts the existing water line

- 1. SAM, Inc. located Test Hole # 7 by No additional utilities were found within Test electronically designating the water line prior to air/vacuum excavation of the utility. Hole # 7 excavation.
- All excavation was performed with air/vacuum excavation equipment. The Test Hole was backfilled with
- excavated material.
