**STRUCTURAL ENGINEERING
ASSOCIATES, INC.
CONSULTING ENGINEERS**

Project Name: SAWS - Dos Rios Digester No. 6 Tank Evaluation

STRUCTURAL SITE VISIT REPORT

The purpose of the site visit was to give SAWS initial recommendations for life safety and a path forward for structural repairs and rehabilitation due to a sludge overflow event that caused the digester dome to be shifted out of its position.

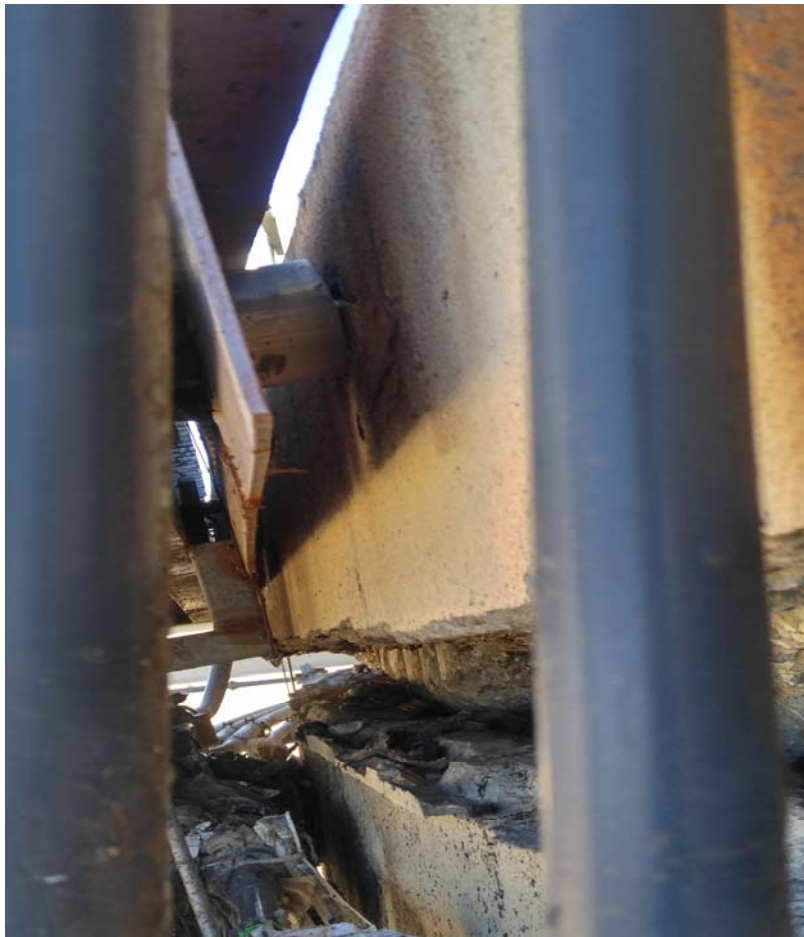
Figure 1

The mixer platform moved away from the prestressed composite core wall horizontally and vertically (Figure 1) and tilted slightly (Figure 2) due to the overflow. The pipe that is connected to the motor at the top of the mixer platform was damaged due to the vertical movement of the digester dome. Some damage was observed at the outside cover of the mixer draft tube. It was not clear if this damage was due to the overflow, or the pressure built up due to the overflow. A few of the steel angles that were supporting the platform were detached from the ring around the mixer draft tube (Figure 3). A steel hollow section was observed under the mixer platform, which was completely detached. Some of the pipes under the mixer platform appeared to be damaged and detached (Figure 3).

- 3) The concrete between the prestressed core wall and the concrete dome should be repaired and sealed.
- 4) All damaged steel angles supporting the mixer platform that have been broken or damaged should be replaced.

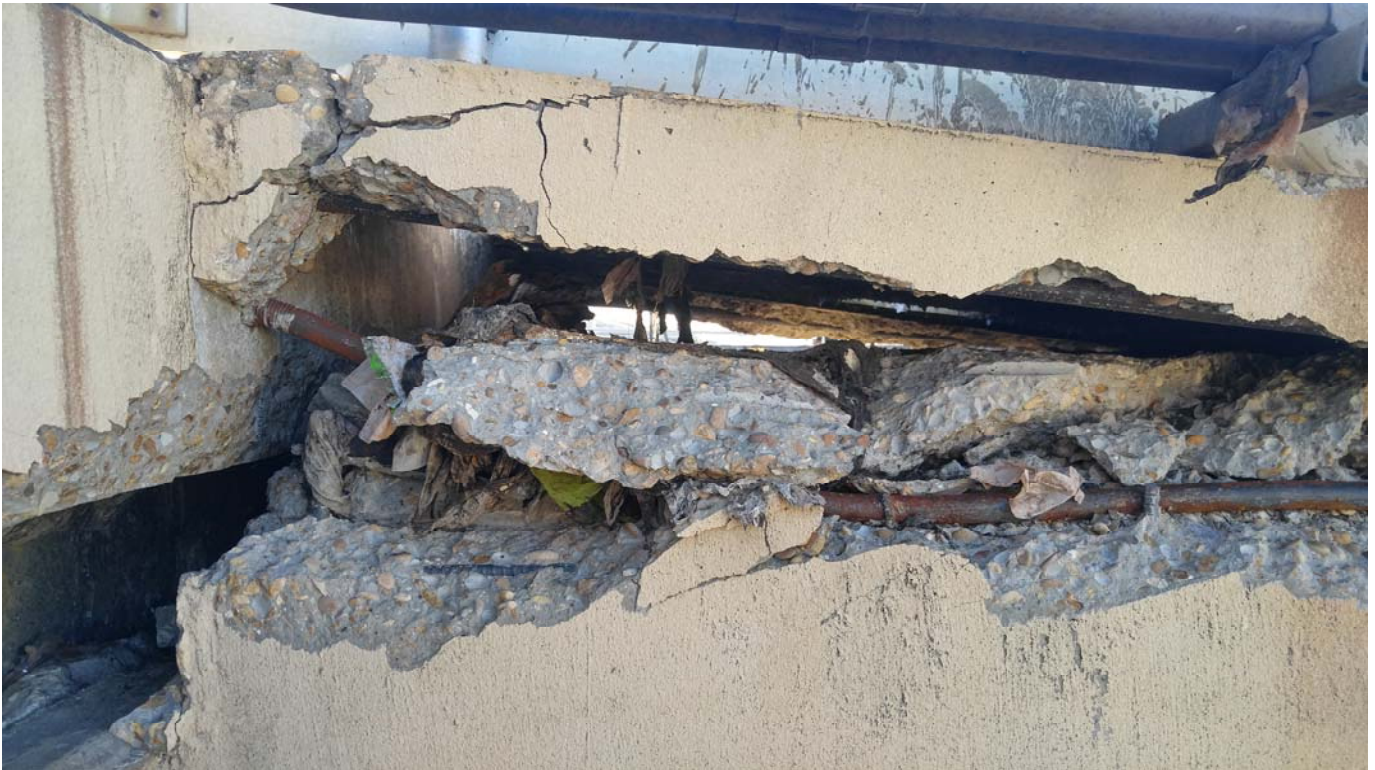
Figure 4

The transfer box is attached to both the dome and the prestressed composite core wall. When the pressure from the overflow lifted the dome, the concrete box split into two pieces vertically and moved away from the prestressed composite core wall horizontally and vertically (Figure 4). The gap between the two pieces varies from a hairline, to 12 in. vertically. Pipes and rebar within the box are currently exposed and appeared to be damaged. Bars are also exposed at the face of the box at two locations due to spalled concrete (Figure 5). The concrete spalls are 7 in. to 12 in long horizontally.

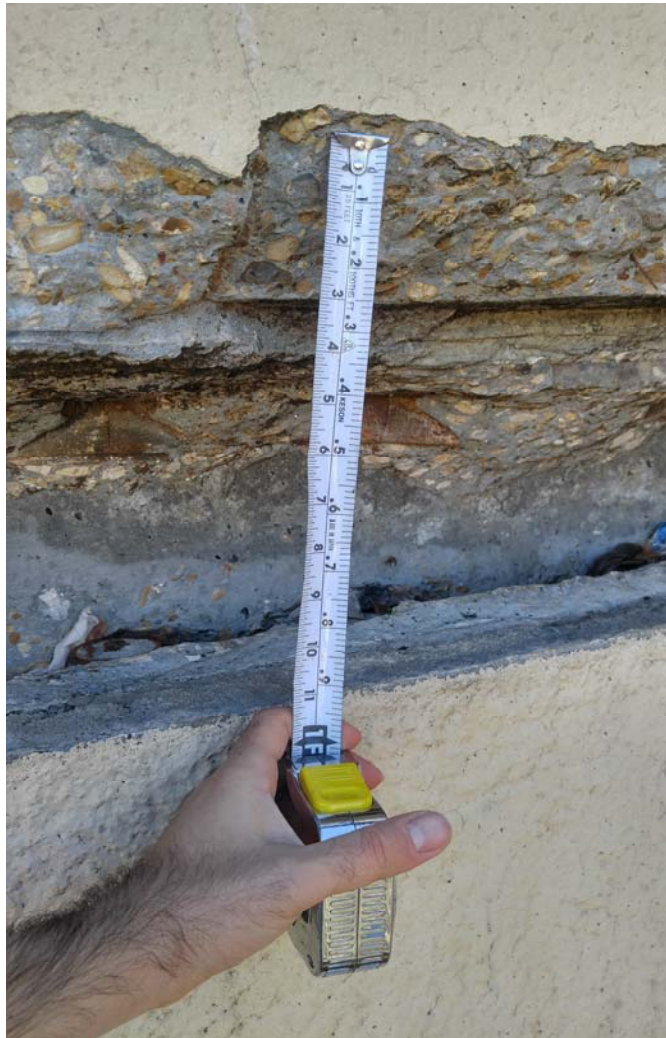
Figure 6

The vertical gap between the concrete dome and the prestressed composite core wall varies from 0 in. to 12 in. (Figure 6). The horizontal distance from the outer face of the wall to the outer face of the dome is 8.5 in. (Figure 7). No dowels were observed between the dome and the wall (Figure 8). Moderate to severe concrete spalling was observed where the dome meets the wall (Figure 8).

- 2) A specialized lifting/shoring company should be hired to shore/lift the concrete dome, repair the coped lid and tank rim, and place it back into it's original location.

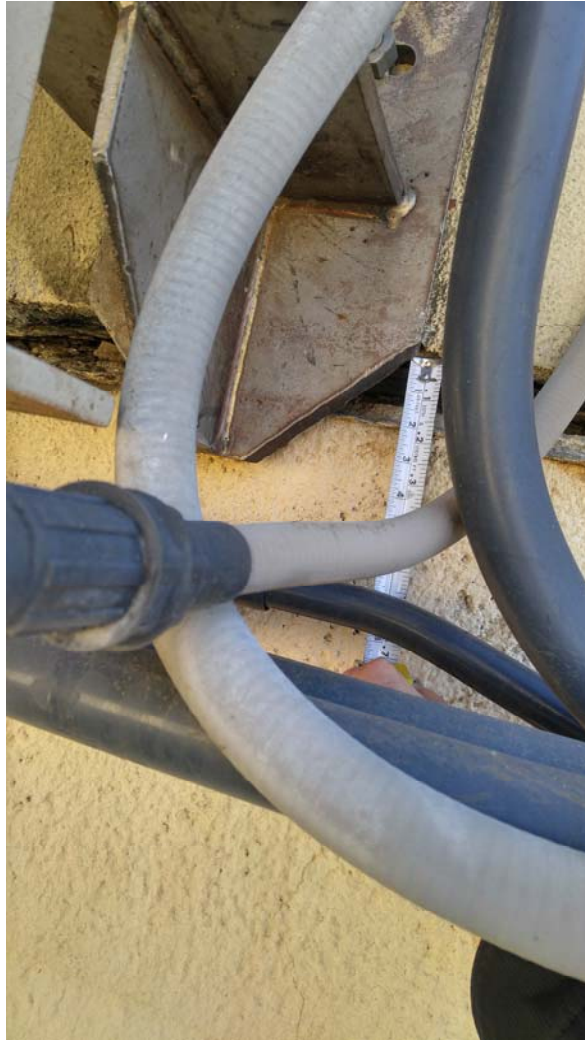
Figure 9

The catwalk connecting the first and second rows of digesters is currently lifted 2 in. at the connection attached to the Digester No. 6 due to the vertical movement of the digester dome (Figure 9).

- 5) No damage was visible at the Catwalk connections. However, the lifting/shoring contractor should evaluate the conditions, shore the catwalk as needed, and release the existing connections if necessary prior to lifting the lid. After dome/tank repairs are made and the lid is placed to it's original location, the catwalk connections should be repaired/replaced.
