CAPACITY, MANAGEMENT, OPERATION, AND MAINTENANCE ALTERNATIVES ANALYSIS

Project Scoping Report

2022 CMOM Central West Sewershed Project

PREPARED FOR: San Antonio Water System

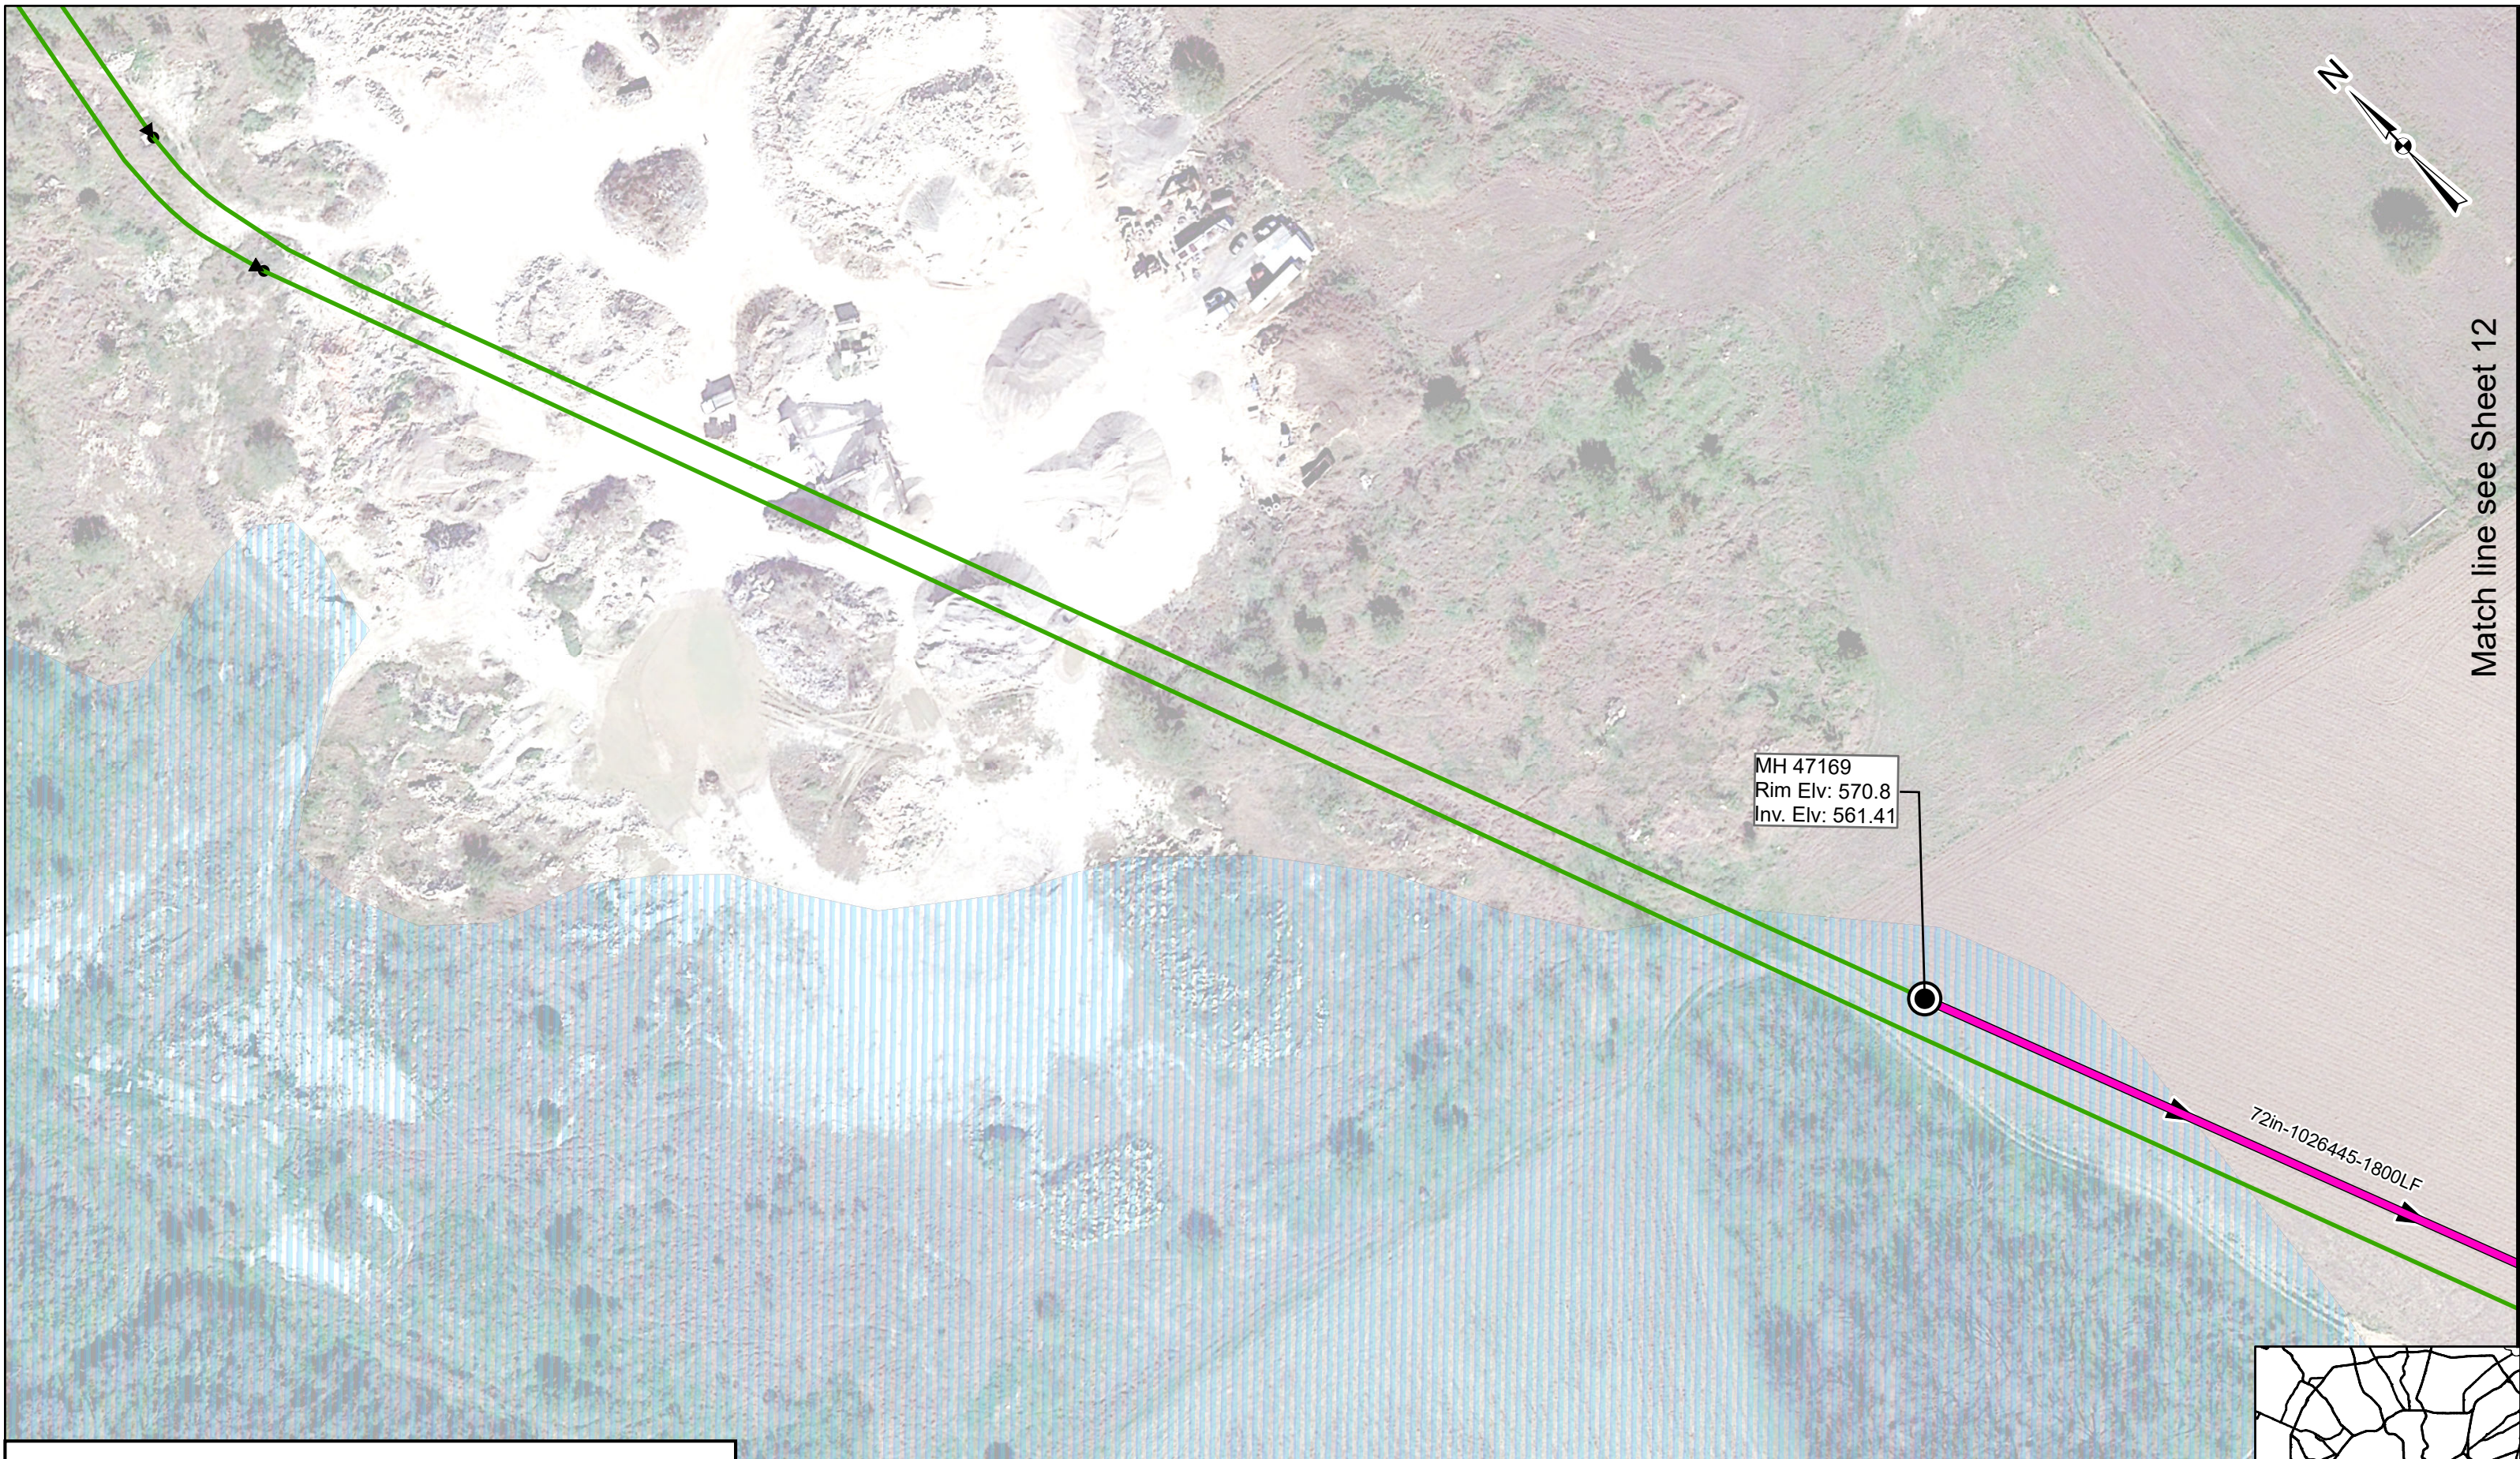
72in-1026445-1800LF

11	1026445	CIPP	72	1800	RCP	1986	DS CCTV from 2021 includes MH to MH coverage and sonar available. Pipe has reinforcement visible/projecting and intruding sealing rings and rags hanging throughout. Pipe is a candidate for CIPP. As-built indicates main is in a 50' sewer easement that also covers the parallel 54" sewer main. Consultant to confirm easement. As-built also indicates the main is within a 130LF concrete saddle near the USMH where there is shallow ground coverage and there is a curve in the main near the DSMH. There is a parallel 42" recycle main along the length of the pipe. Sewer mains upstream of this segment are part of Multiple Sewershed Pkg 18 project. Propose CIPP due to pipe size, condition, and location.
12	976097	CIPP	54	1030	RCP	1965	DS CCTV from 2021 includes MH to MH coverage and sonar available. Pipe has reinforcement visible/projecting throughout and deposits attached ragging. CCTV shows slight curve in the pipe near the DSMH. Pipe is a candidate for CIPP. As-built indicates main is in a 50' sewer easement. Consultant to confirm easement. There is a parallel 42" recycle main along the length of the pipe. Sewer mains upstream of this segment are part of Multiple Sewershed Pkg 18 project. Propose CIPP due to pipe size, condition, and location.

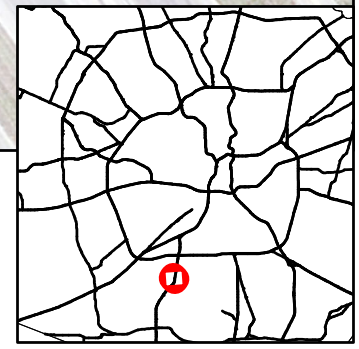
54in-3213786-1243LF

14	3213786	CIPP	54	1243	RCP	2003	DS CCTV from 2021 includes MH to MH coverage and sonar available. Pipe has reinforcement visible/projecting and deposit attached ragging. Pipe is a candidate for CIPP. As-built indicates main is in a 50' sewer easement. Consultant to confirm easement. There is also a parallel 42" recycle main. Propose CIPP due to pipe size, condition, and location.
15	1010674	CIPP	60	496	RCP	2003	DS CCTV from 2021 includes MH to MH coverage and sonar available. Pipe has reinforcement visible and surface aggregate missing. Pipe is a candidate for CIPP. Segment appears to cross two gas mains, a 16" water main, OHE, and a concrete drainage channel along Applewhite Rd; segment also runs parallel to a 42" recycle main. Propose CIPP due to pipe size, condition, and location.

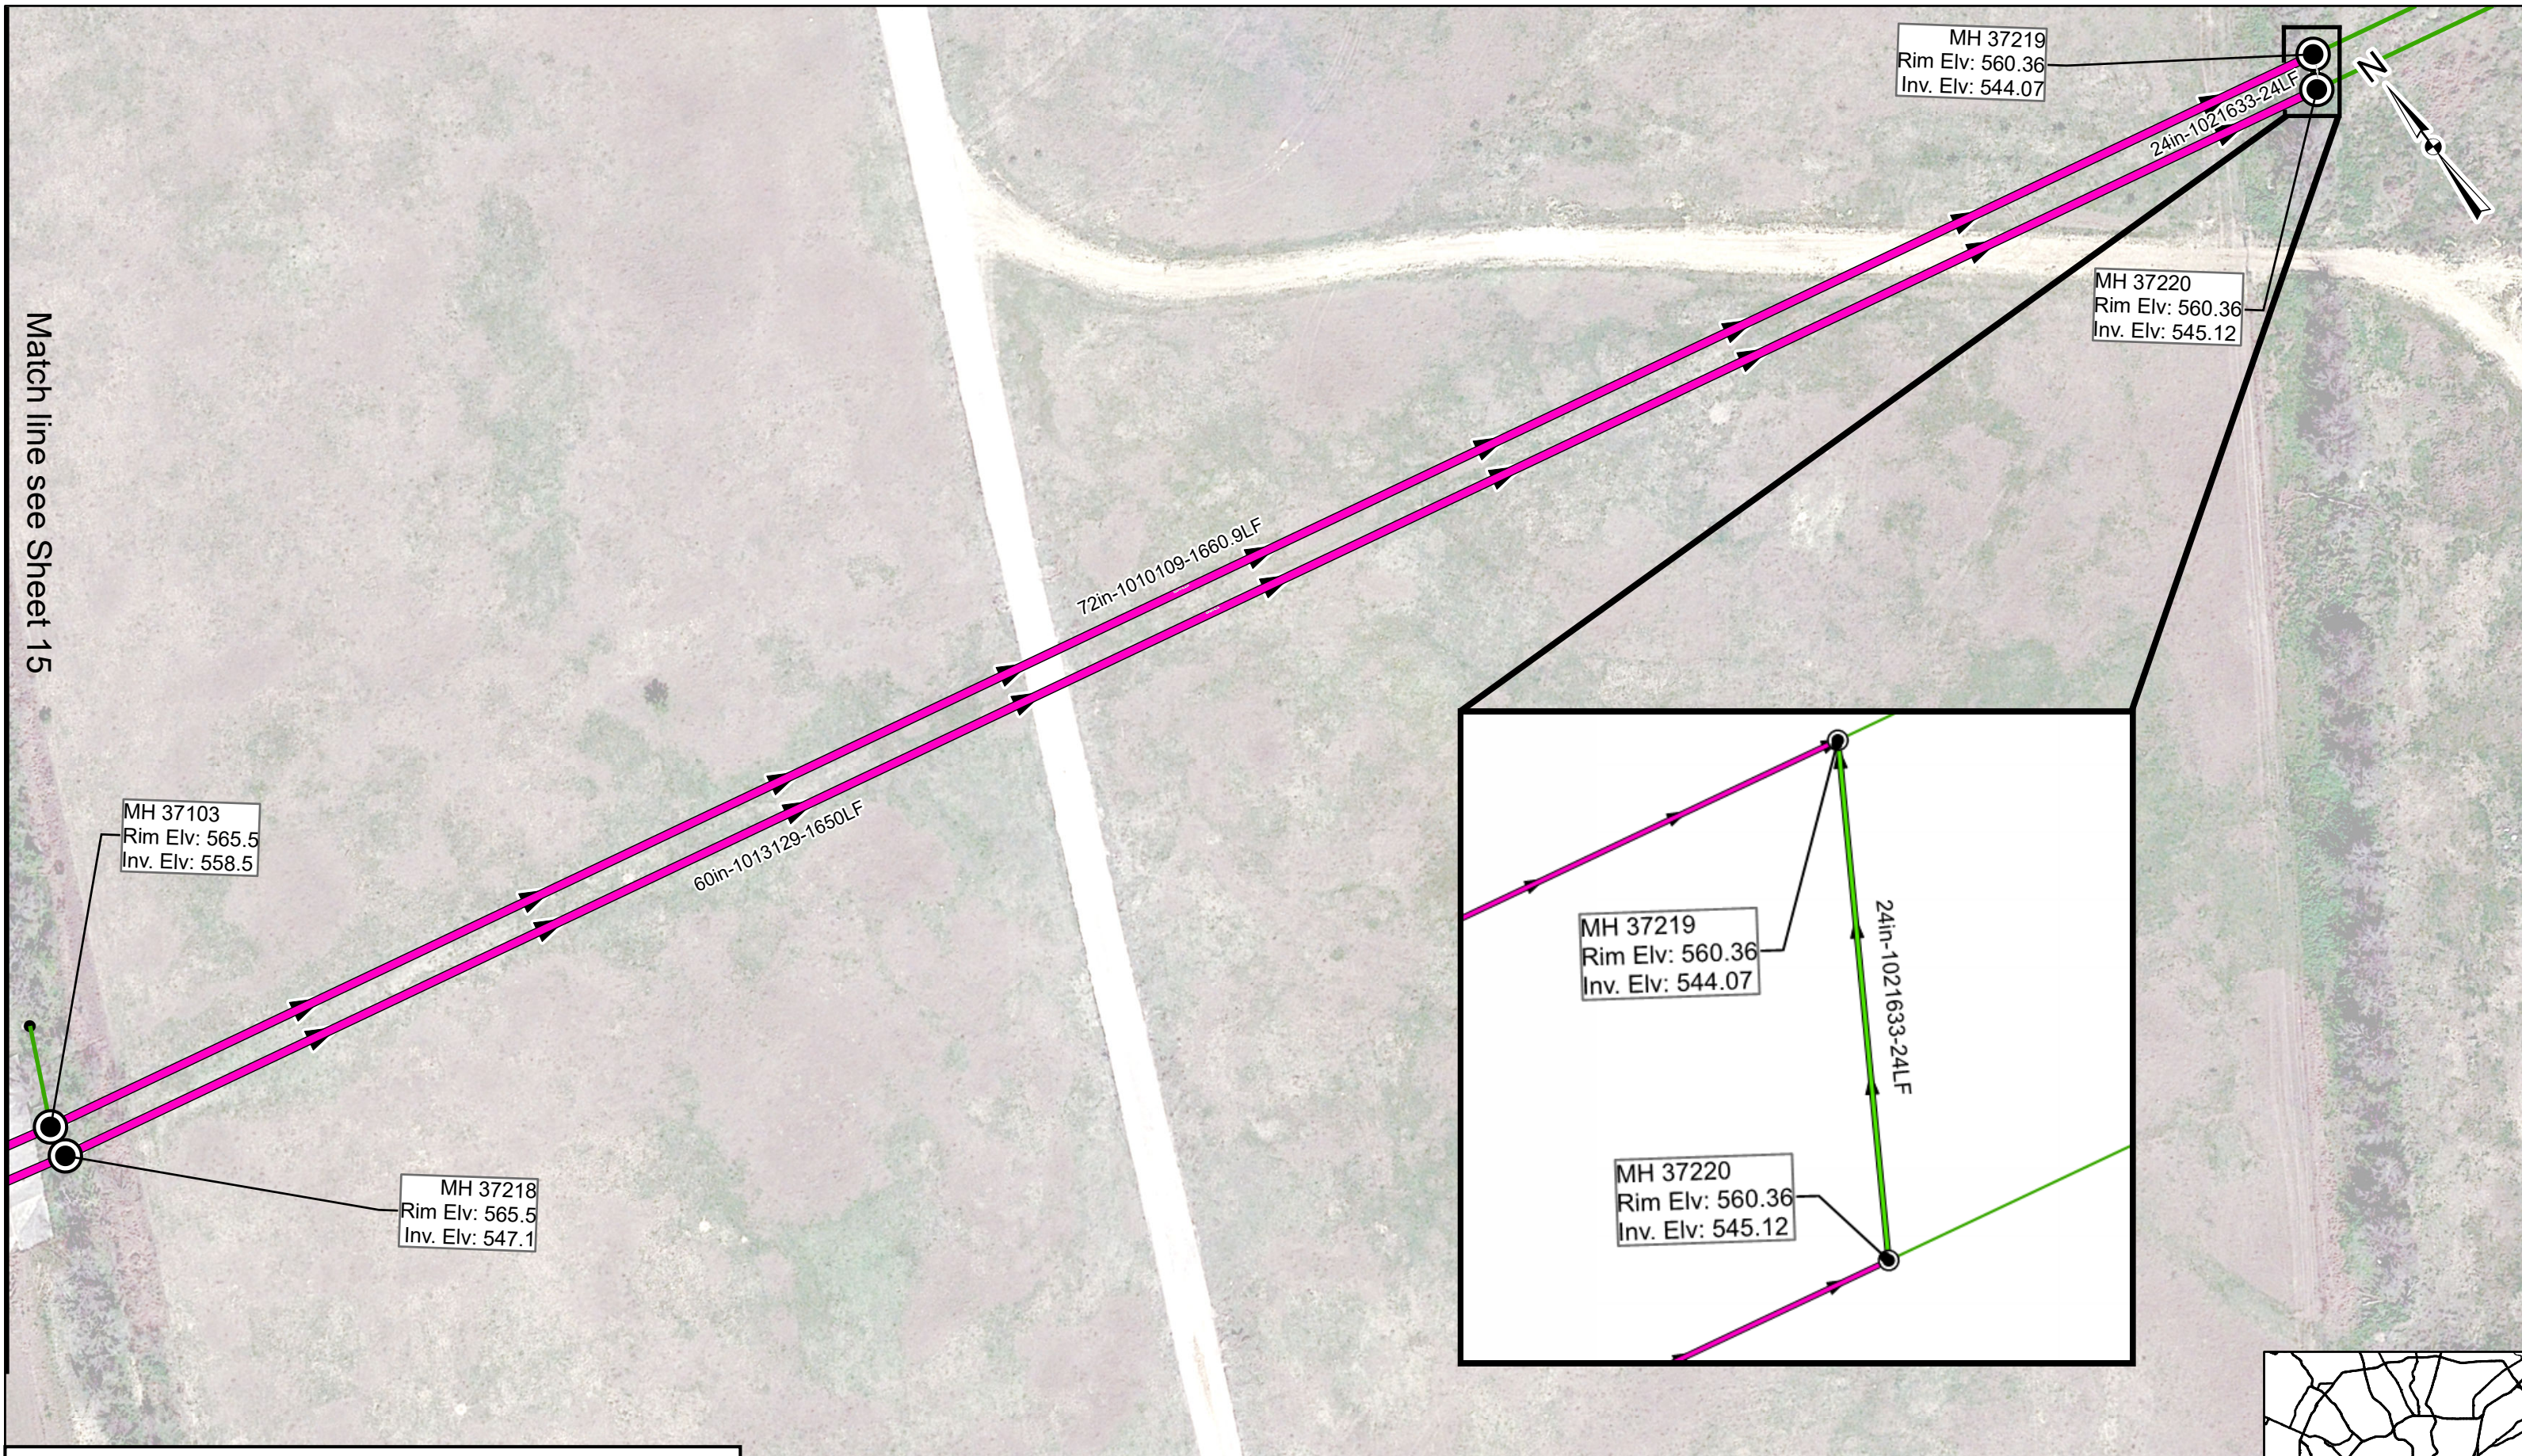
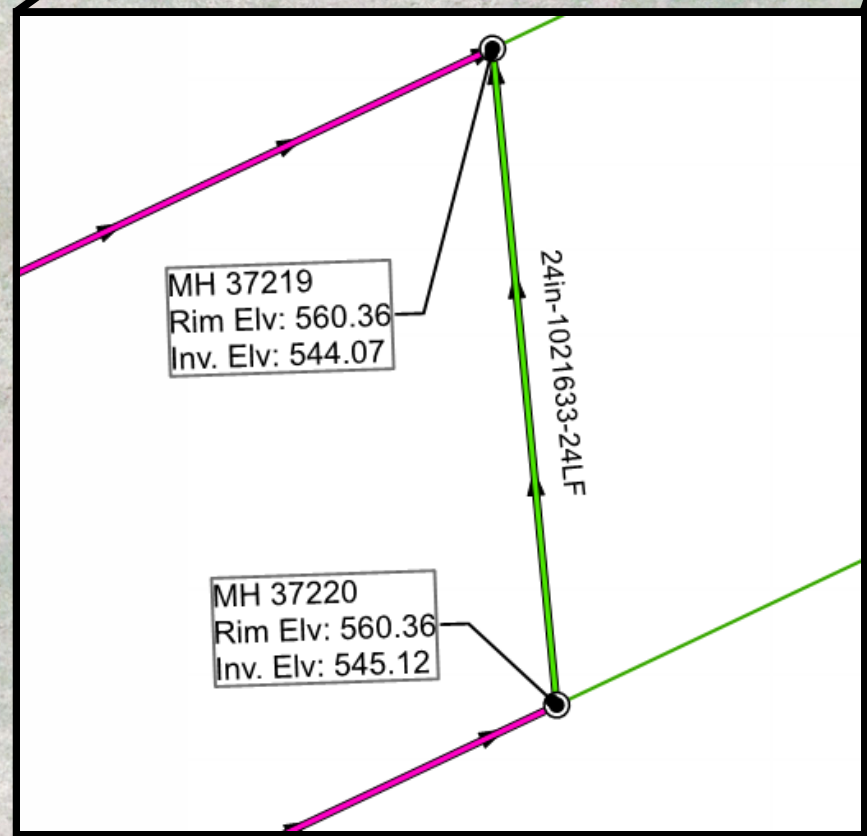
24in-1021633-24LF

16	1021633	OPEN CUT	24	24	PVC	1986	DS CCTV from 2021 includes MH to MH coverage. Pipe has reinforcement visible, surface aggregate missing, and also appears to have deposit attached encrustation. Pipe could be lined but may require mechanical cleaning. Pipe acts as a balancing line between the 60" main and 72" main. Propose Open Cut due to pipe condition, size, and short segment length.
16	1013129	CIPP	60	1650	RCP	2003	DS CCTV from 2021 includes MH to MH coverage and sonar available. Pipe has reinforcement visible and surface aggregate missing. Pipe is a candidate for CIPP. Segment runs parallel to a 42" recycle main. Propose CIPP due to pipe size, condition, and location.
