CAPACITY, MANAGEMENT, OPERATION, AND MAINTENANCE ALTERNATIVES ANALYSIS

Project Scoping Report

2022 CMOM Central West Sewershed Project

PREPARED FOR: San Antonio Water System

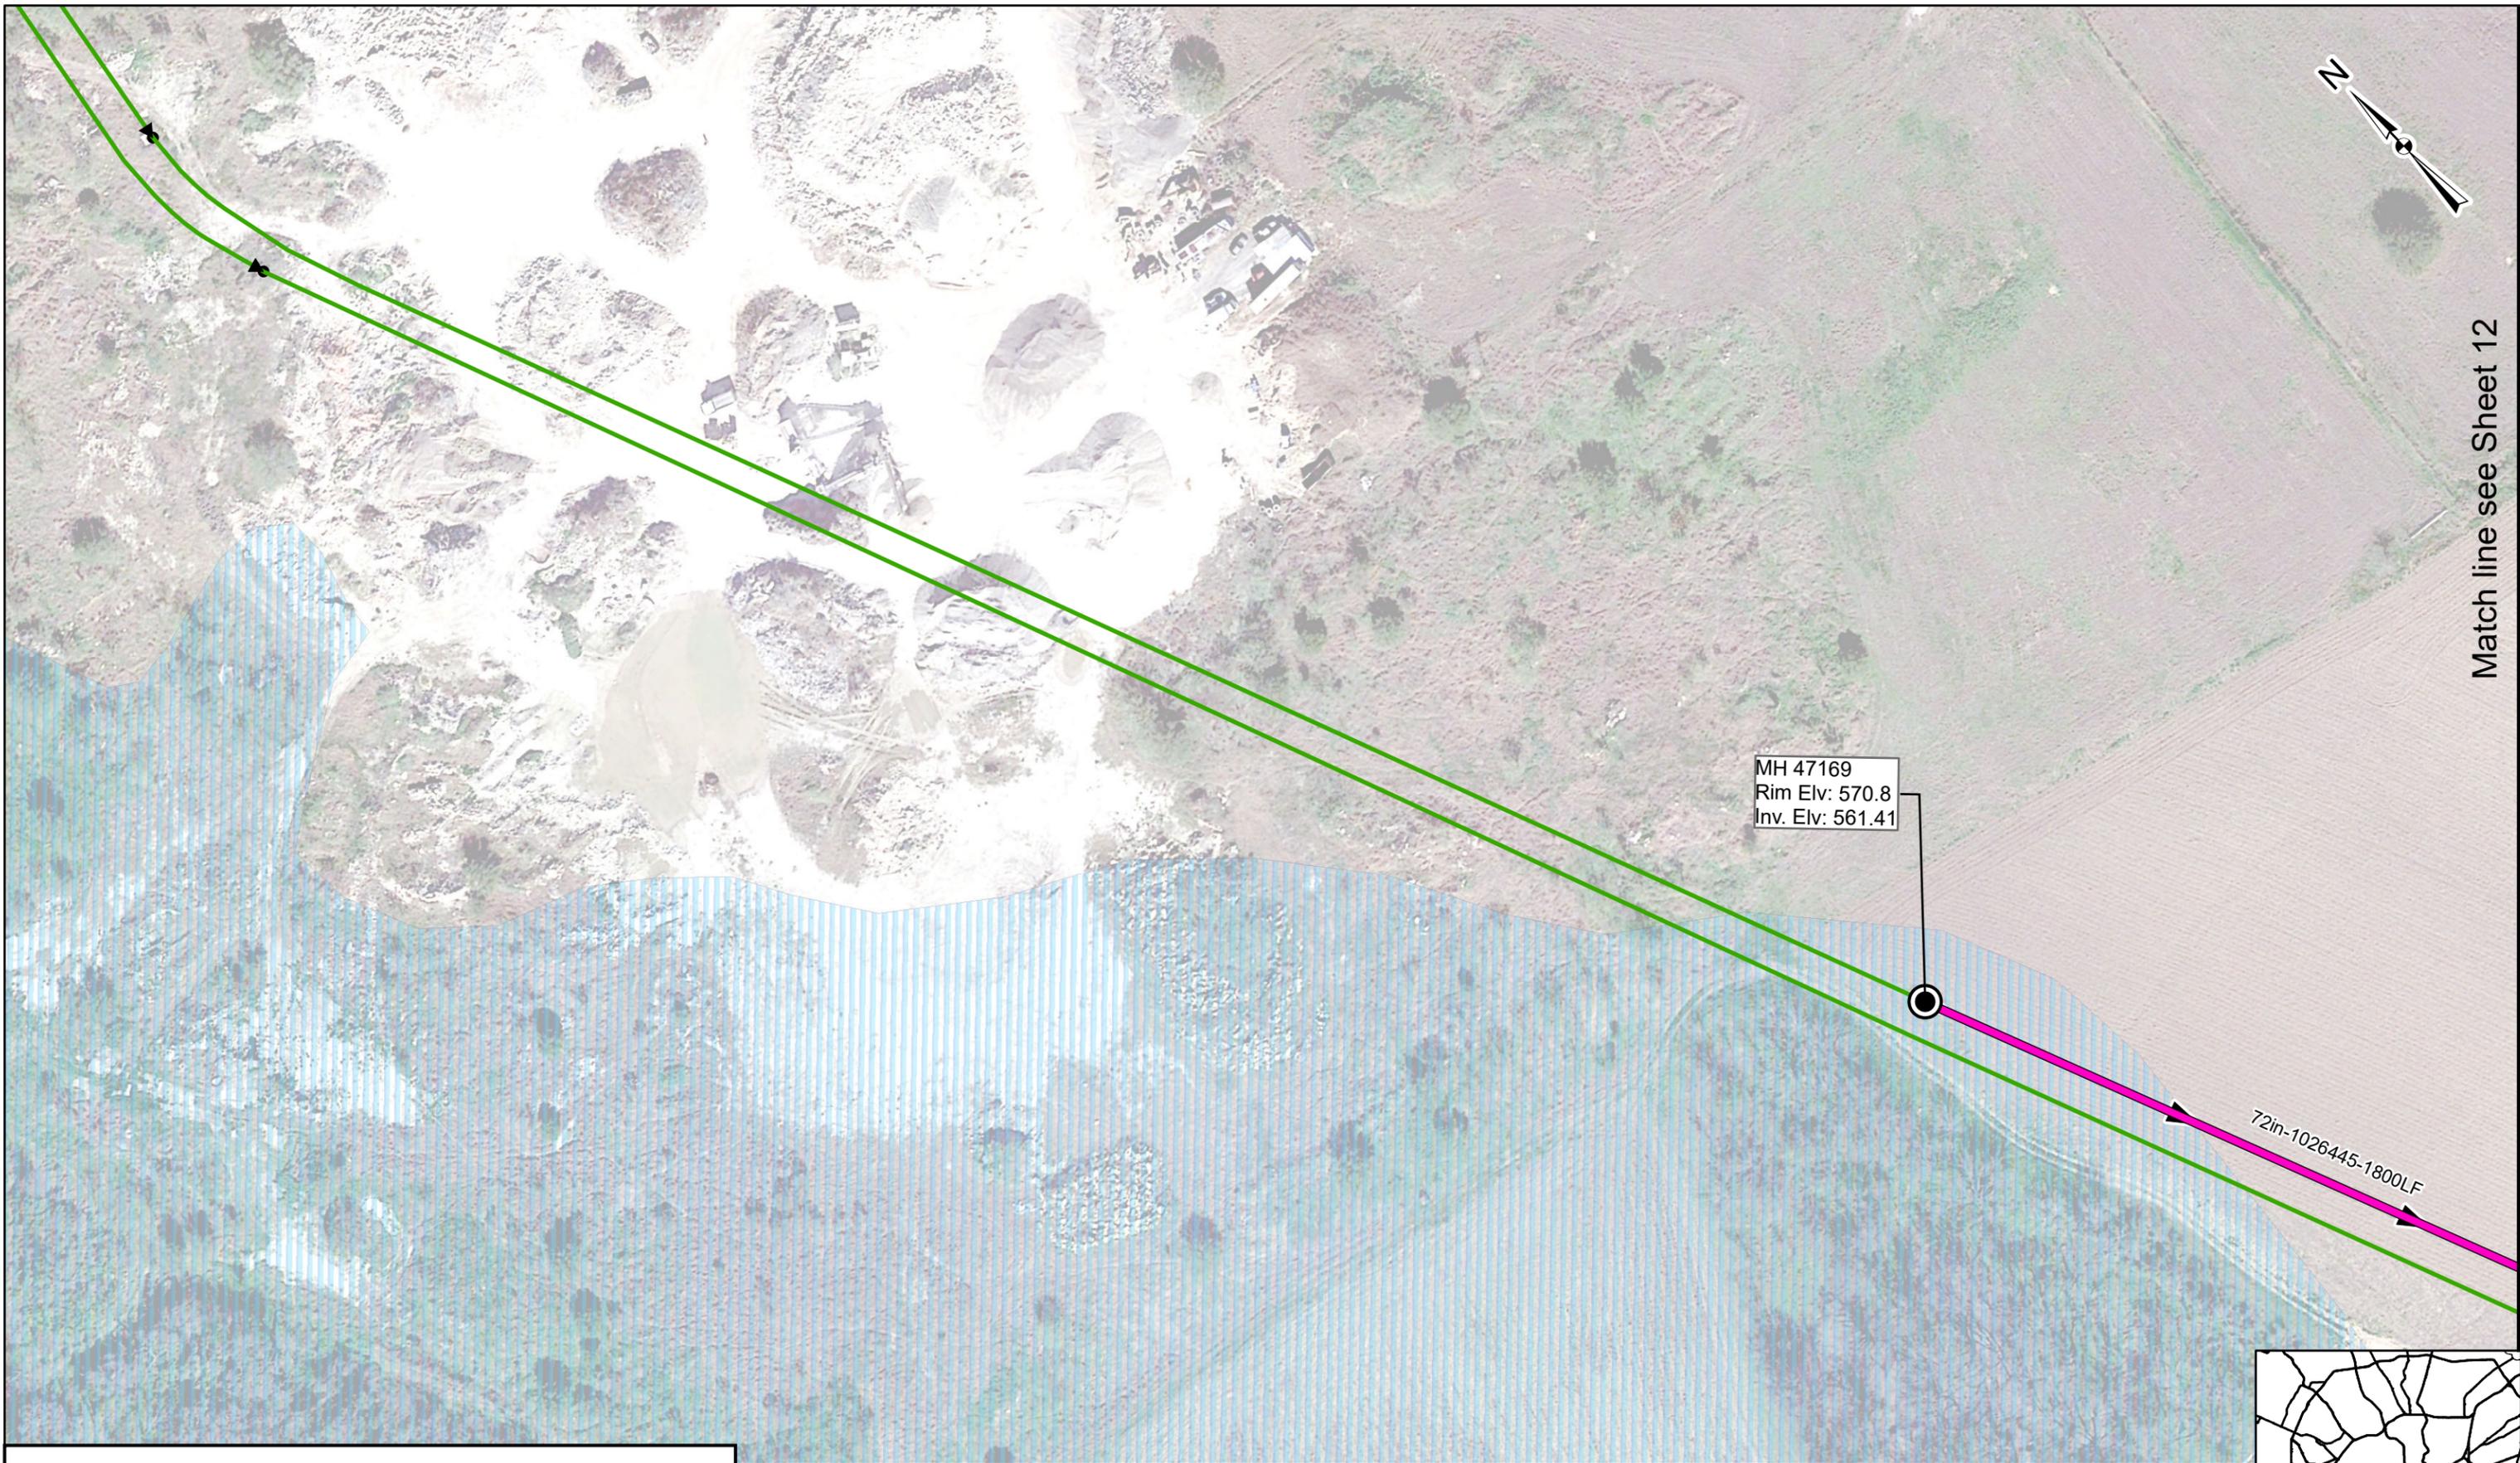
11	1026445	CIPP	72	1800	RCP	1986	DS CCTV from 2021 includes MH to MH coverage and sonar available. Pipe has reinforcement visible/projecting and intruding sealing rings and rags hanging throughout. Pipe is a candidate for CIPP. As-built indicates main is in a 50' sewer easement that also covers the parallel 54" sewer main. Consultant to confirm easement. As-built also indicates the main is within a 130LF concrete saddle near the USMH where there is shallow ground coverage and there is a curve in the main near the DSMH. There is a parallel 42" recycle main along the length of the pipe. Sewer mains upstream of this segment are part of Multiple Sewershed Pkg 18 project. Propose CIPP due to pipe size, condition, and location.
12	976097	CIPP	54	1030	RCP	1965	DS CCTV from 2021 includes MH to MH coverage and sonar available. Pipe has reinforcement visible/projecting throughout and deposits attached ragging. CCTV shows slight curve in the pipe near the DSMH. Pipe is a candidate for CIPP. As-built indicates main is in a 50' sewer easement. Consultant to confirm easement. There is a parallel 42" recycle main along the length of the pipe. Sewer mains upstream of this segment are part of Multiple Sewershed Pkg 18 project. Propose CIPP due to pipe size, condition, and location.

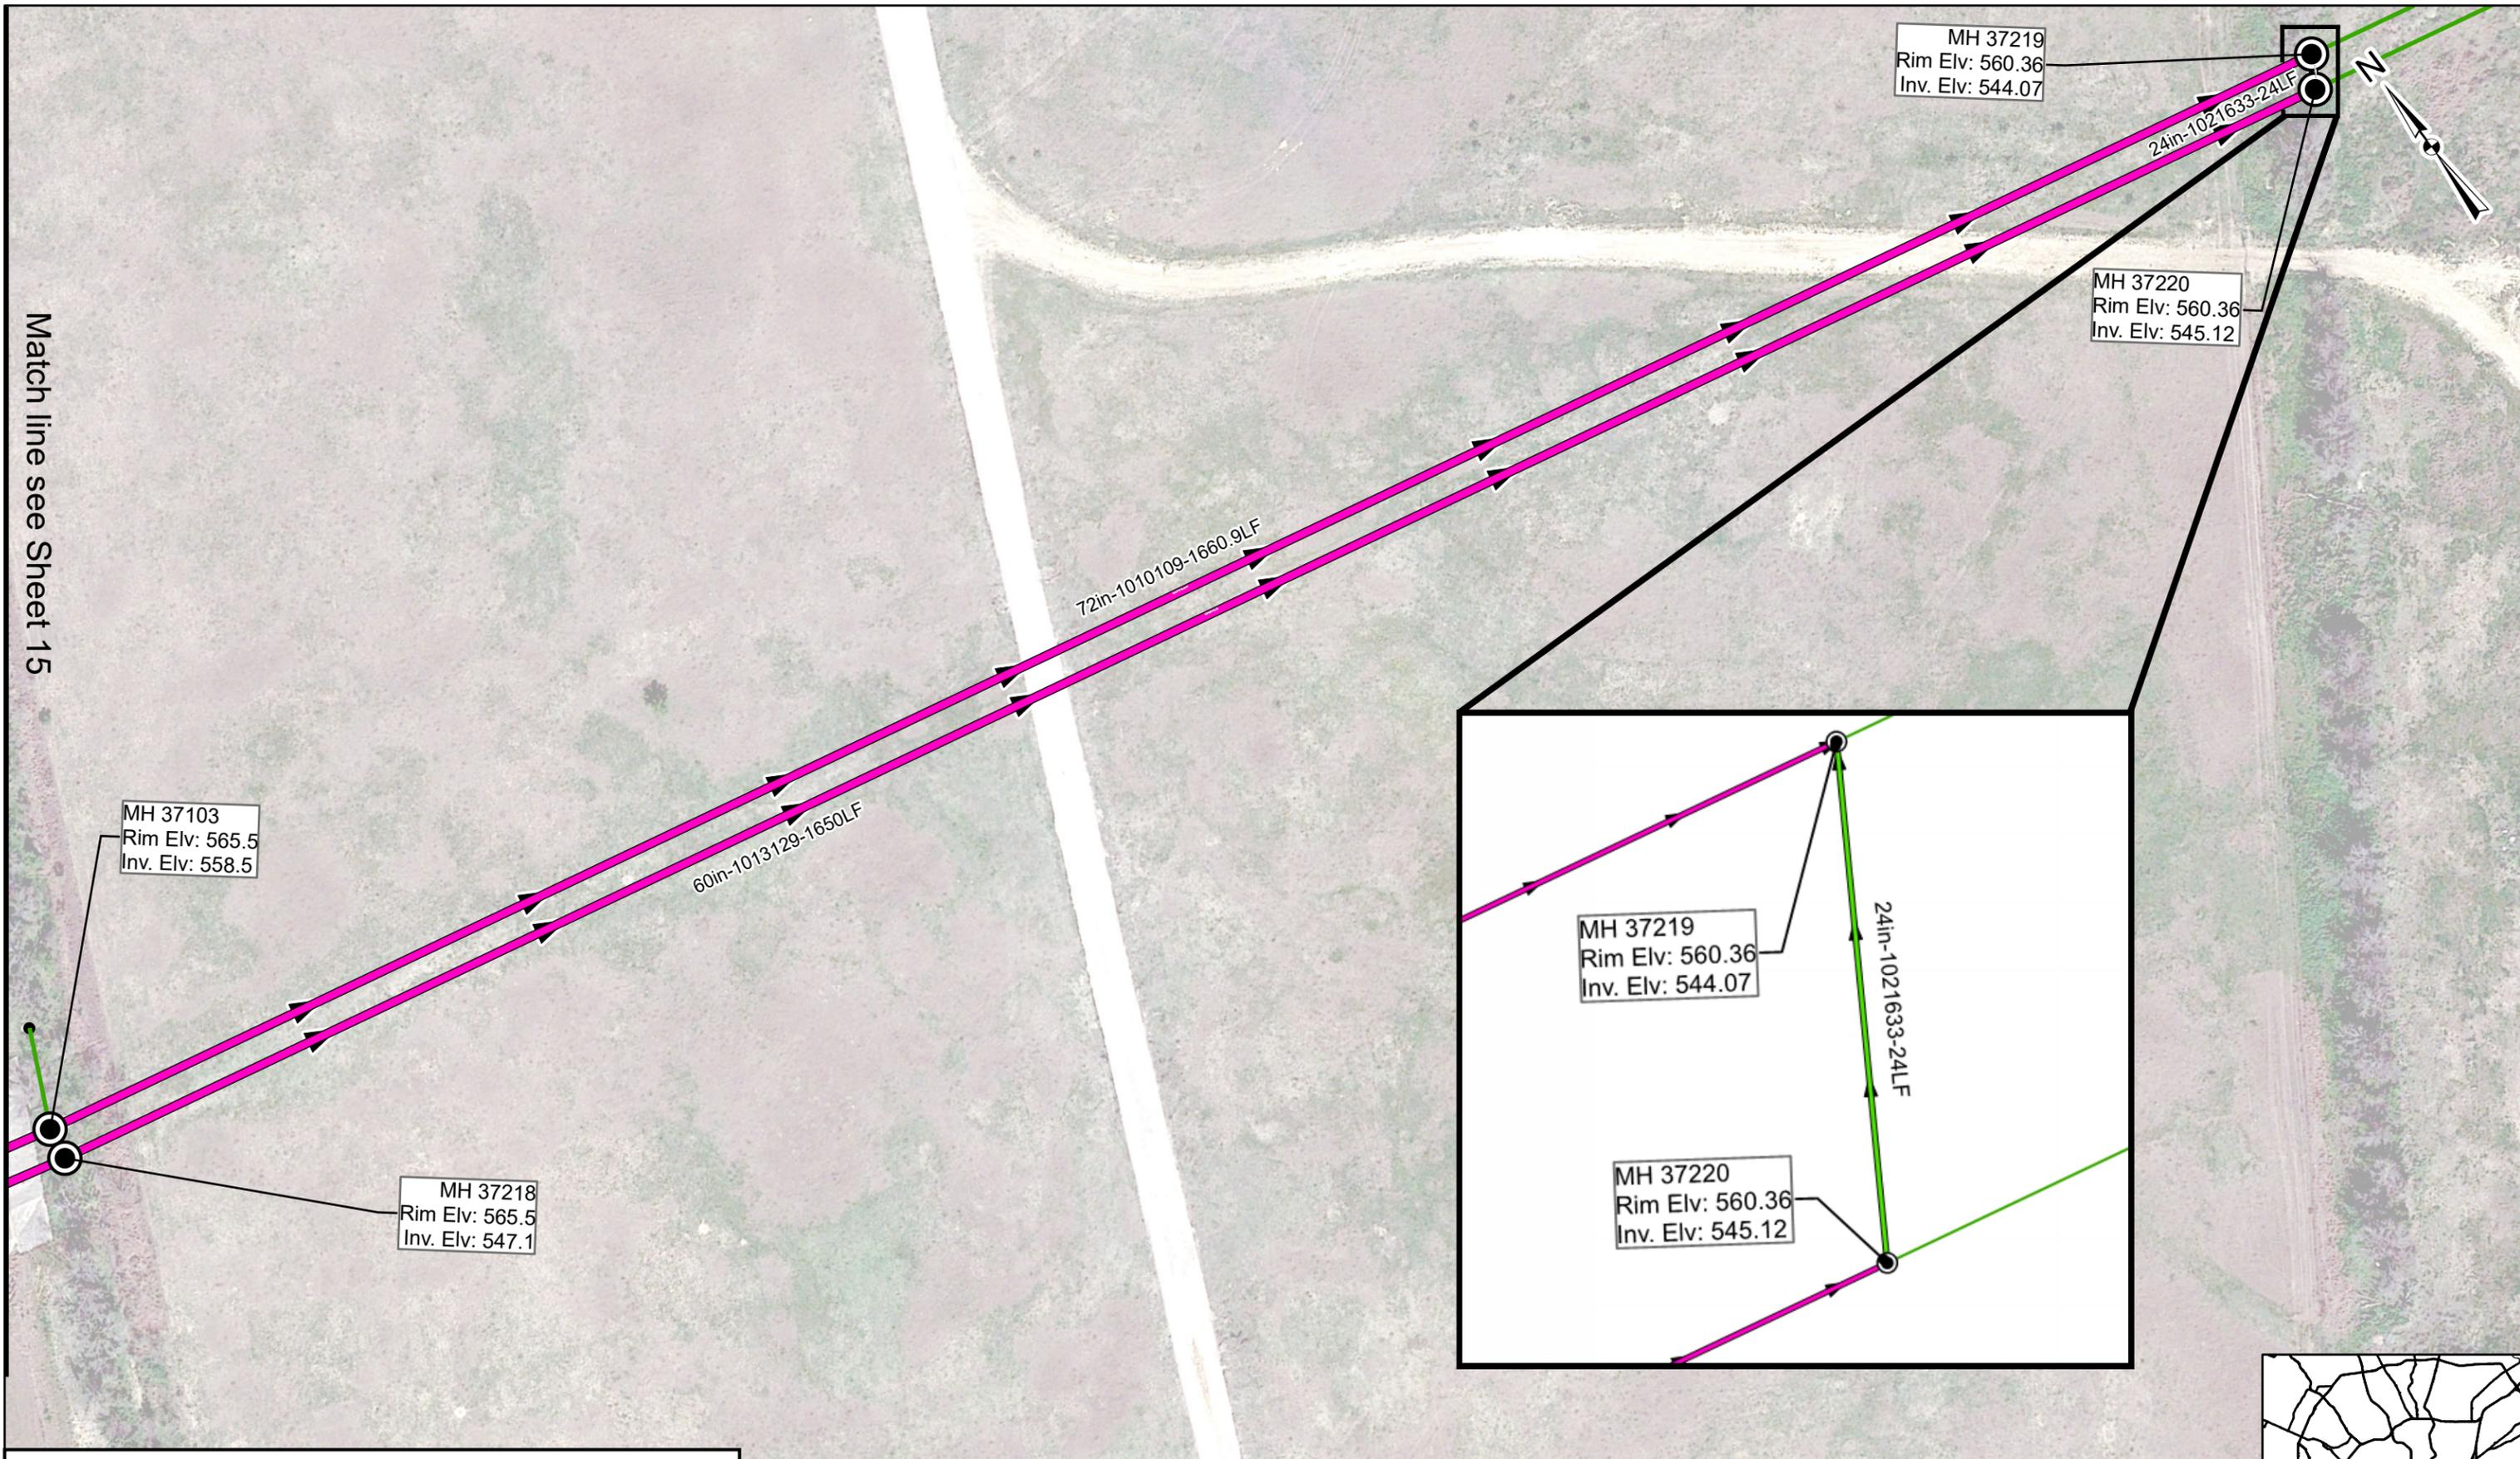
16	1021633	OPEN CUT	24	24	PVC	1986	DS CCTV from 2021 includes MH to MH coverage. Pipe has reinforcement visible, surface aggregate missing, and also appears to have deposit attached encrustation. Pipe could be lined but may require mechanical cleaning. Pipe acts as a balancing line between the 60" main and 72" main. Propose Open Cut due to pipe condition, size, and short segment length.
16	1013129	CIPP	60	1650	RCP	2003	DS CCTV from 2021 includes MH to MH coverage and sonar available. Pipe has reinforcement visible and surface aggregate missing. Pipe is a candidate for CIPP. Segment runs parallel to a 42" recycle main. Propose CIPP due to pipe size, condition, and location.
