MITCHELL LAKE DAM IMPROVEMENTS PRELIMINARY ENGINEERING REPORT

NOVEMBER 2020

FREESE AND NICHOLS, INC.
Texas Professional Engineering Firm No. F-2144
9601 McAllister Freeway, Suite 1008
San Antonio, Texas 78216

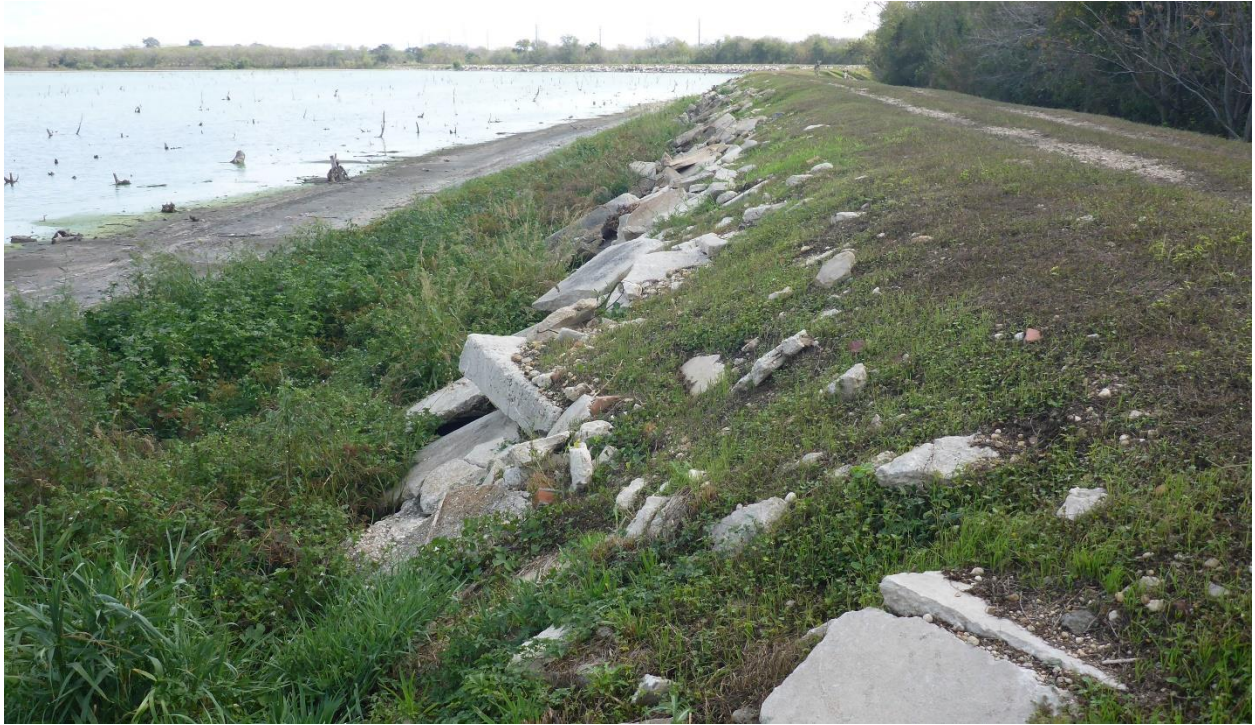
- The upstream slope is sparsely covered with concrete rubble as erosion protection, with coverage increasing closer to the spillway. Erosion from wave action was noted in several locations along the upstream slope. In general, the existing concrete rubble is not adequate to provide long-term protection against erosion due to wave action. The upstream slope also had localized areas of dense vegetation.

Photo 1: Embankment Upstream Face (Note steepness and sparse coverage of rubble erosion protection)

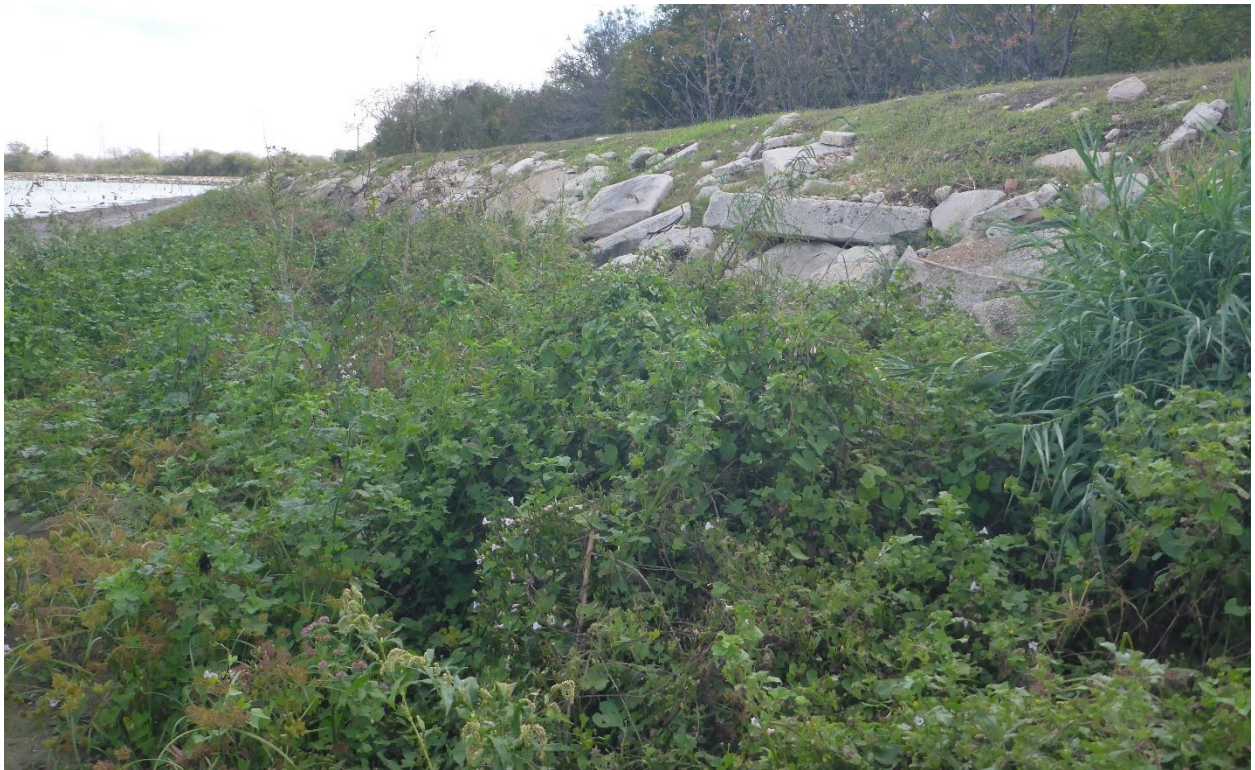
Photo 2: Dense Vegetation at Toe of Upstream Slope

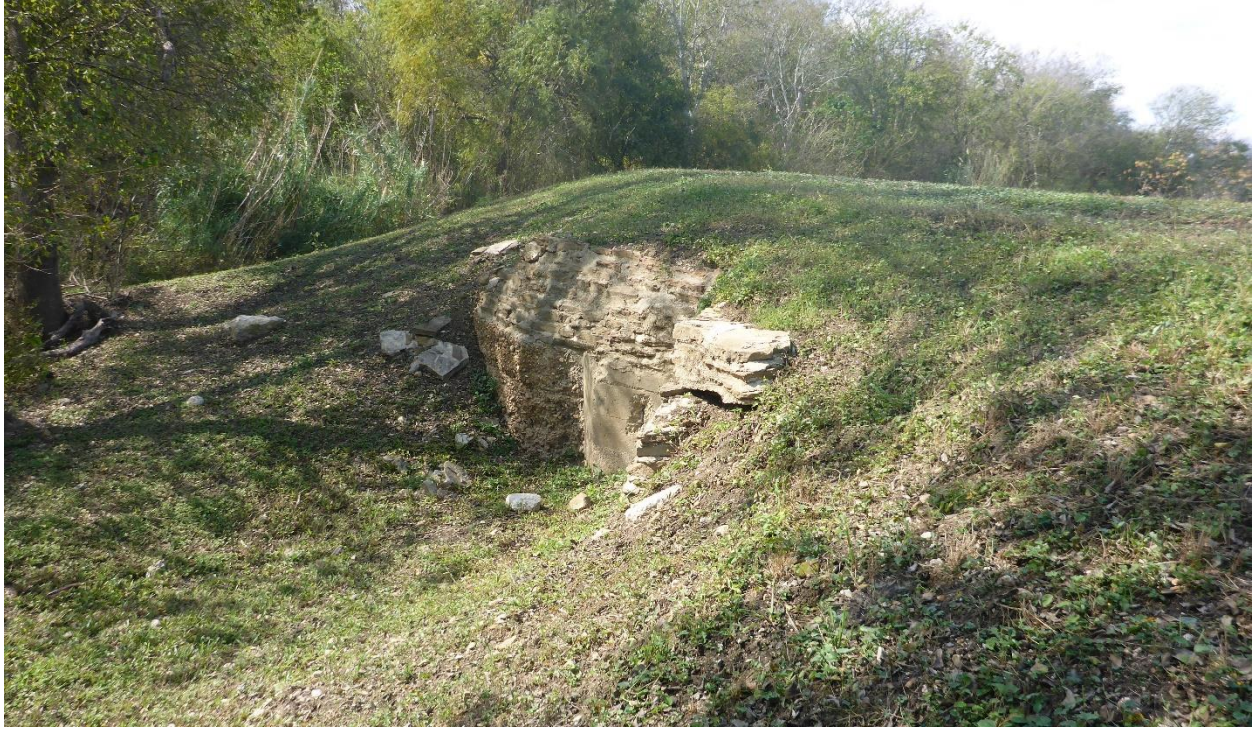
- Abandoned irrigation features were noted in several locations. In most cases, these channels and conduits do not pose any issue to the dam. However, there is at least one location on the embankment where an abandoned pipe penetrates the embankment with a masonry headwall. Any penetration is a potential location for seepage through the embankment.

Photo 5: Headwall Structure on Downstream Slope

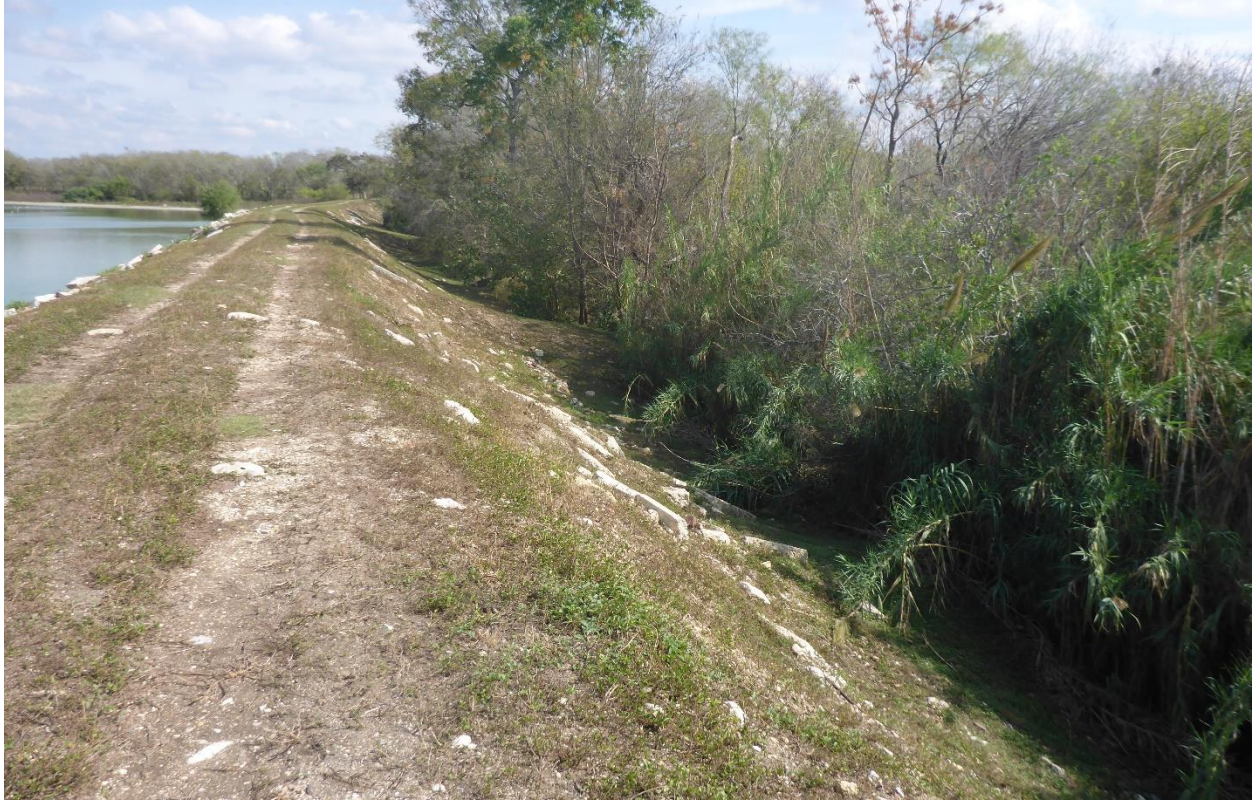
- The crest of the embankment was in good condition with consistent width and no major rutting from vehicular traffic.
- The downstream slope was in good condition. The slope varies in steepness between around 2:1 (H:V) and 3:1 and has large rocks scattered along the surface. These conditions may make mowing of the slope difficult. One small animal burrow was noted on the downstream slope.

Photo 7: Downstream Embankment Slope (Note steepness and dense vegetation)

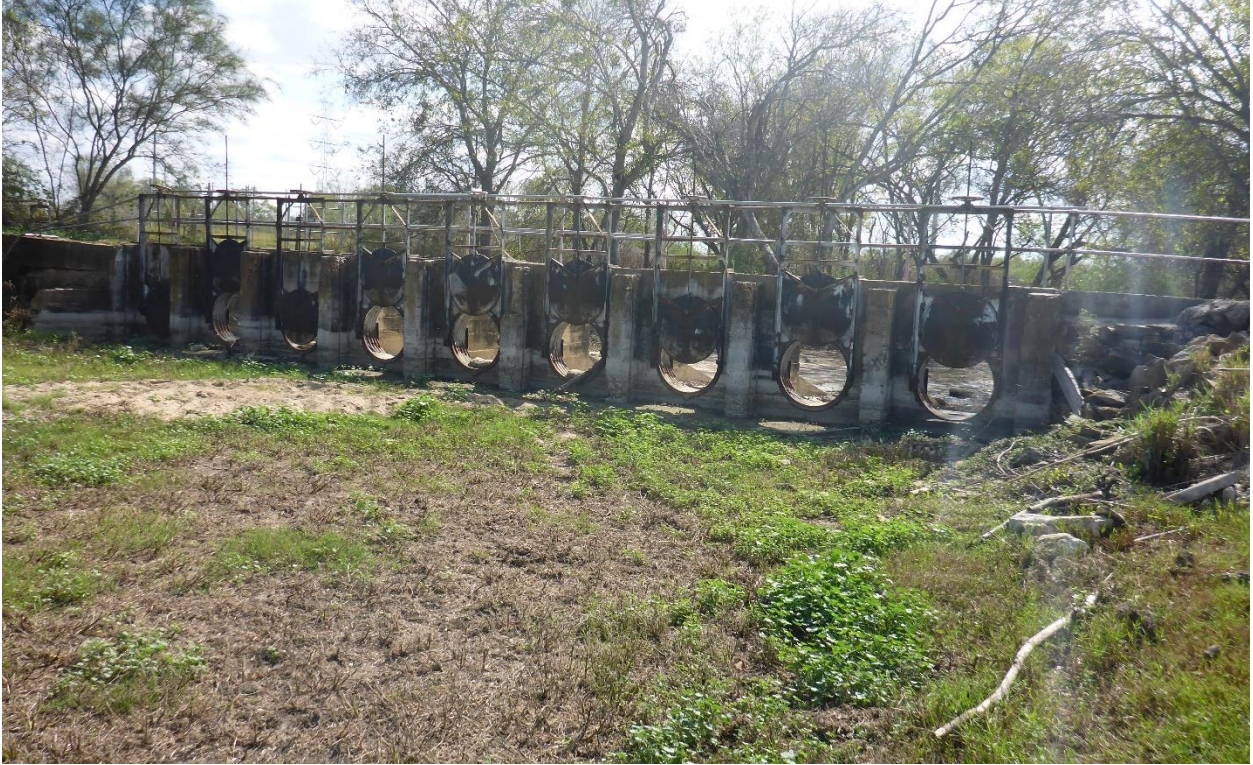
- The spillway gates and concrete bulkhead were in fair condition. Some of the gates have been welded in the open position. The steel catwalk over the spillway appeared to be in fair condition with no major corrosion or damaged members.

Photo 9: Spillway Upstream Face and Gates

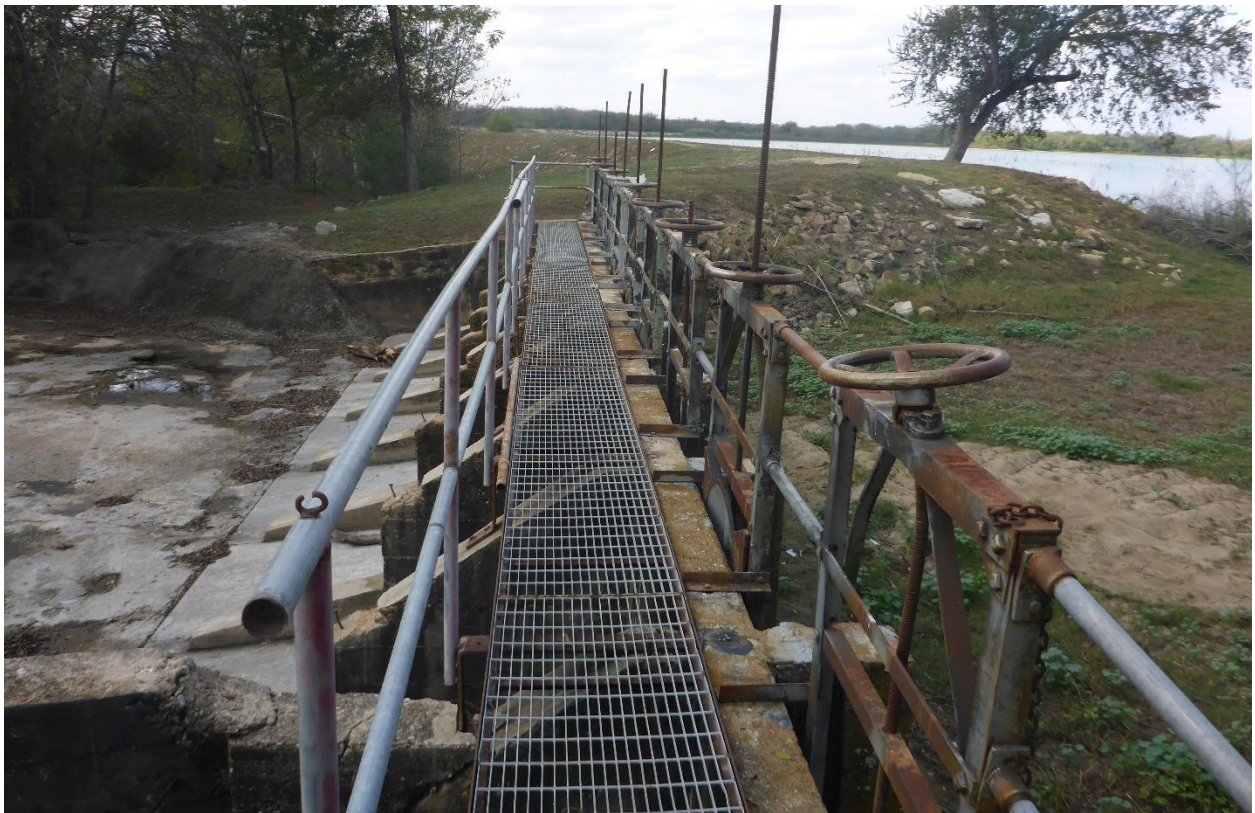
Photo 12: Spillway Bulkhead Catwalk and Gate Handwheels

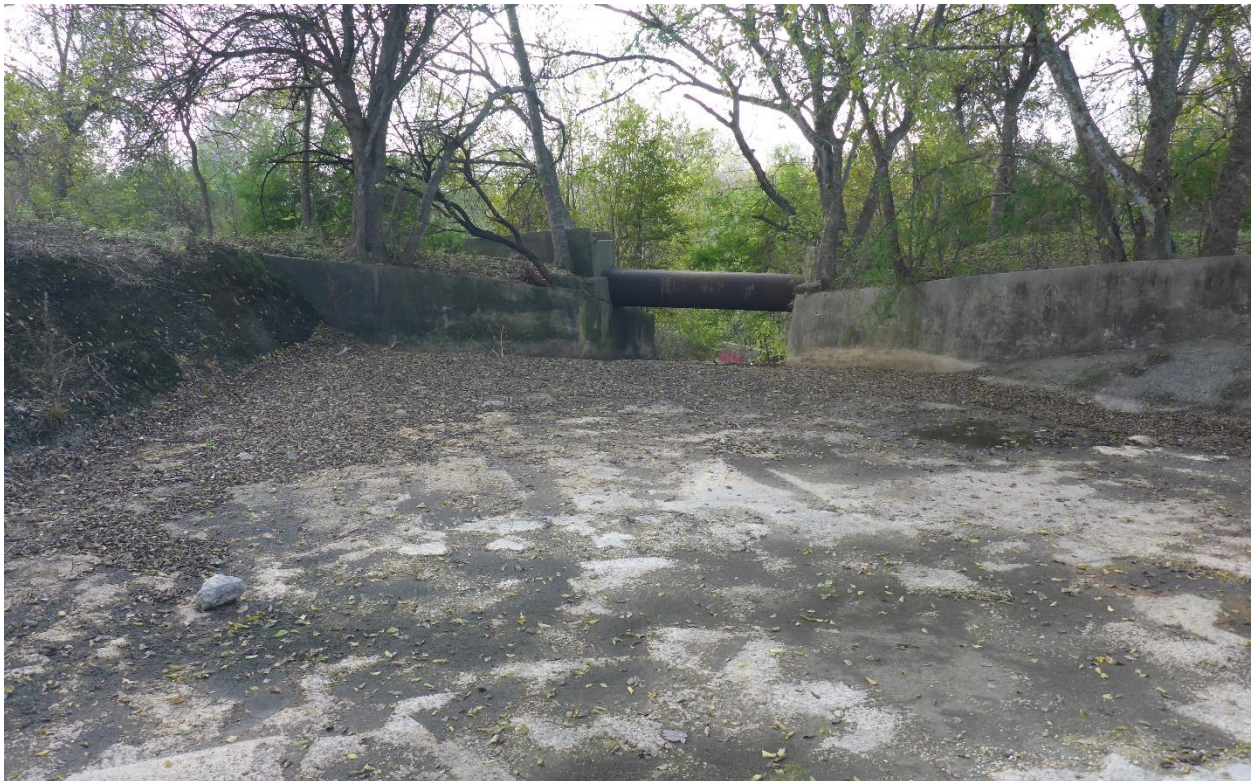
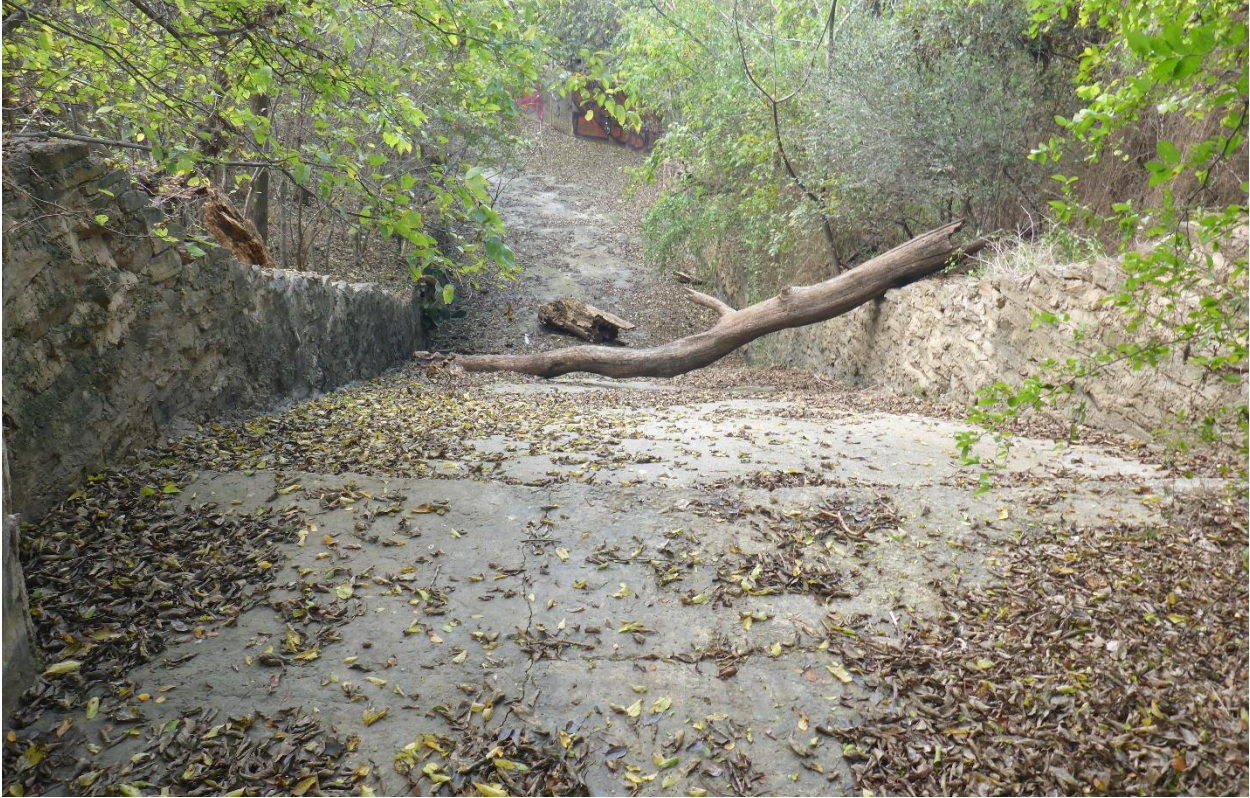
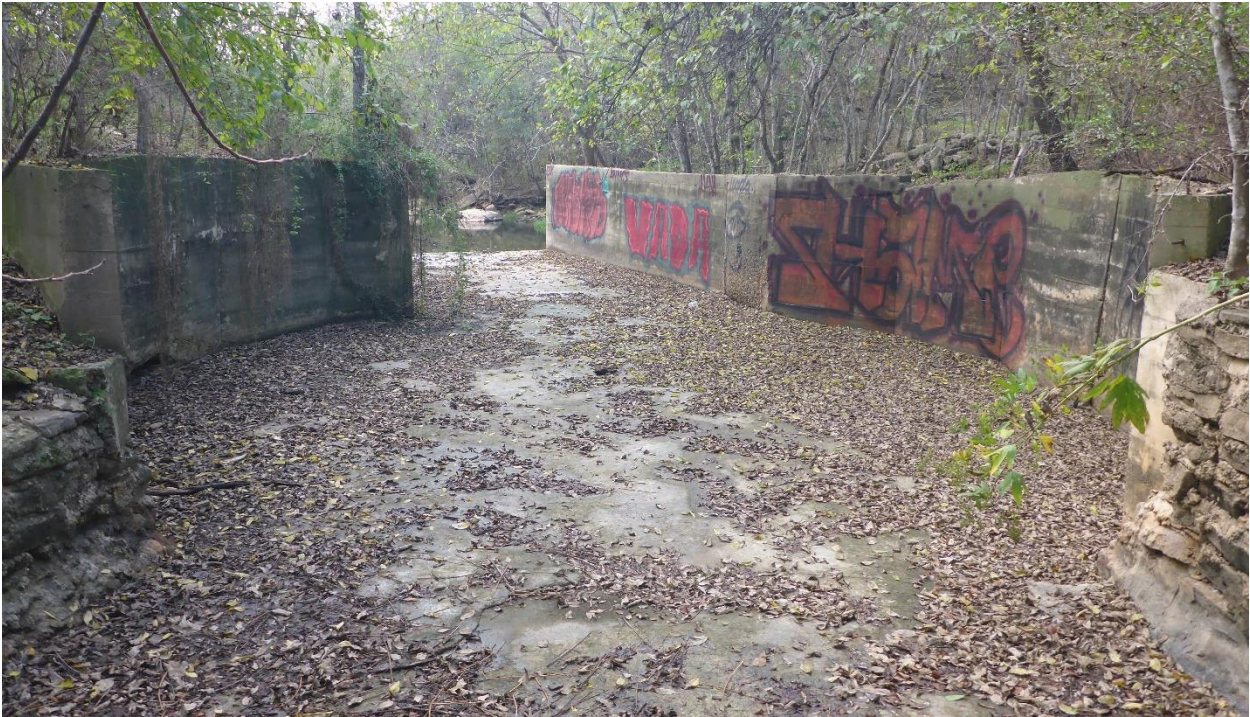
- The spillway exit channel was in poor condition. Deterioration of the channel lining was noted in several locations. The downstream end of the exit channel is eroded and undermined at the plunge pool. At least one section of the channel lining has failed at the downstream end as evidenced by the exposed steel reinforcement. The channel beyond the plunge pool is significantly eroded and incised.

Photo 14: Spillway Channel Looking Downstream

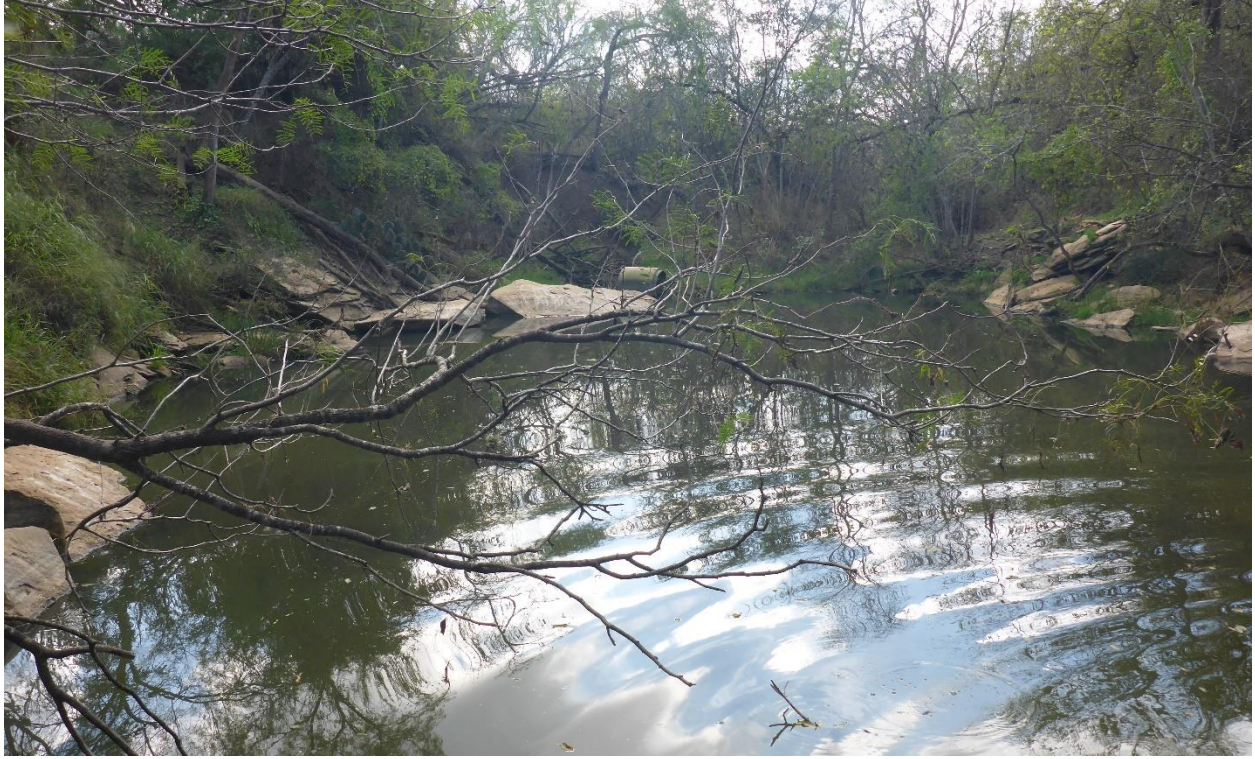
Photo 17: Plunge Pool Looking Downstream

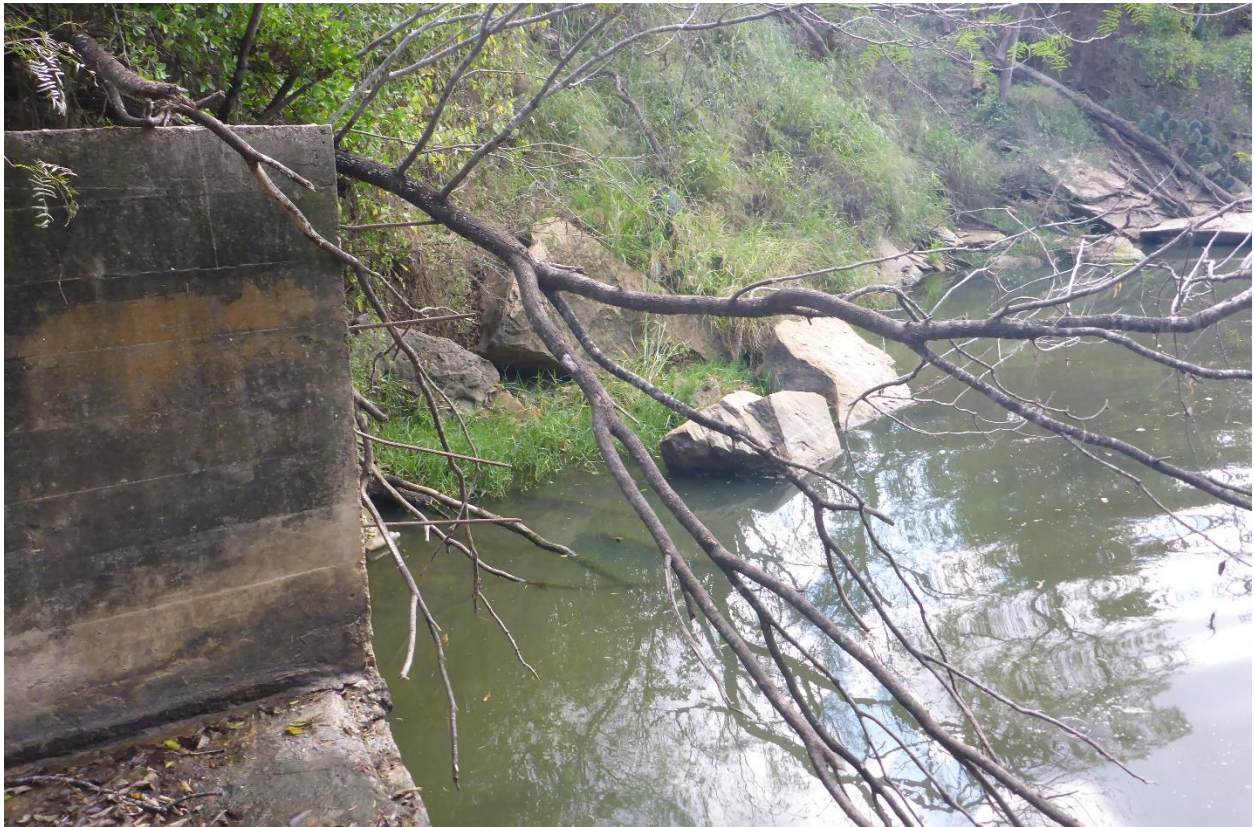
Photo 18: Spillway Channel Wall (Note exposed reinforcing steel and sheer drop)
