ADDENDUM NO. 1
to
PLANS and SPECIFICATIONS
for

Medina River Sewer Outfall, Segment 4
SAWS Job No. 12-2504

**SAN ANTONIO WATER SYSTEM
MEDINA RIVER SEWER OUTFALL, SEGMENT 4
SAWS PROJECT # 12-2504
ADDENDUM NO. 1**

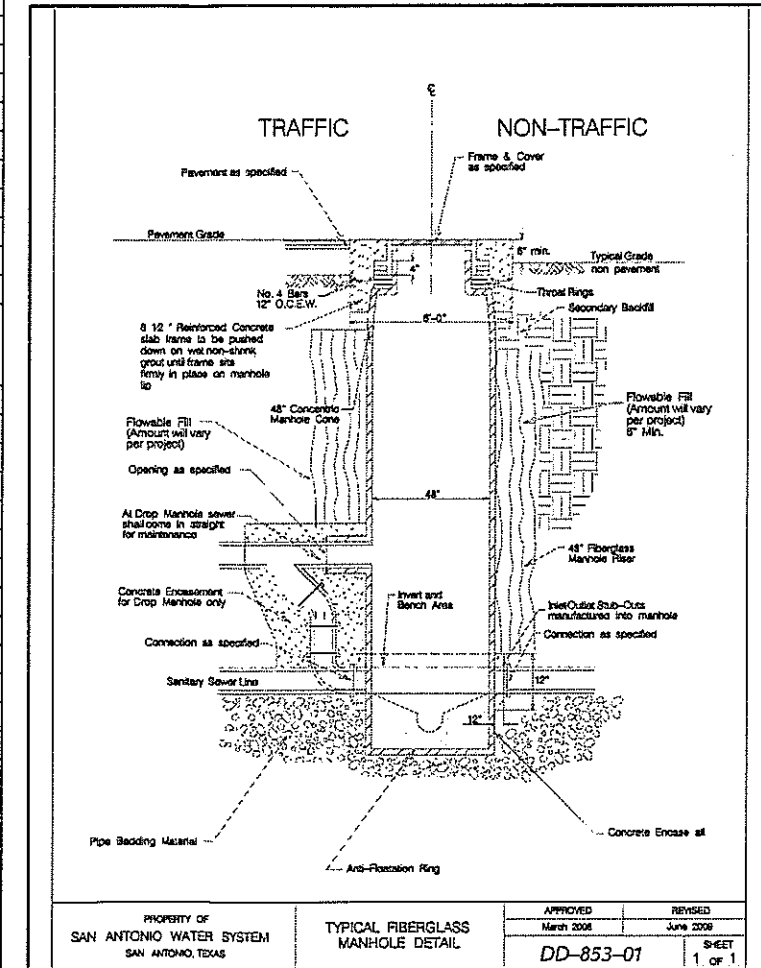
TYPICAL FIBERGLASS MANHOLE DETAIL
N.T.S.

PROPERTY OF SAN ANTONIO WATER SYSTEM SAN ANTONIO, TEXAS	TYPICAL FIBERGLASS MANHOLE DETAIL	APPROVED March 2008	REVISED June 2008
		DD-853-01	
		1 SHEET OF 1

A. Drawing No. D-12, Sheet No. 64 – Have revised SAWS Detail DD-853-01. Remove and Replace this sheet with the attached plan sheet.

- D. Question: Do the fiberglass manholes need to be backfilled with flowable fill? The detail D-12-A on sheet 64 (DD-853-01), does not indicate that flowable fill is required. The SAWS Detail DD-853-01 per the SAW's web site indicates that flowable fill is required backfill? Do the Base Tee risers need to be backfilled with flowable fill?

Answer: Will need to comply with SAWS specifications. See item 4.A of this addendum.

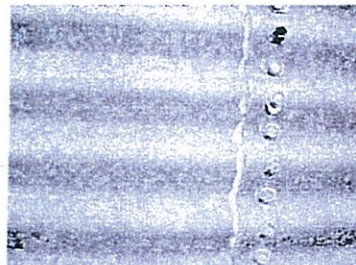
#11 Grain Silo Caulking

A12: Chrysotile fibers observed but did not fall under any counted points.
