September 30, 2013
Arias Job No. 2011-605

RE: Summary of Geotechnical Results
SAWS C-13 Sanitary Sewer Project – Additional Bores
San Antonio, Texas

Manhole Investigation
 SAWS C-13 Project
 San Antonio, Bexar County, Texas

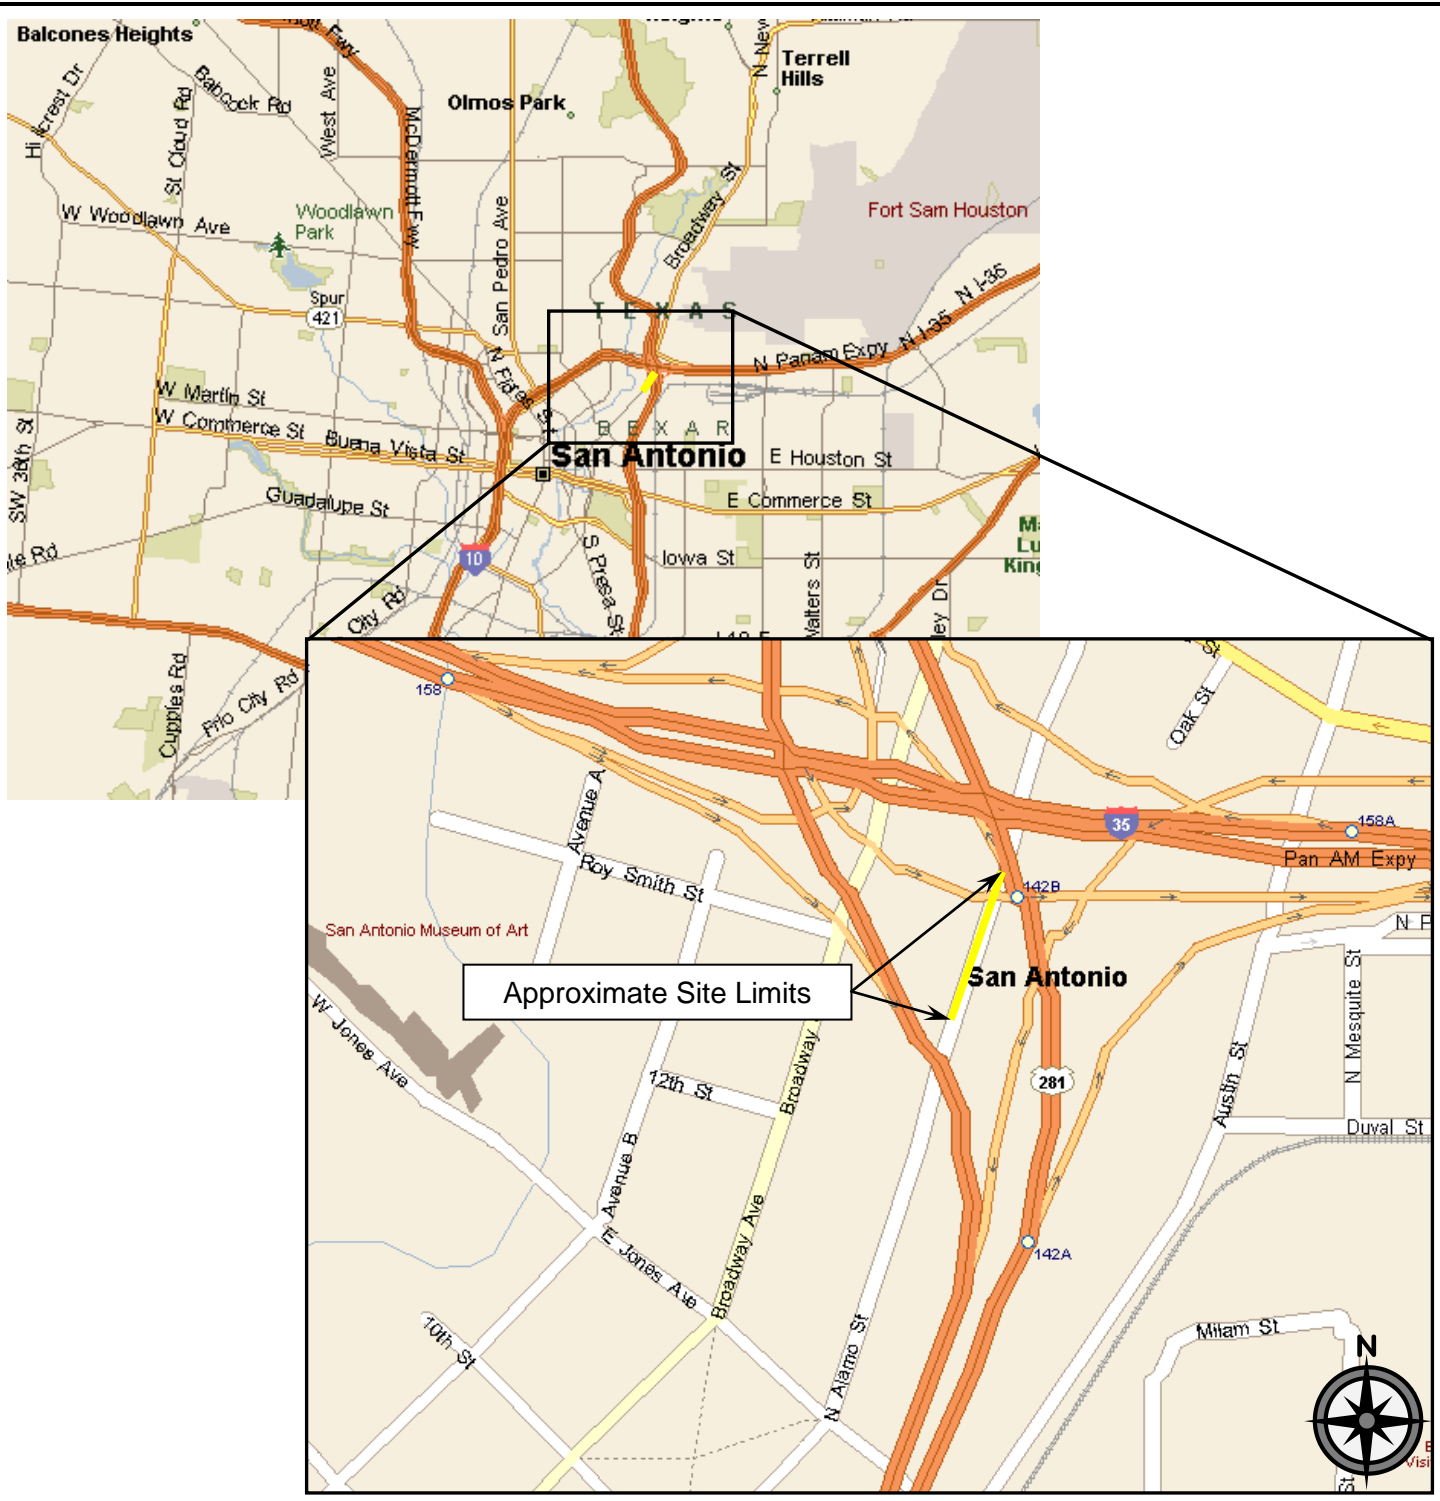
VICINITY MAP

The site location is depicted on the Vicinity Map, Figure 1 in Appendix A. Photographs taken at some of the soil boring locations are also included in Appendix A.

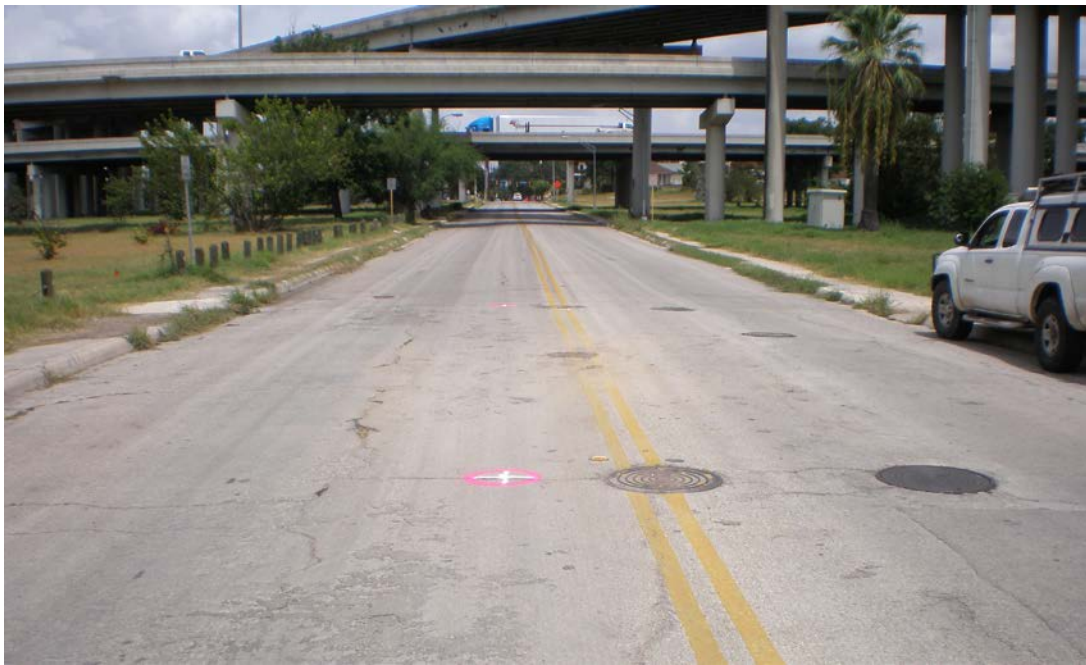
Photo 1 – View looking northeast to the proposed locations of Boring B-101 and B-102.

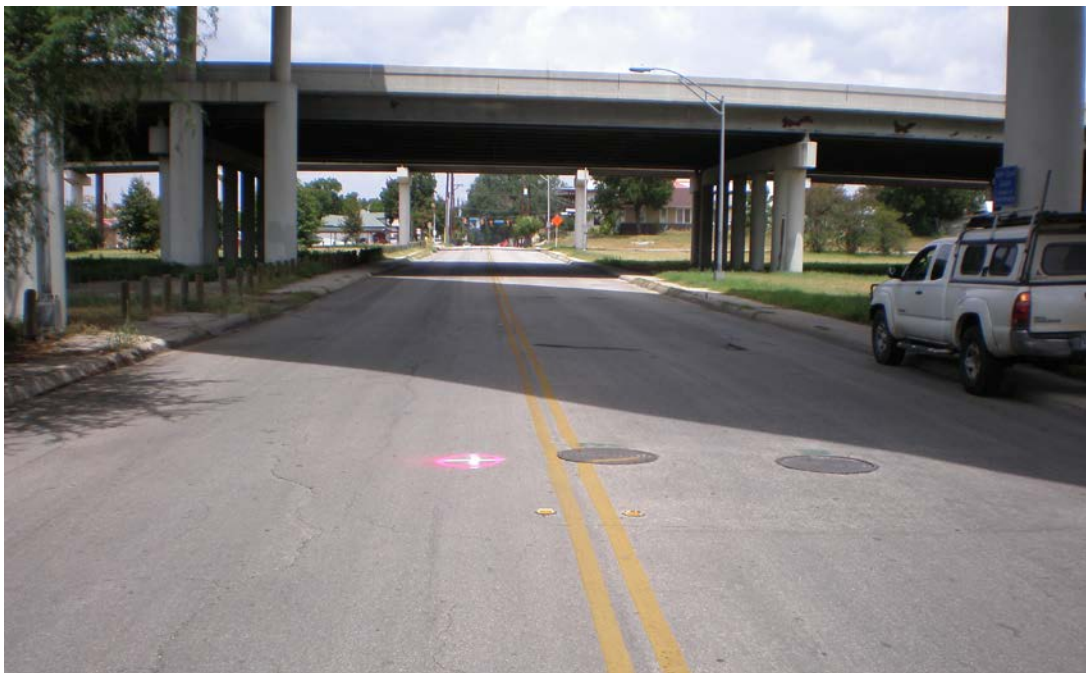
Photo 2 – View looking northeast to the proposed location of Boring B-103.

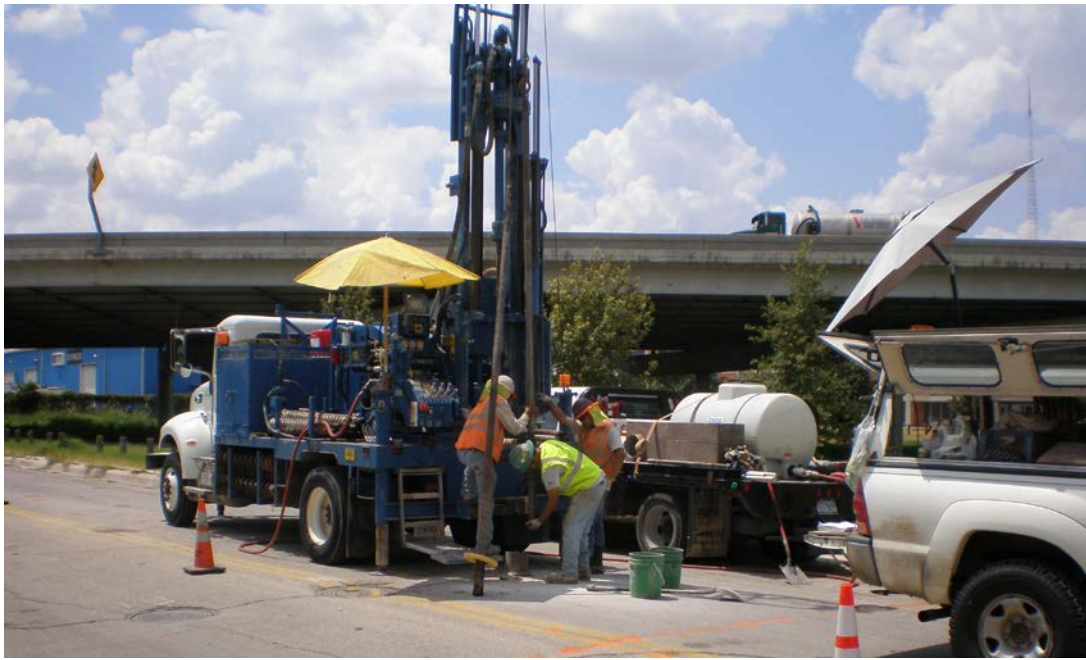
The initial borehole for Boring B-102 was drilled at 68½ inches west of the manhole center, and was drilled to about 36 feet without encountering an obstruction such as concrete. Another borehole was located 60 inches west of the manhole center (i.e. 8½ inches away from the initial B-102) and was drilled to about 28 feet without encountering an obstruction, such as concrete, as noted on the Log of Boring B-102.

Photo 3 – View looking southwest at the drilling operations of Boring B-102.

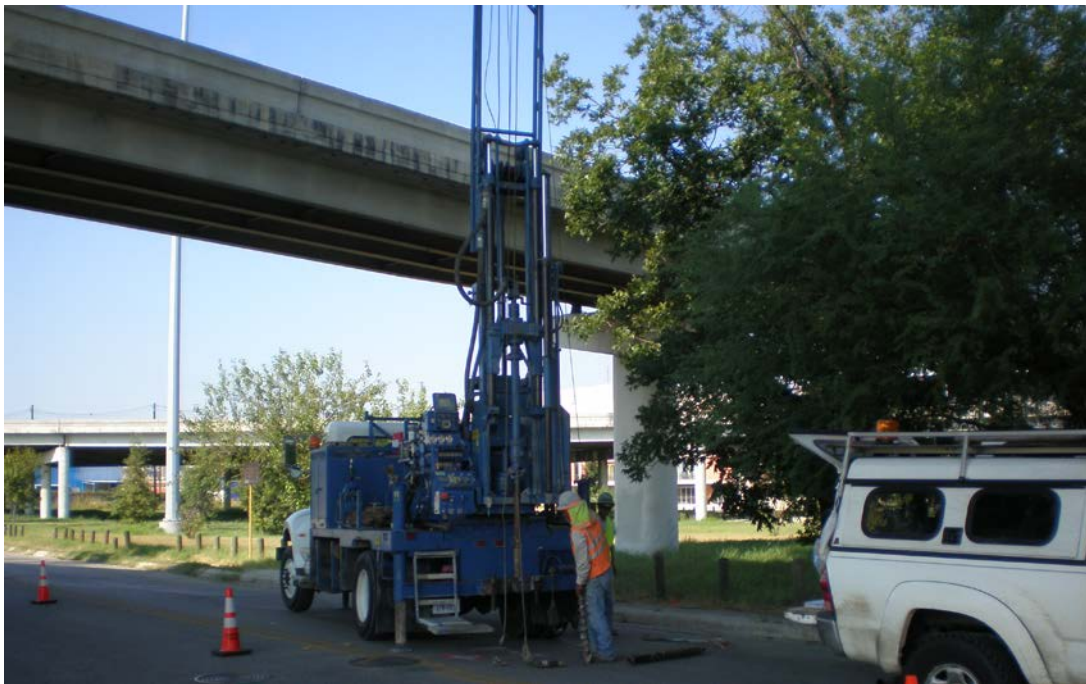
Boring B-103 was drilled at 46½ inches west of center of manhole. No obstructions, such as concrete, were encountered during the drilling operations of this borehole.

Photo 4 – View looking southwest at the drilling operations of Boring B-103.
