**SUBSURFACE UTILITY ENGINEERING**  
**QUALITY LEVEL - A: Test Hole Data Information**  
 SAM, Inc. Project Number: 31151-31

**TEST HOLE NUMBER: 1**  
 Date: July 8, 2011  
 Client: C P & Y, Inc.  
 Project: Leon Creek Interceptor

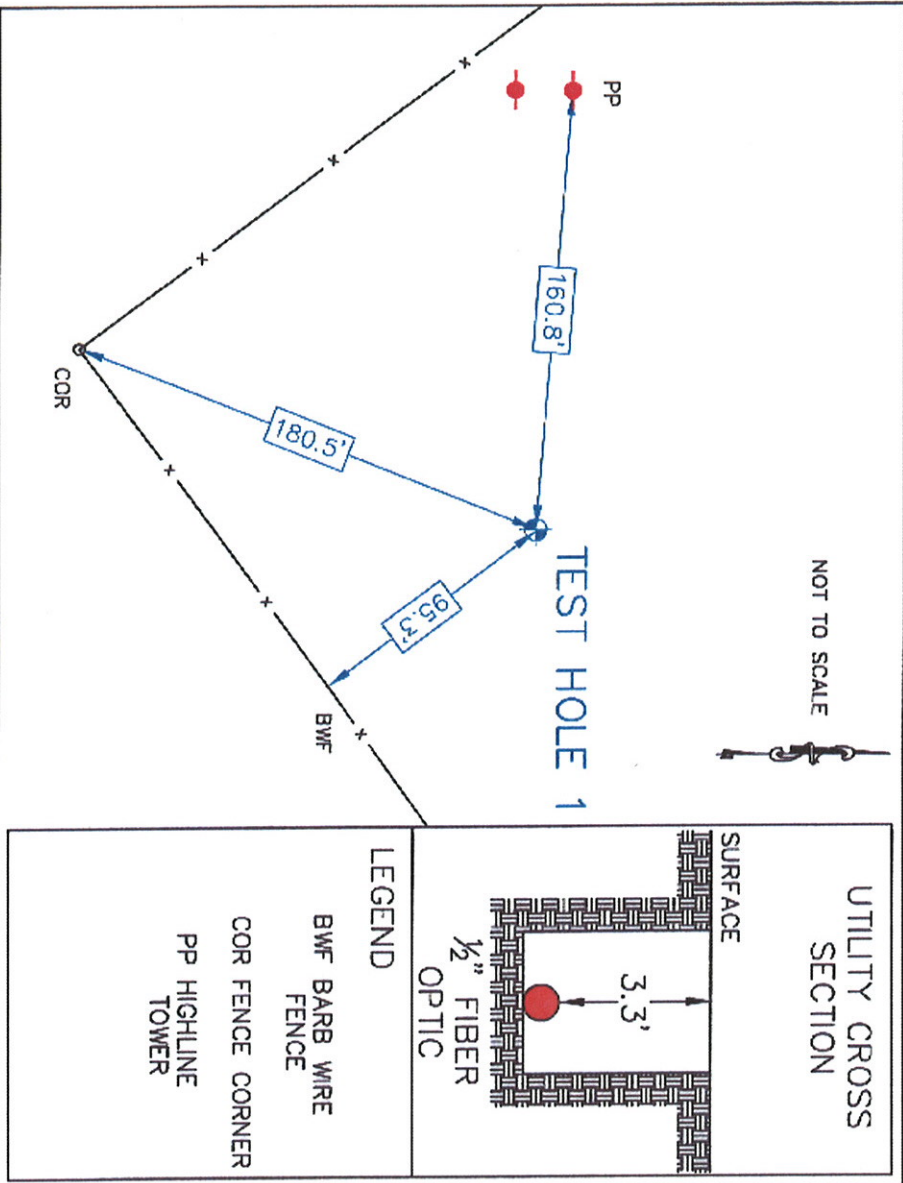
Surface Material: **Natural ground**  
 Surface Elevation: **520.50**  
 Thickness & Condition: **Dry**  
 Trench Material: **Black clay**  
 Utility Bedding Material: **Black clay**  
 Utility Found: **1/2" direct bury Fiber Optic line**  
 Utility Condition: **Good**  
 Utility Depth (Top): **3.3'**

1. SAM, Inc. located Test Hole # 1 by records and utility locator for the fiber optic line prior to air/vacuum excavation of the utility.
2. No additional utilities were found within Test Hole # 1 excavation.
3. All excavation was performed with air/vacuum excavation equipment.
4. The Test Hole was backfilled with excavated material.
5. The picture depicts the existing fiber optic line.

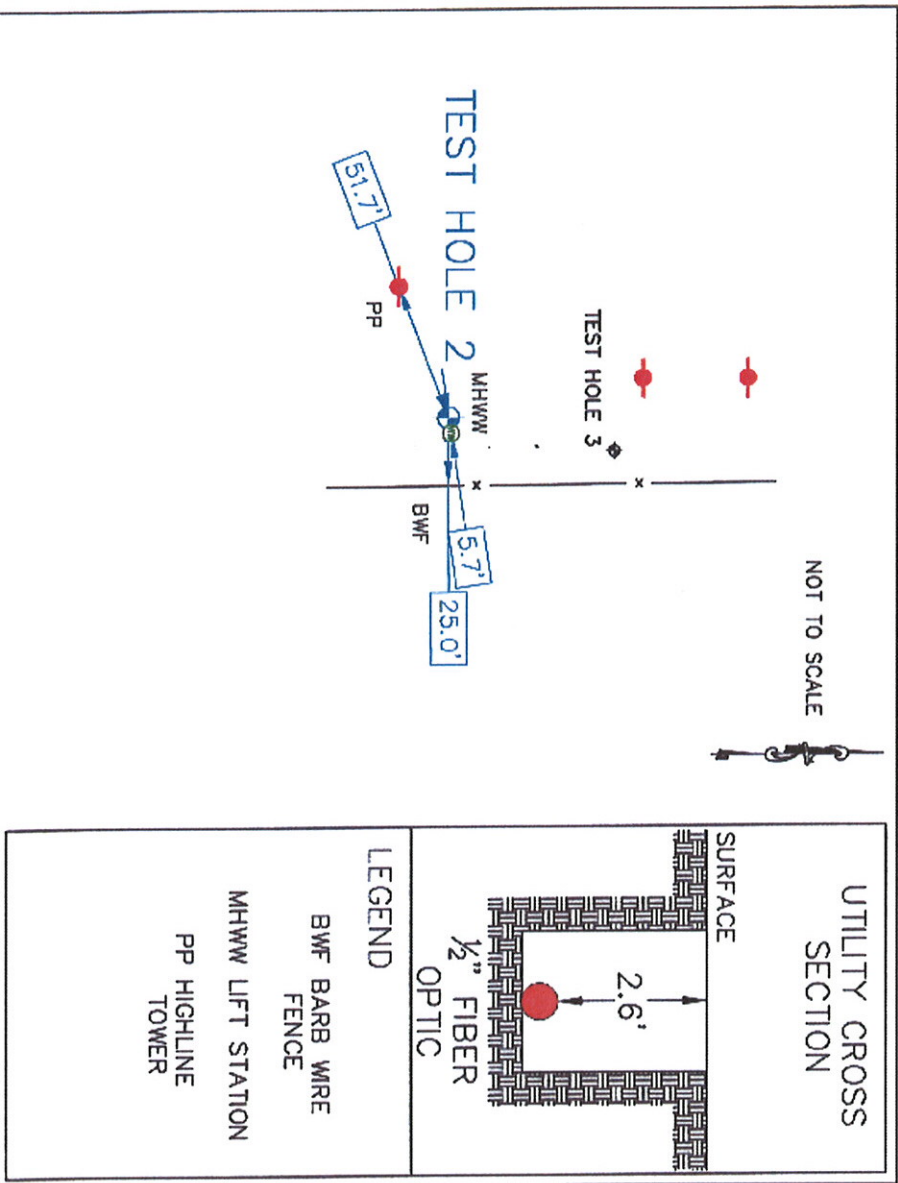
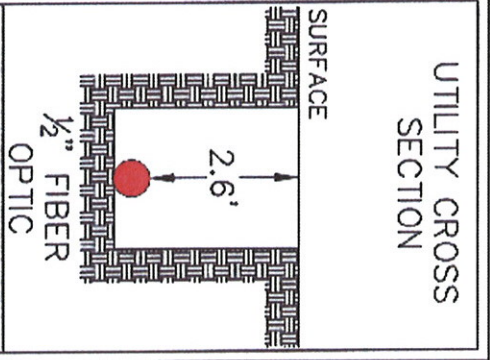
Project Location:	San Antonio, Texas	Surface Material:	Natural ground
Utility Location:	Leon Creek Wastewater Plant	Surface Elevation:	527.68
Utility Sta./Offset:	N/A	Thickness & Condition:	Dry
Record Utility:	Fiber Optic line	Trench Material:	Rocky black clay
Utility Owner:		Utility Bedding Material:	Rocky black clay
Contact/Phone:		Utility Found:	1/2" direct bury fiber optic line
Address:		Utility Condition:	Good
Field Crew:	Gabe Johnson and Miller Pipeline	Utility Depth (Top):	2.6'
Field Conditions:	Off roadway

1. SAM, Inc. located Test Hole # 2 by records and utility locator for the fiber optic line prior to air/vacuum excavation of the utility.
2. No additional utilities were found within Test Hole # 2 excavation.
3. All excavation was performed with air/vacuum excavation equipment.
4. The Test Hole was backfilled with excavated material.
5. The picture depicts the existing fiber optic line.

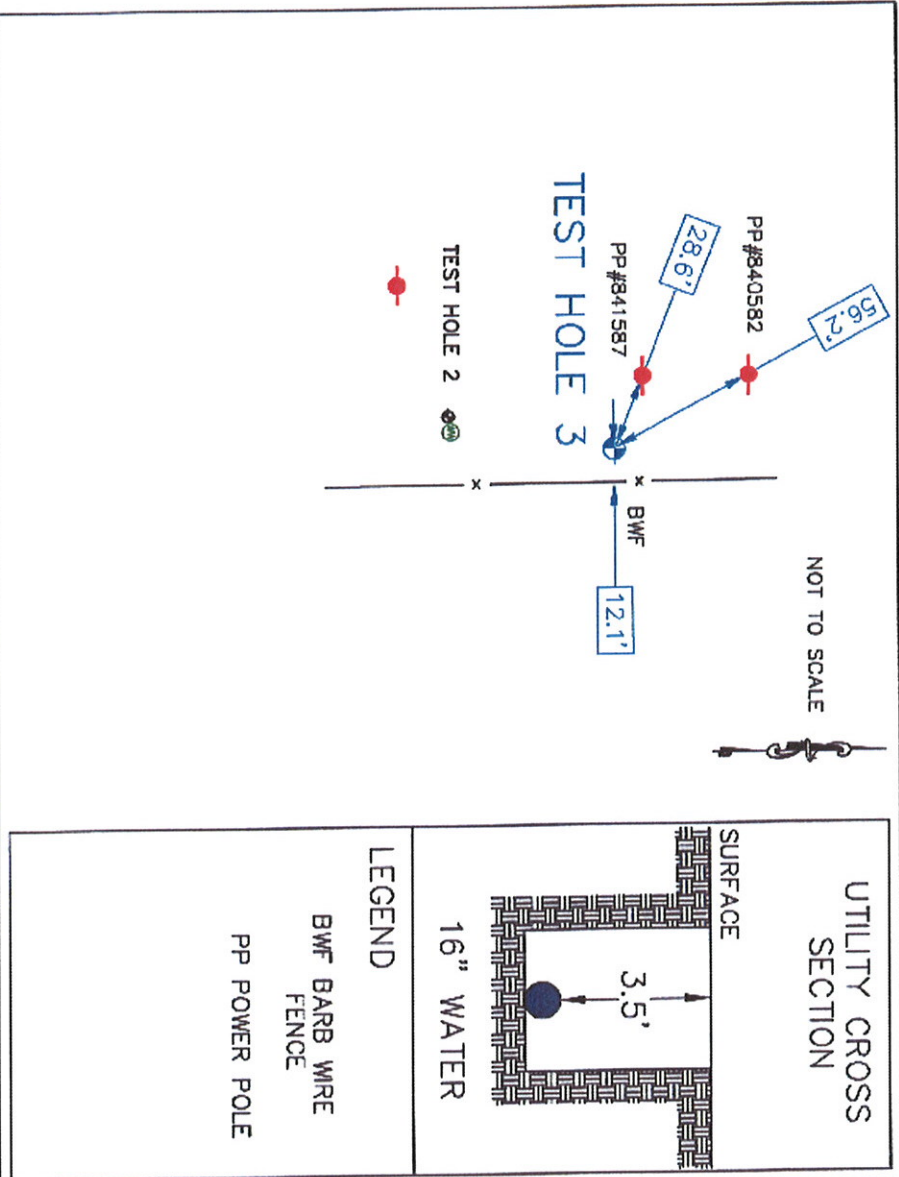
Surface Material: **Natural ground**  
 Surface Elevation: **527.89**  
 Thickness & Condition: **Dry**  
 Trench Material: **Rocky black clay**  
 Utility Bedding Material: **Rocky black clay**  
 Utility Found: **16" poly pipe with tracer wire**  
 Utility Condition: **Good**  
 Utility Depth (Top): **3.5'**

1. SAM, Inc. located Test Hole # 3 by records and utility locator for the water line prior to air/vacuum excavation of the utility.
2. No additional utilities were found within Test Hole # 3 excavation.
3. All excavation was performed with air/vacuum excavation equipment.
4. The Test Hole was backfilled with excavated material.
5. The picture depicts the existing water line.

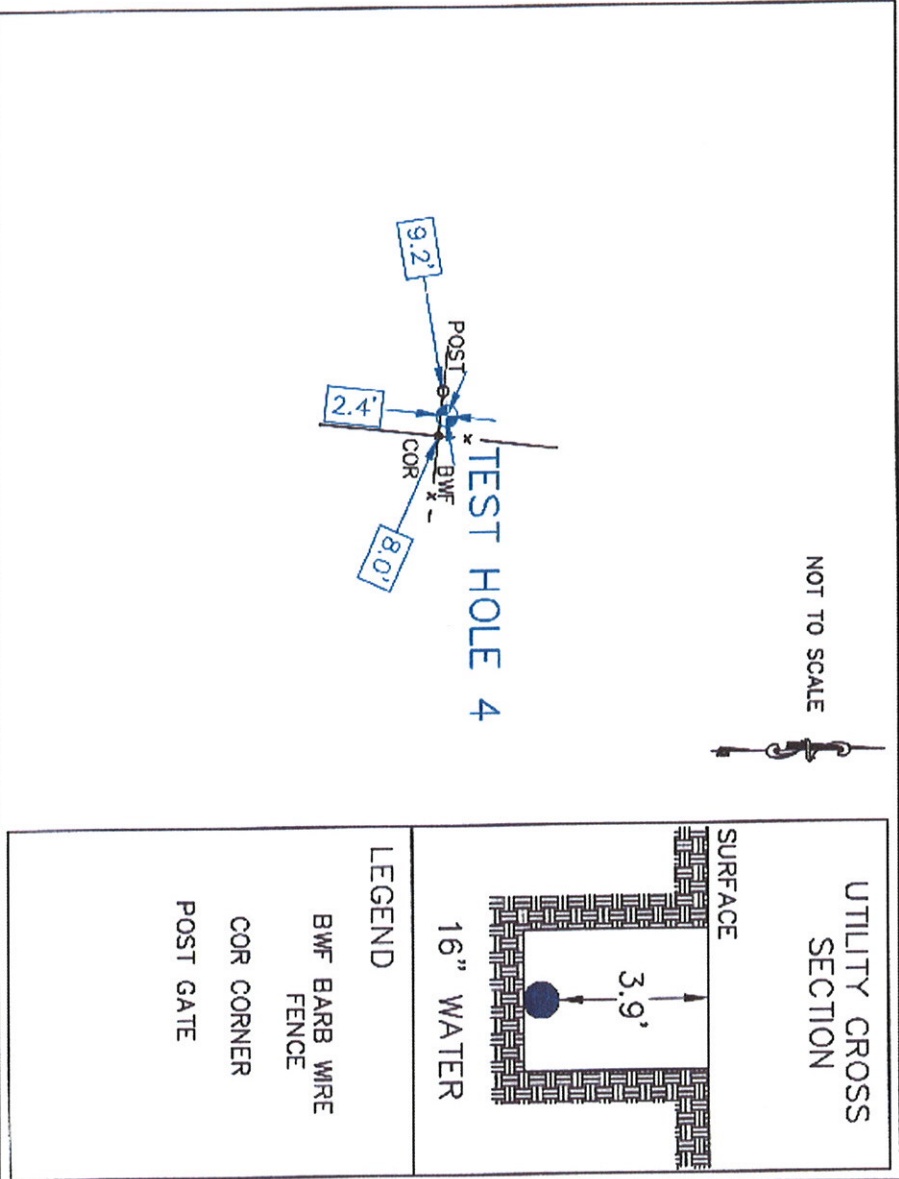
Utility Found: **16" poly pipe without tracer wire**  
 Utility Condition: **Good**

1. SAM, Inc. located Test Hole # 4 by utility records for the water line prior to air/vacuum excavation of the utility.
2. No additional utilities were found within Test Hole # 4 excavation.
3. All excavation was performed with air/vacuum excavation equipment.
4. The Test Hole was backfilled with excavated material.
5. The picture depicts the existing water line.

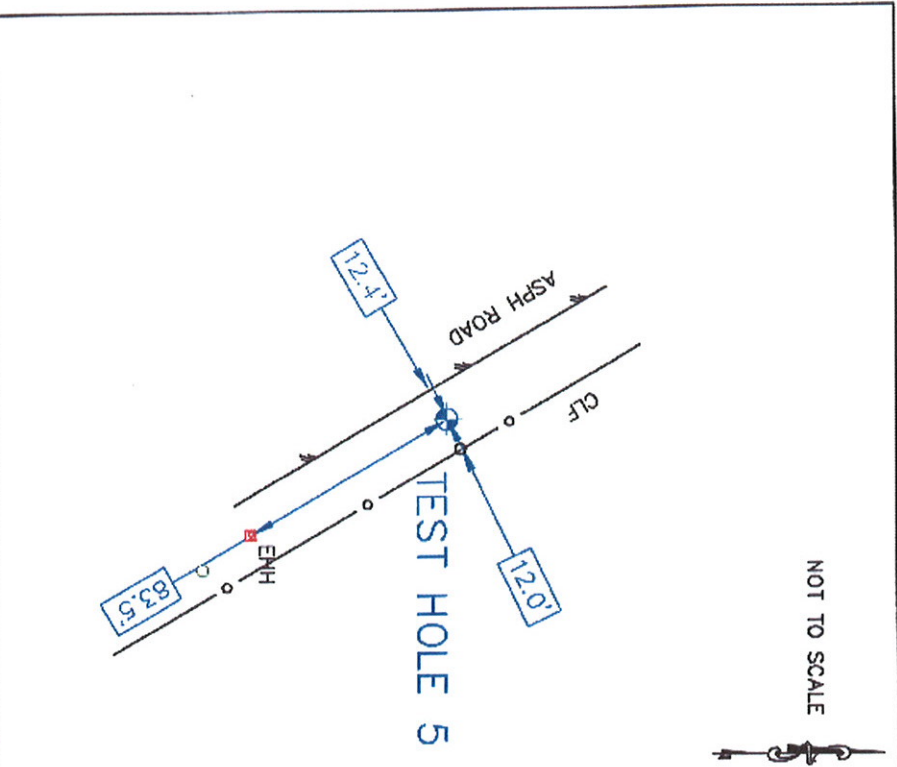
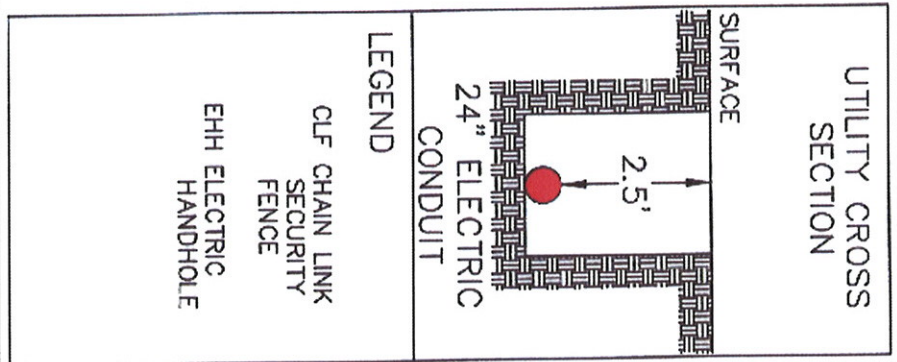
Surface Material: **Natural ground**  
 Surface Elevation: **527.19**  
 Thickness & Condition: **Dry**  
 Trench Material: **Black clay**  
 Utility Bedding Material: **Black clay**  
 Utility Found: **24" concrete conduit**  
 Utility Condition: **Good**  
 Utility Depth (Top): **2.5'**

1. SAM, Inc. located Test Hole # 5 by records and utility locator for the electric line prior to air/vacuum excavation of the utility.
2. No additional utilities were found within Test Hole # 5 excavation.
3. All excavation was performed with air/vacuum excavation equipment.
4. The Test Hole was backfilled with excavated material.
5. The picture depicts the existing conduit.
