CONDITION REMEDIATION ALTERNATIVES ANALYSIS

Project Scoping Report

Multiple Sewershed Package 12

PREPARED FOR: San Antonio Water System

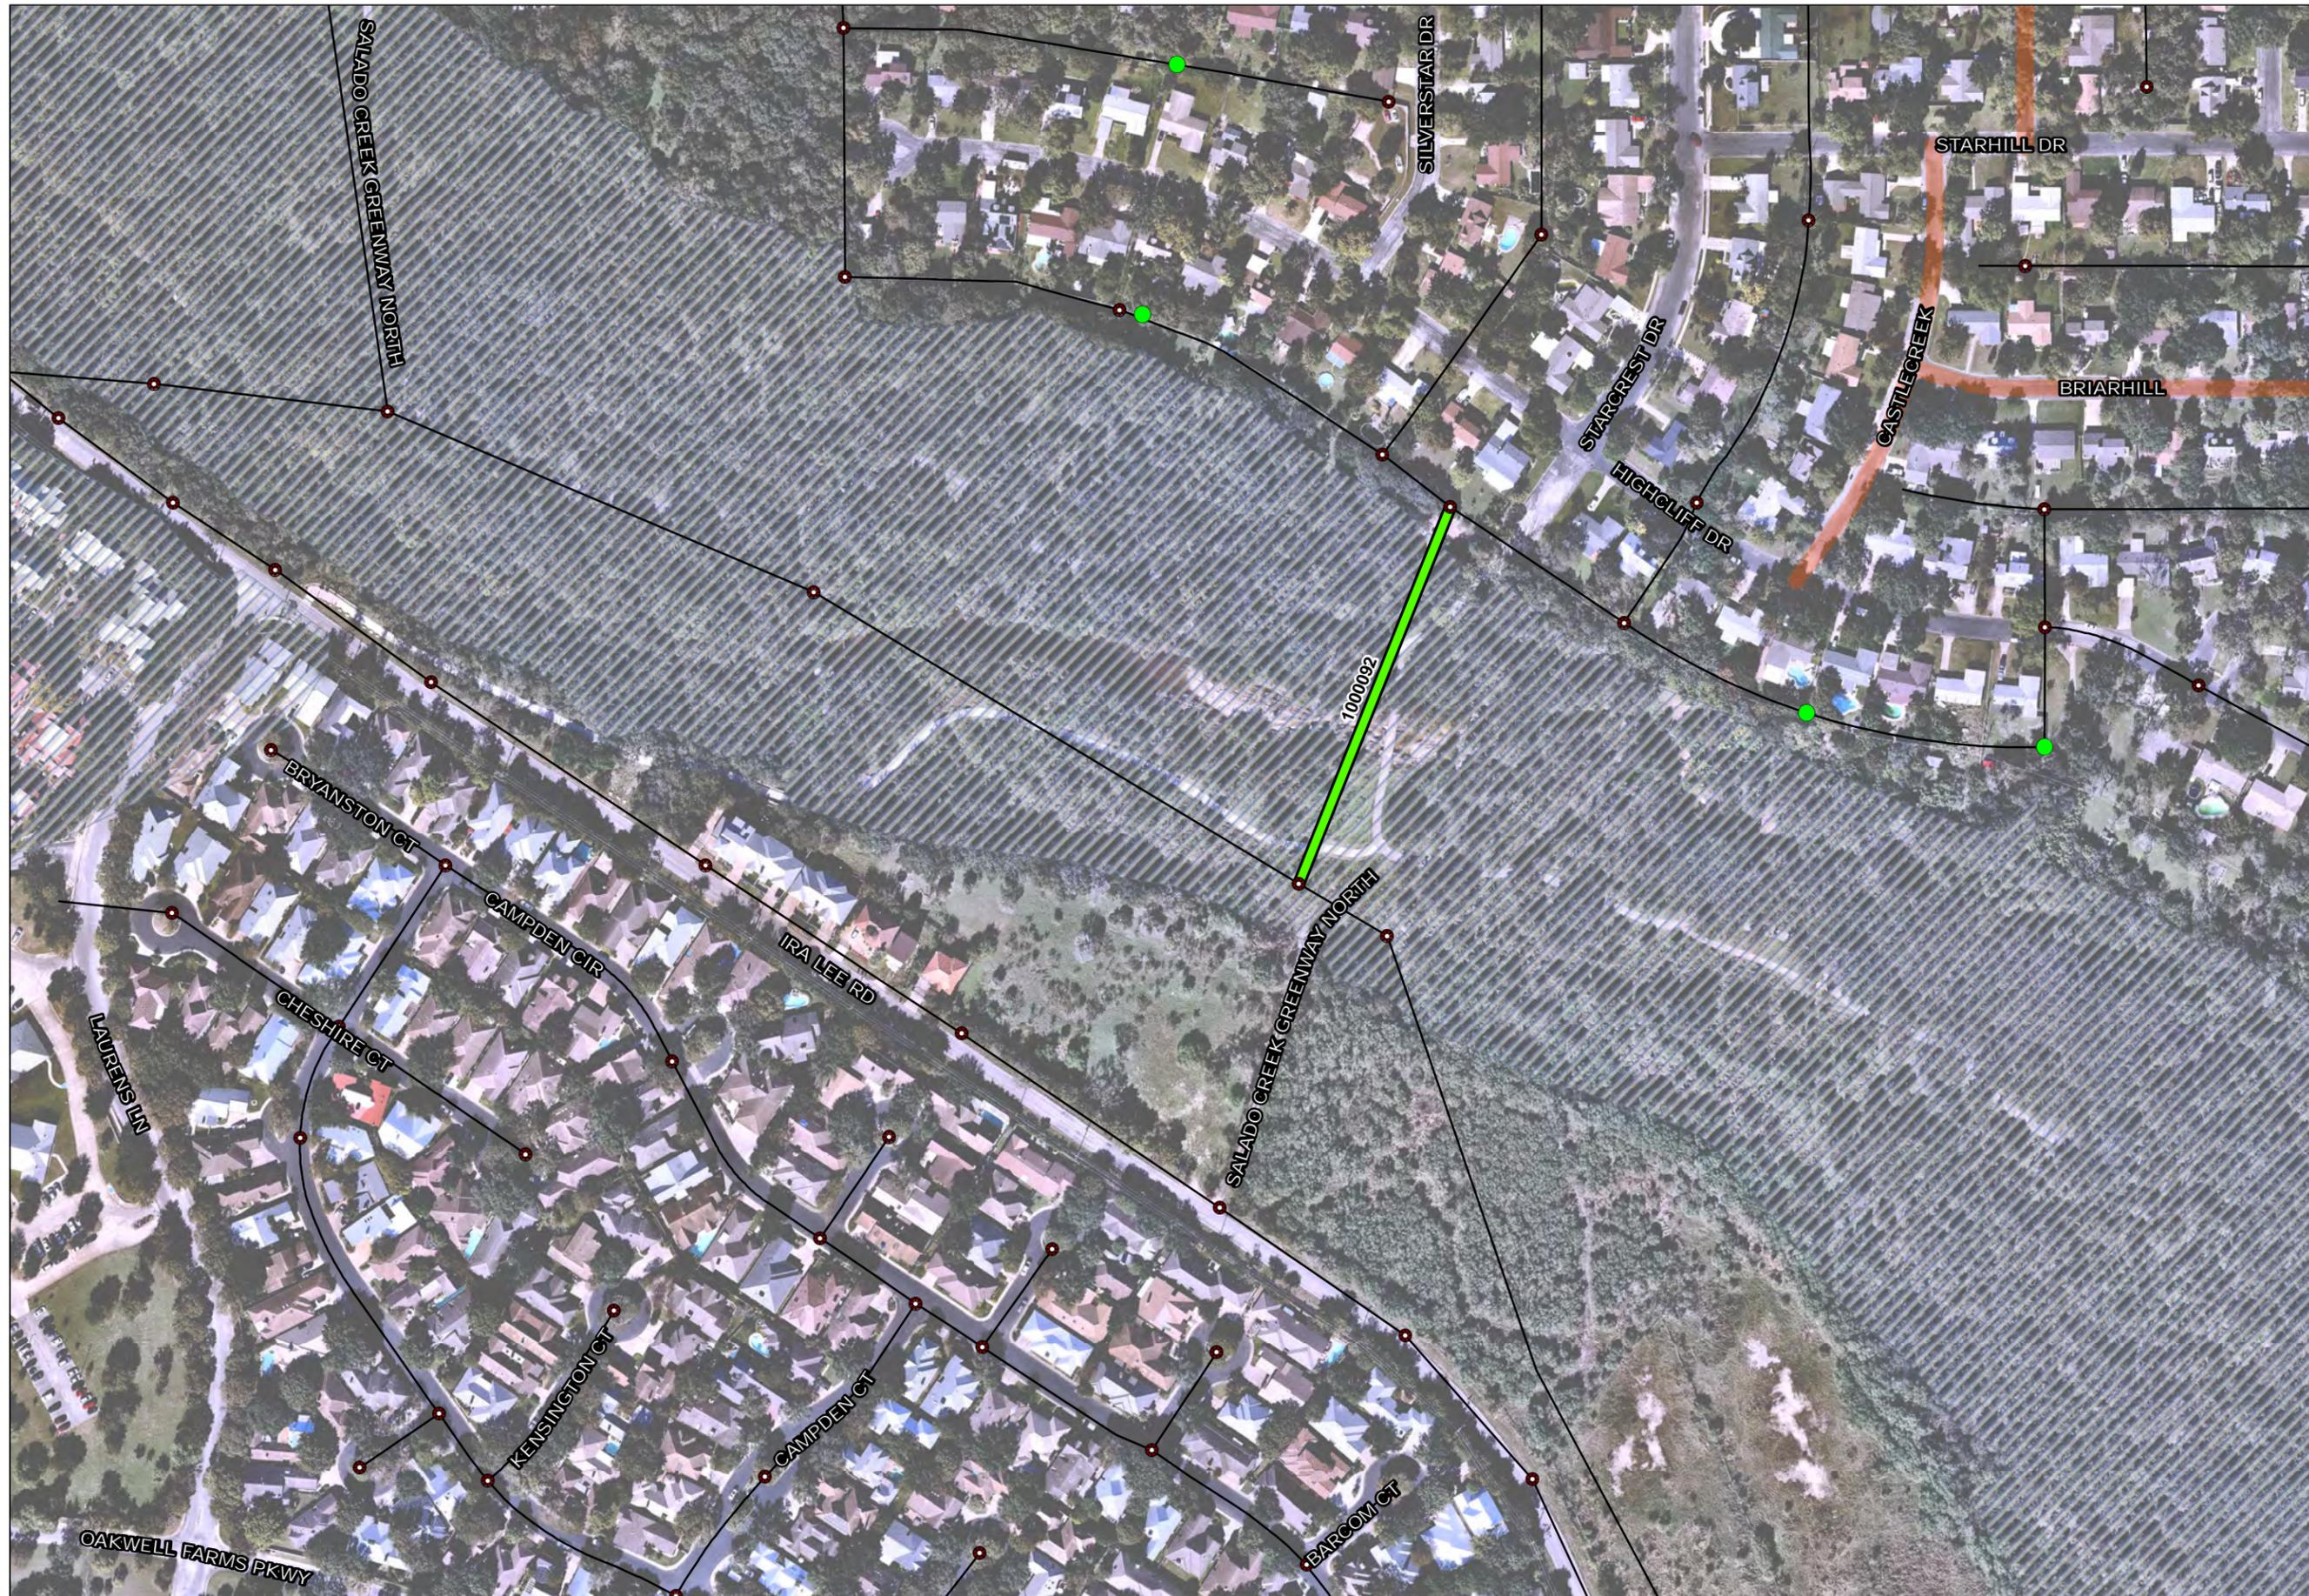
Sheet AO41

Index Page	Compkey	As-built No.	Block Map No.	Install Year	Dia. (in.)	Material	Avg. Depth (feet)	Length (feet)	Verified Cond. Rating	Preliminary Remediation Method	Decision Notes and Design Considerations
AO41	1057967	OM-4844	176612	1958	8	CP	4	167	D	Replace	This asset was included in a previous package. The consultant recommended replacement due to the depth of line.
AP43	1000092	DJ-1095	182610	1963	8	DIP	10	630	E	Replace	The majority of the survey is missing. An additional manhole may be needed.
AT42	997434	OM-2711	178600	1952	8	CP	7	228	E	Replace	The pipe includes projecting aggregate and missing pipe. There is also a possible sag.
AY40	976999	OM-4334	172592	1927	8	CP	9	305	E	Replace	There are several sections of crushed pipe. Based on SAWS review, the pipe is under a home.
BE29	2758473	OM-186	142580	1950	8	CP	8	10	E	Replace	There is large void behind the missing pipe.
BE31	1048481	OM-2238	148580	1928	8	CP	6	485	E	Replace	The pipe includes projecting aggregate, missing pipe, and roots. The pipe is close to (or under) buildings.
