MITCHELL LAKE DAM IMPROVEMENTS PRELIMINARY ENGINEERING REPORT

NOVEMBER 2020

FREESE AND NICHOLS, INC.
Texas Professional Engineering Firm No. F-2144
9601 McAllister Freeway, Suite 1008
San Antonio, Texas 78216

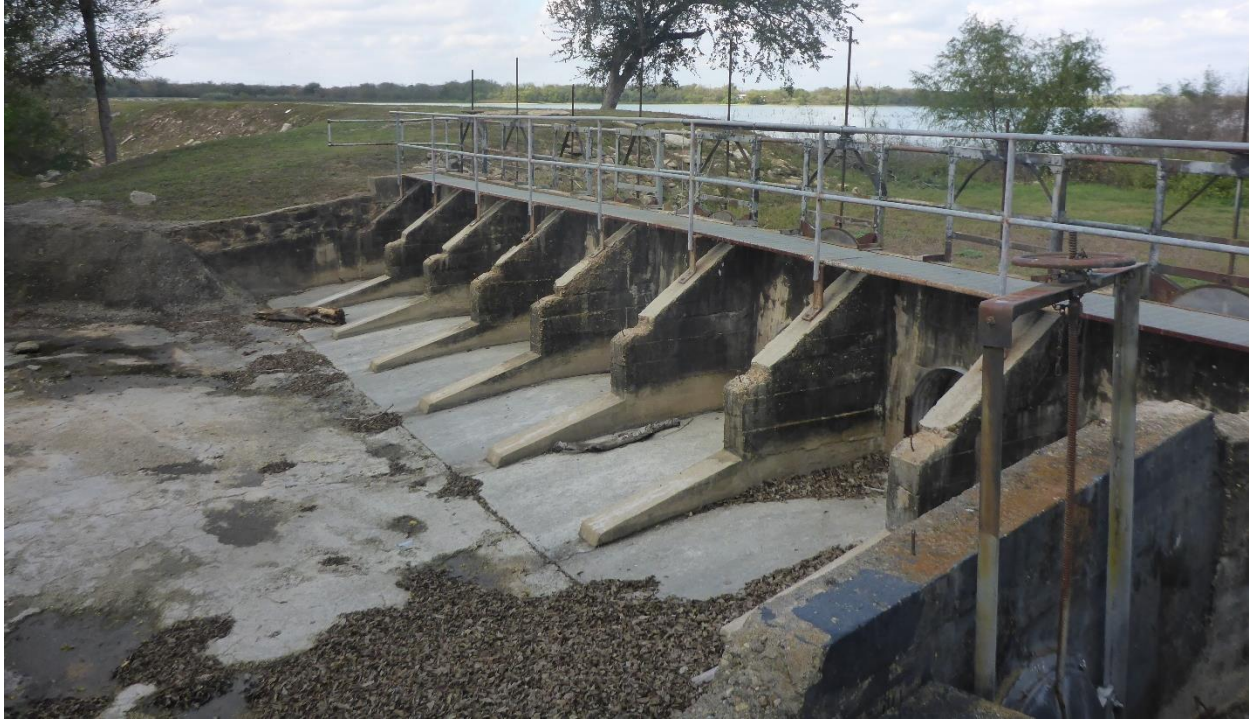
Figure 1.2: Mitchell Lake Dam Spillway (Looking Right along Downstream Side of Gate Valves)

The existing service spillway consists of a 55-foot long concrete gravity structure with eight 36-inch diameter gate valves. A ninth gate valve discharges to a 36" RCP which leads to an irrigation canal away from Cottonmouth Creek. Eight gate valves in the service spillway have invert elevations ranging from 520.71 to 520.78 feet, with an average invert elevation of 520.76 feet. Water passing through the gate valves passes through a stone and mortar chute approximately 225 feet in length, terminating in an eroded plunge pool on Cottonmouth Creek, a tributary to the Medina River. Figure 1.2 shows the existing spillway.

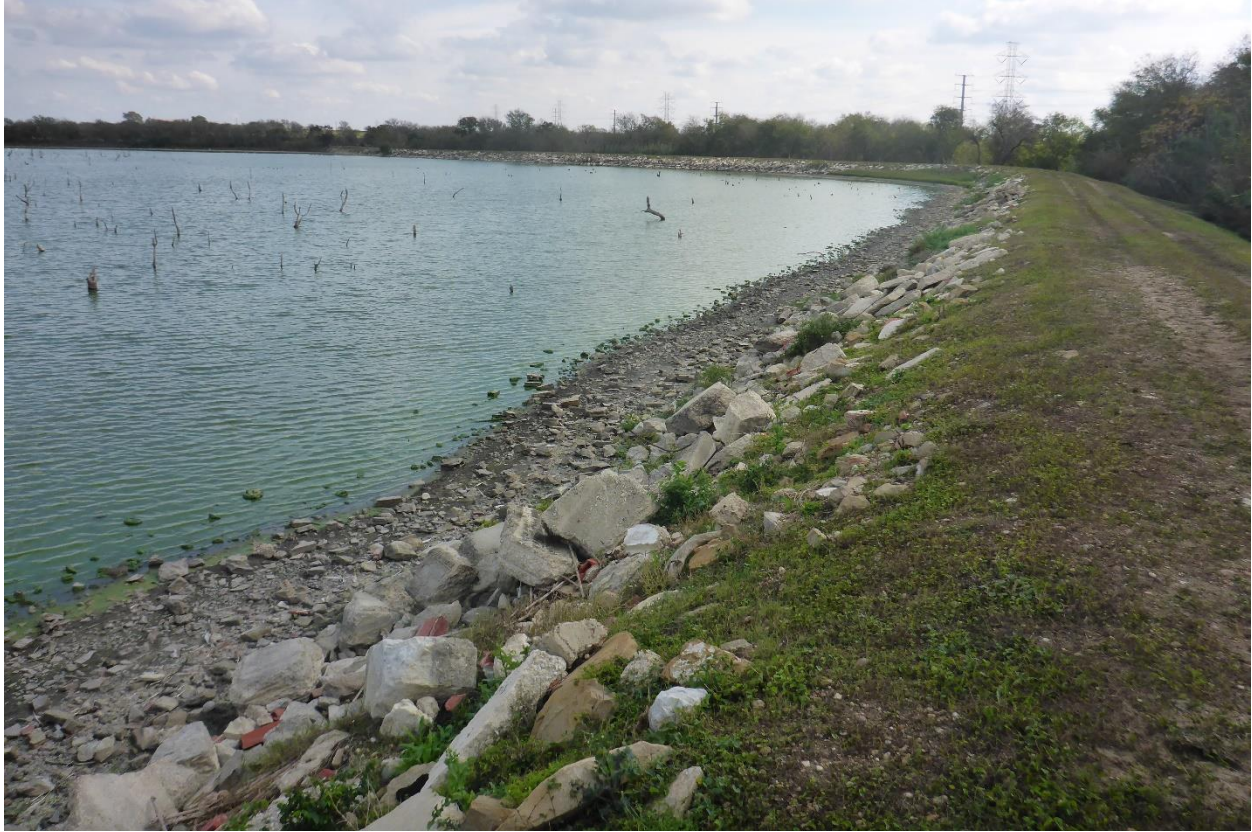
Photo 3: Upstream Embankment Slope

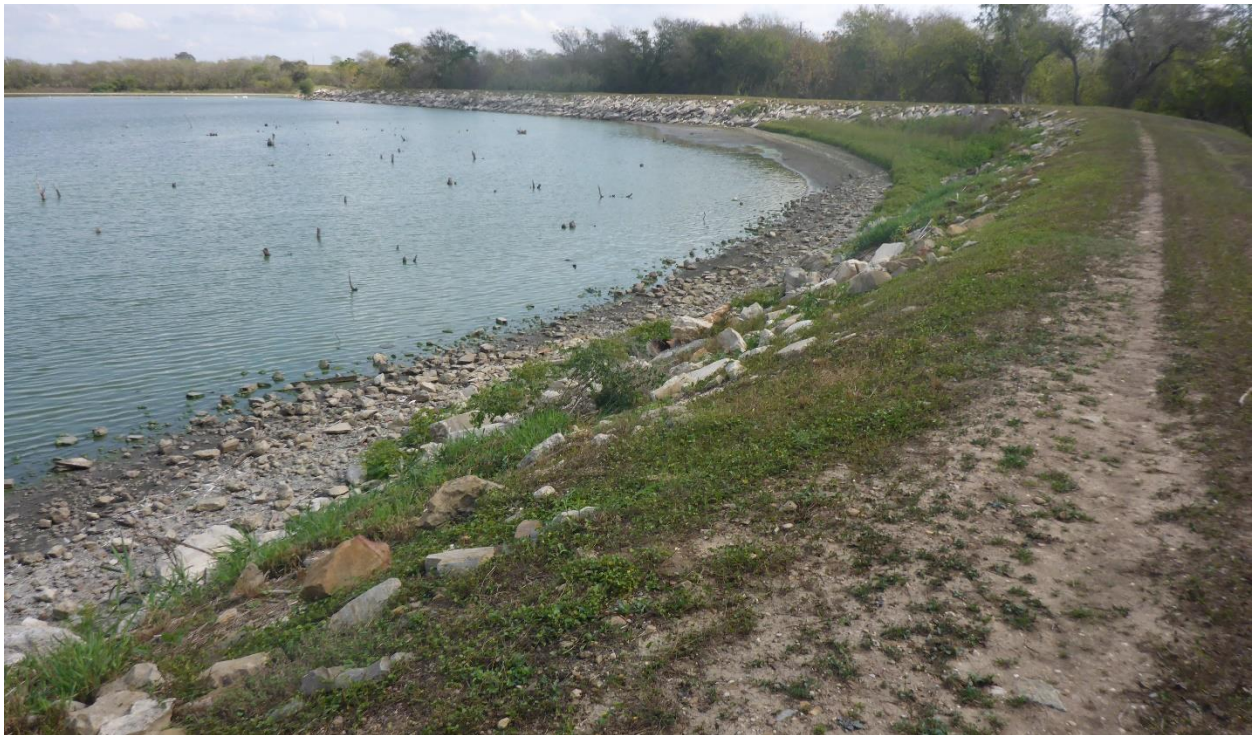
Photo 4: Upstream Embankment Slope

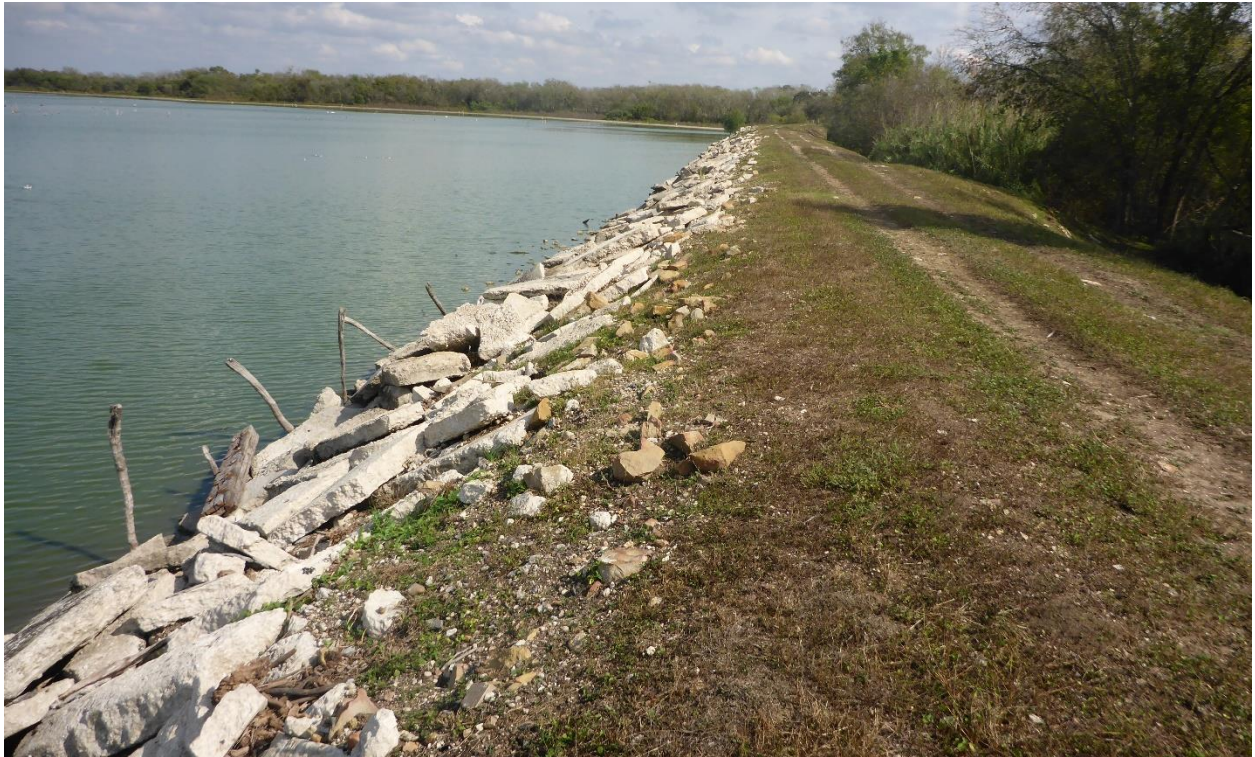
Photo 6: Upstream Embankment Slope

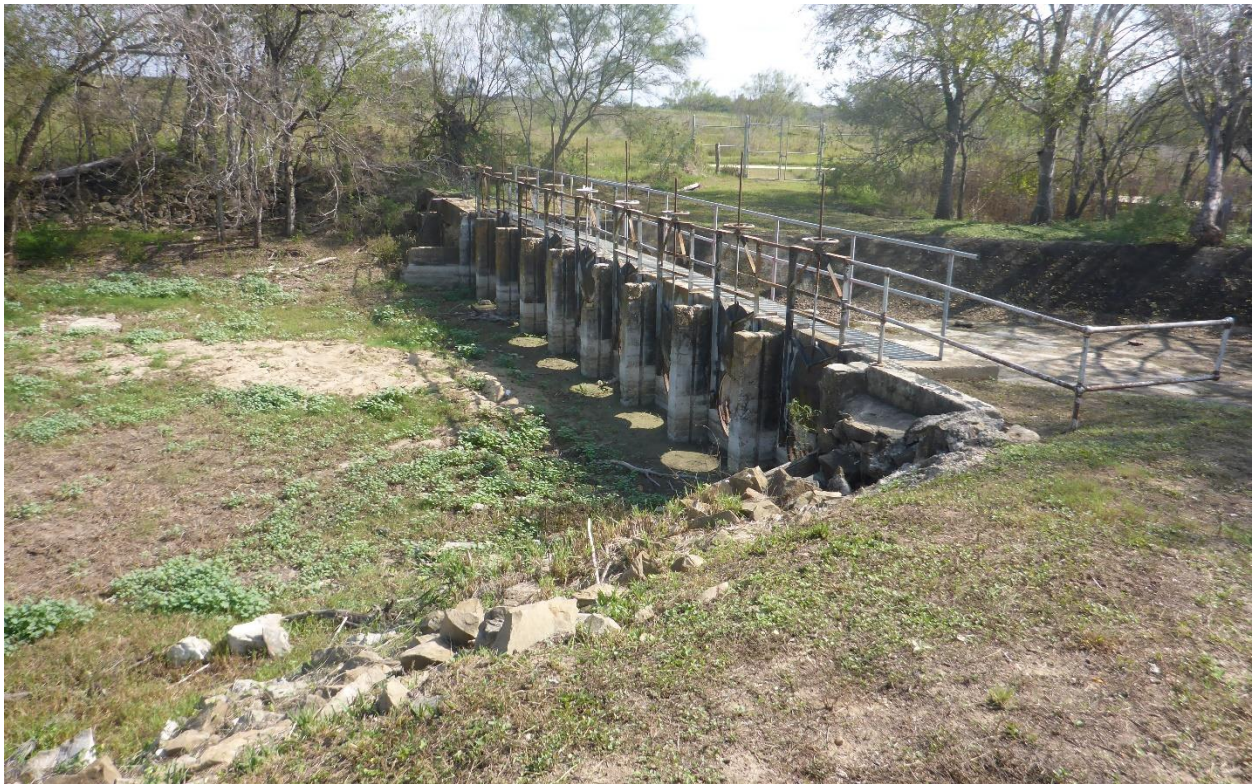
Photo 8: Spillway (Looking left from upstream)

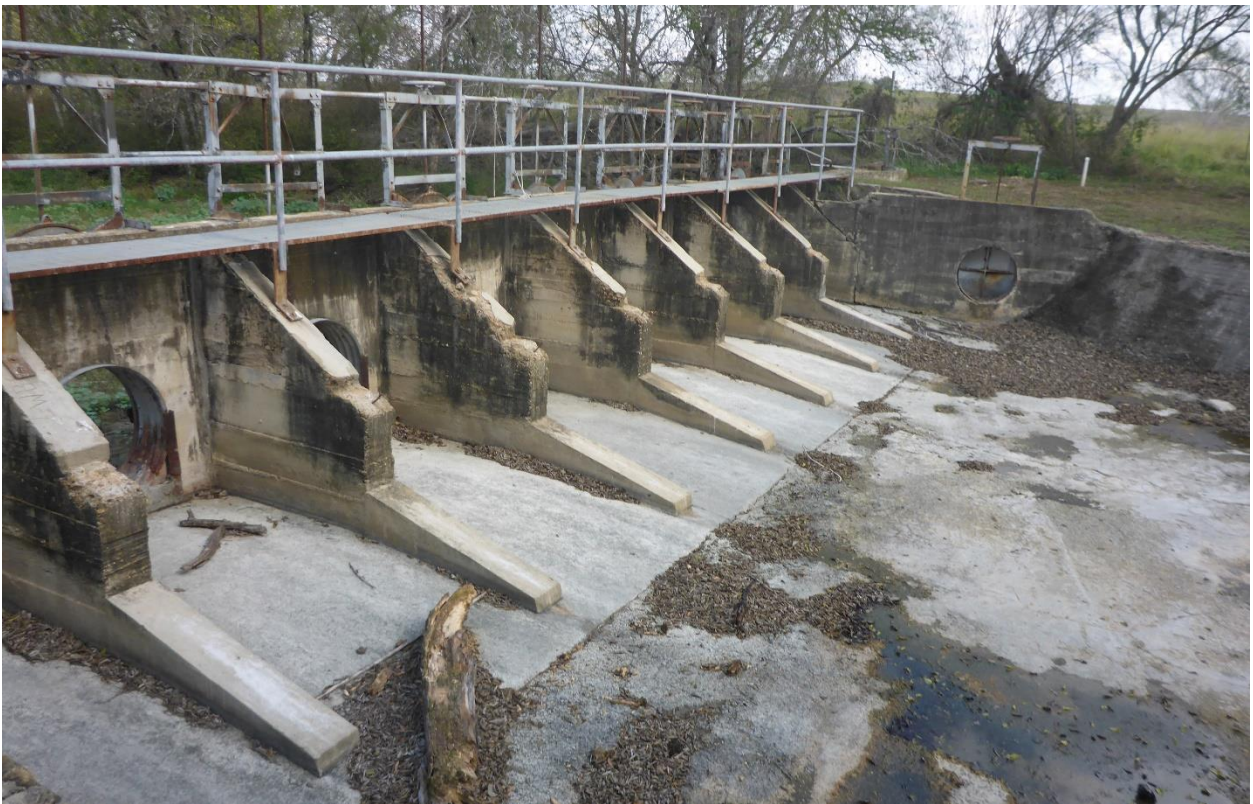
Photo 10: Spillway Downstream Face and Channel (Looking left)

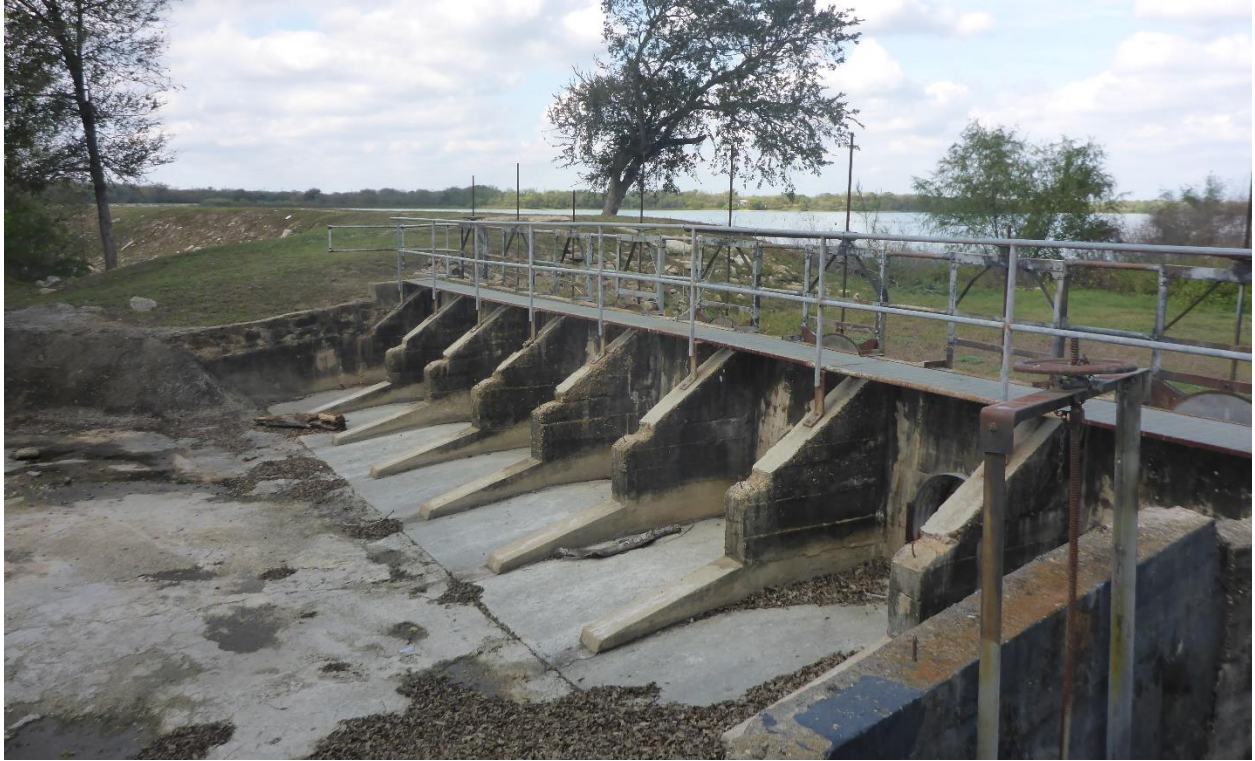
Photo 11: Spillway Downstream Face and Channel (Looking right)

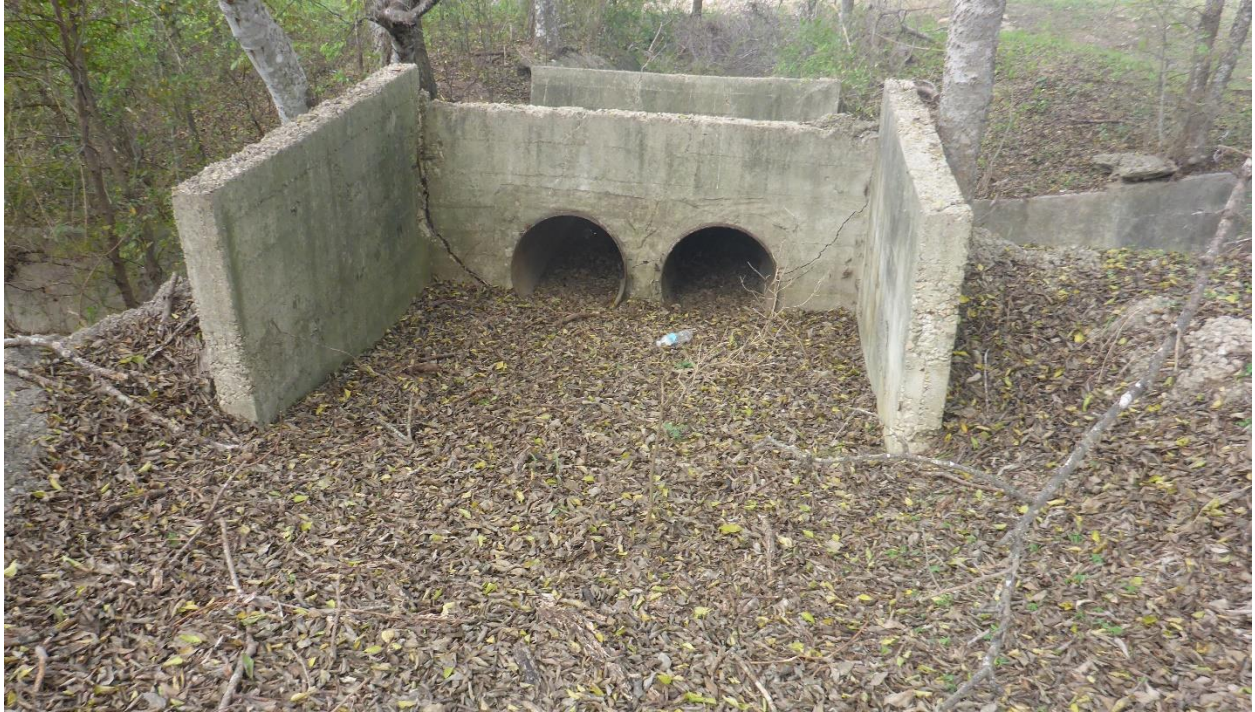
Photo 13: Irrigation Culvert Crossing over Spillway Channel
