GRAYSON ARMATURE WORKS
LARGE MOTOR DIVISION
 1910 JASMINE - PASADENA, TX 77503
 713-473-3231 FAX: 713-473-4201

SAN ANTONIO WATER SYSTEMS

GRAYSON SHOP JOB NUMBER 036108	ESTIMATED REPAIR COST
CUSTOMER PO# 201355	DATE RECEIVED 3/15/2013
EQUIPMENT ID	RFQ/WO

MANUFACTURER SIEMENS	HP/KW 3000	STYLE	TEMP. RISE C	PHASES 3	SF/PF 1.15
MODEL NUMBER 145	VOLTAGE 4000	RPM 3590	TYPE: RGWS	MOUNTING HORIZONTAL	
FRAME 8012	AMPS 370	SERIAL 1-5141-50198-1-3		ENCLOSURE

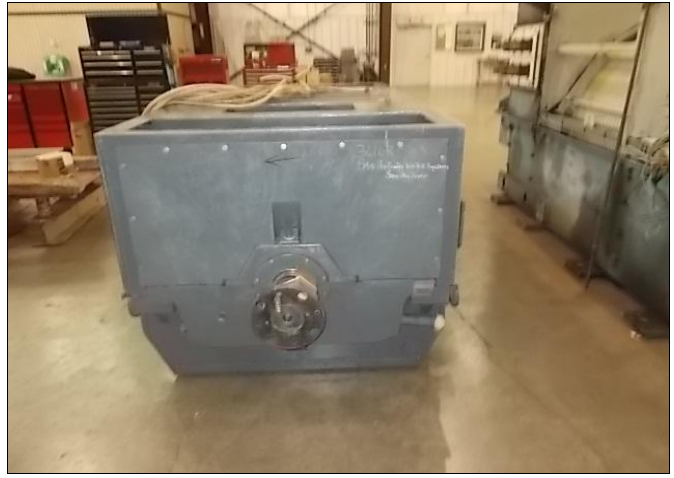
The center balance weight in the middle of the rotor is missing. This is part of a Siemens design that improves the balance of the rotor. This was probably done in the factory. All shaft fits, bearings and seals are worn.

DISASSEMBLE, CLEAN & TEST
 CLEAN ALL PARTS
 SANDBLAST ALL PARTS
 CHECK MAIN FRAME IN MILL
 LATHE CHECK ROTOR
 MACHINE ROTOR CORE TRUE
 REBUILD COUPLING FIT

REBUILD INBOARD BEARING JOURNAL
 REBUILD OUTBOARD BEARING JOURNAL
 GRIND AND BURNISH PROBE AREAS
 DYNAMIC BALANCE ROTOR
 REBUILD INNER SEALS
 REBUILD BEARING HOUSINGS
 REBUILD BOTH BEARINGS
 ASSEMB. MOTOR/TEST RUN FULL V.
 CHECK VIBRATION, AMP. & TEMP.
 PAINT TO CUSTOMER SPECS.
