Condition Remedial Measures Selection

Small Diameter

30% Design Package 2

Basin Planning Consultant for the Sanitary Sewer Overflow Reduction Program (SSORP) Team

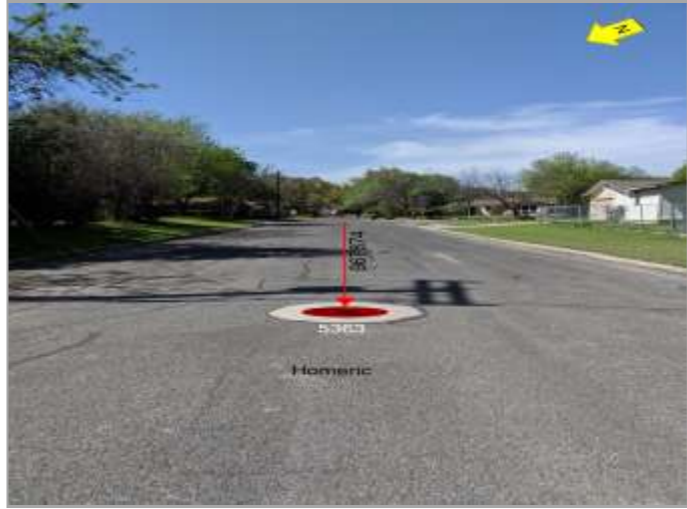
CompKey	967874	Diameter	10	Upstream MH	5363	US Depth	4.98	Material	CP
Final Rehab	REPLACE OPEN-CUT	Length	370.00	Downstream MH	4039	DS Depth	5	VerifiedCondition	E
Basin	CENTRAL	Length Surveyed	318.00	Siphon #		Condition (Consultant)			
		<input checked="" type="checkbox"/> 75% Televised		Sag	yes	No of Point Repairs	0	<input type="checkbox"/> yes	Point Repair Identified by a Professional
						No of Laterals	0

Construction Access	Yes	Homeric
Operational Access	Yes	Homeric
Jurisdictional Water	No	None likely.
Exist Utilities	Yes	Crosses 2" gas line at MH #5363, crosses 2" gas line at MH #4039, OHE
Permit Conditions	Yes	CoSA ROW Permit (Homeric)
Endangered Species	No	None likely.
Karst Zones	Yes	Within karst zone 3. Karst survey required.
Critical Habitat	No	No wetlands mapped.
Environmental factors	No	Within transition zone. No action required.
Hazardous Sites	Yes	Brake Check is southeast of the segment and lists two LPST site with significant groundwater contamination. Chico Family Holdings lists IHWCA site and is southeast of the segment. Recommend field investigation for any unreported sites and/or dumps.
Archeological Sites	No	No known cultural resources conflict. Coordination with CoSA OHP needed. If work will exceed five acres or 5,000 cubic yards of earth moving, consultation with THC needed.
Geomorphology Issues	No	Potential Ground Water Not Anticipated

By-Pass Info	
Peak Wet Weather (MGD) - From Model for Pipes > 12" - Calculated for Pipes < 12" with Mannings Assuming Full Flow	0.10
Avg Day (MGD) - From Model for Pipes > 12"	
US Suction Manhole	5563
DS Discharge Manhole	3446
By-Pass Length	920

Street Width	36
Quantity of Street Repair (LF)	370.00
30% Package Number	2
Reason Selected for 30%	Concrete E
Base or Additional Pipe	Base Pipe
Reviewed in 10% Design	Yes
On CPMS Project	No

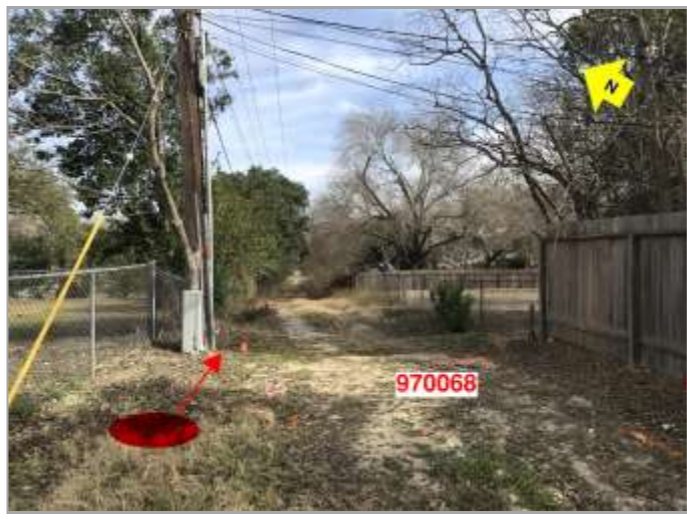
CompKey	970068	Diameter	8	Upstream MH	3974	US Depth	7.3	Material	CP
Final Rehab	CIPP & POINT REPAIR	Length	370.00	Downstream MH	4039	DS Depth	5	VerifiedCondition	E
Basin	CENTRAL	Length Surveyed	372.00	Siphon #		Condition (Consultant)			
		<input checked="" type="checkbox"/> 75% Televised		Sag	No	No of Point Repairs	4	<input checked="" type="checkbox"/> Point Repair Identified by a Professional	
						No of Laterals	9

Construction Access	Yes	Located in alley behind Tamworth Dr, unpaved, utility poles. MH 4039 is located in the ROW of Homeric. MH 3974 is located in the alley.
Operational Access	Yes	
Jurisdictional Water	No	
Exist Utilities	Yes	Parallel 2" gas main, utility poles, underground distribution, telephone, and underground cables.
Permit Conditions	Yes	COSA for Homeric
Endangered Species	NA	
Karst Zones	NA	
Critical Habitat	NA	
Environmental factors	NA	
Hazardous Sites	NA	
Archeological Sites	NA	
Geomorphology Issues	NA	
Geotechnical issues	NA

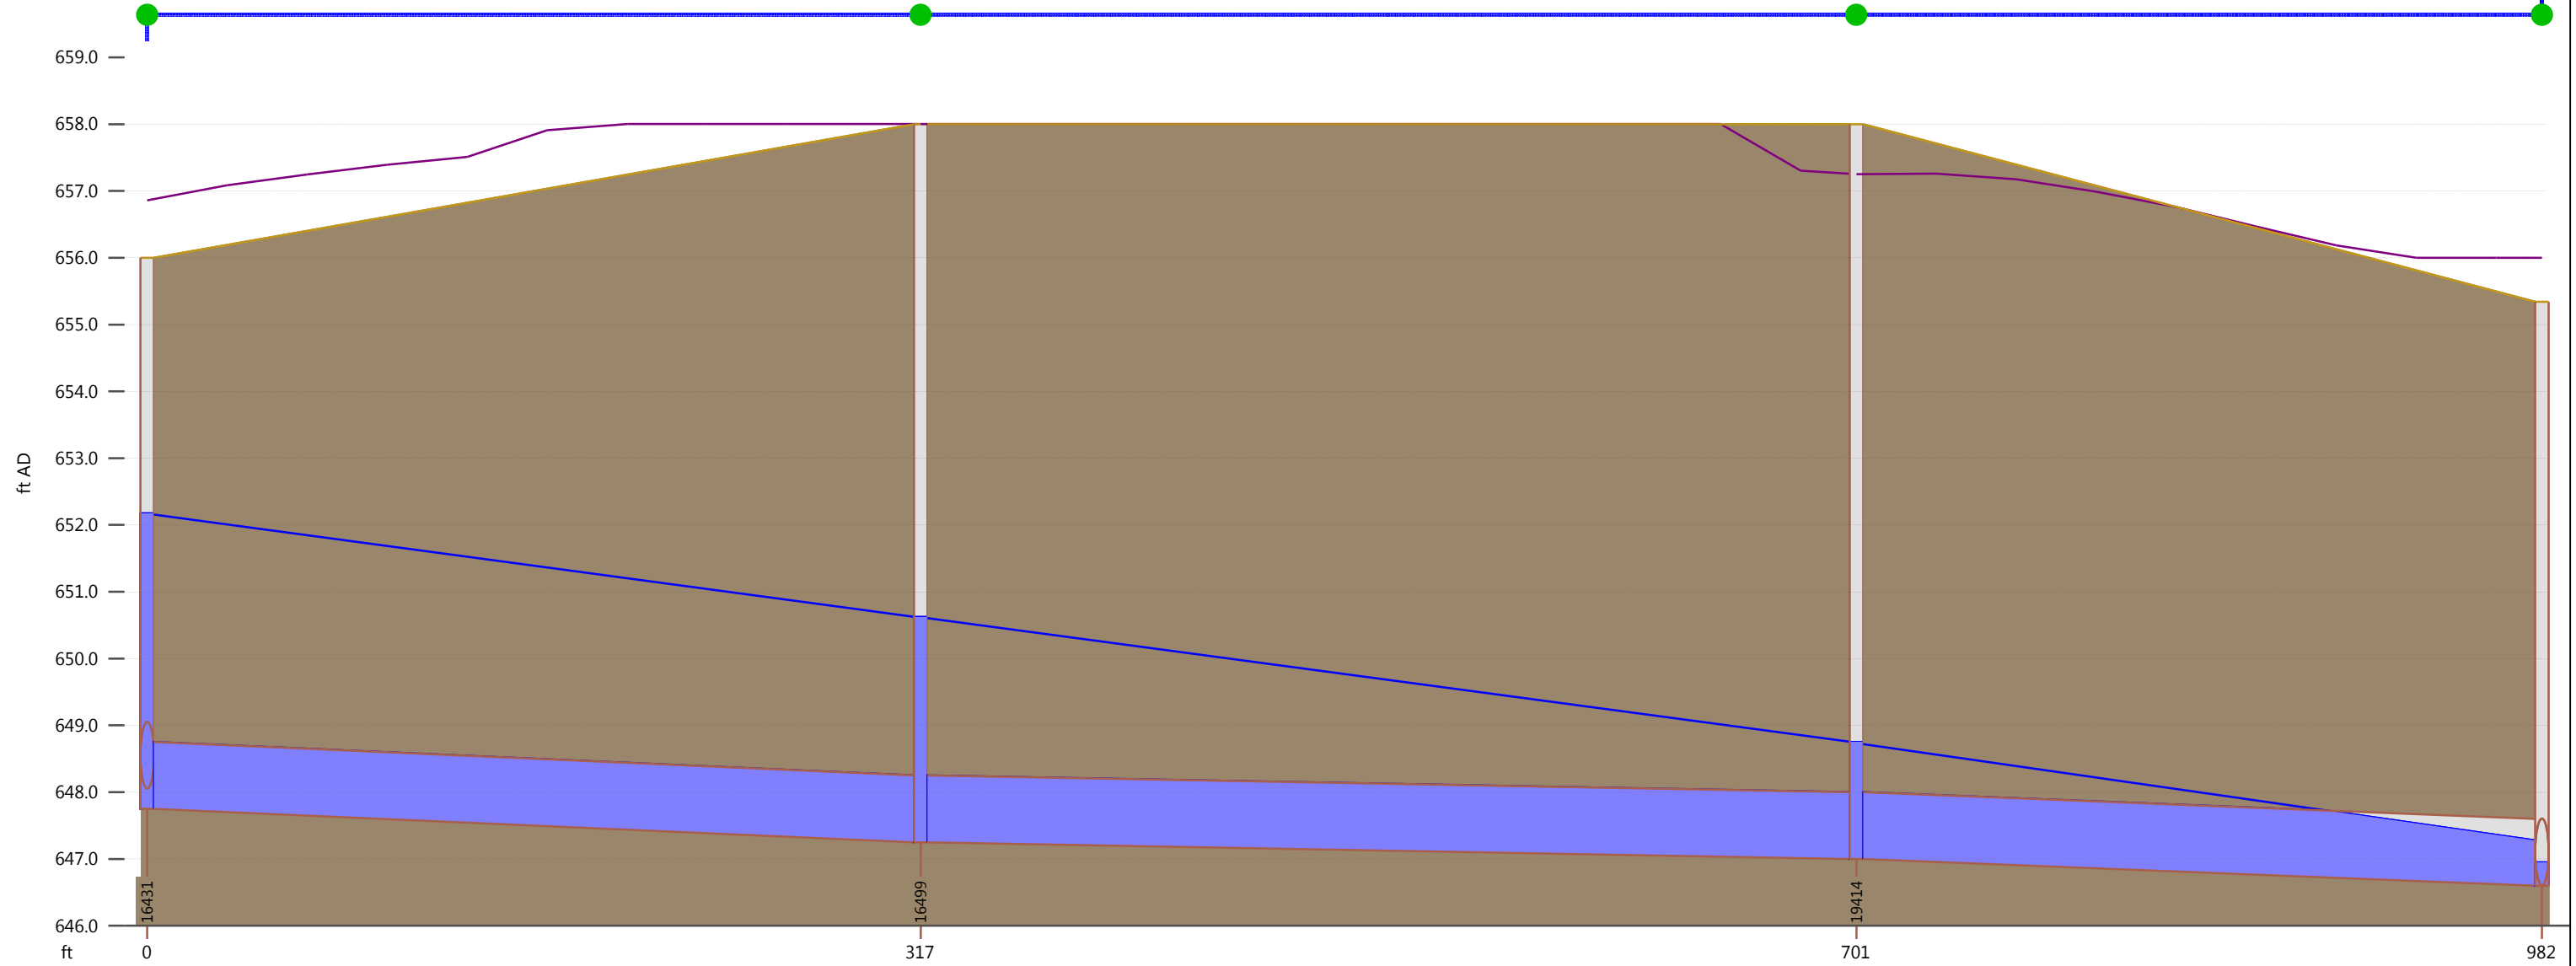
SAN ANTONIO WATER SYSTEM
 CONDITION 30% DESIGN
 PROFILE 6: COMPKEY ID 978096

Link	16431.1	16499.1	19414.1	
Asset ID		978096		
width (in)	12.0	12.0	12.0	
us inv (ft AD)	647.750	647.251	647.000	
ds inv (ft AD)	647.251	647.000	646.601	
grad (%)	0.157	0.065	0.142	
pfc (MGD)	0.91	0.59	0.87	
CC Project Area ID	64-08	64-08	64-08	
CC Alternative				
surc	2.00	2.00	2.00	
US flow (MGD)	1.5895	1.5895	1.5977	
US velocity (ft/s)	2.792	2.860	2.989	
Node	16431	16499	19414	34916
ground (ft AD)	656.000	658.000	658.000	655.340
flood dep (ft)	-3.824	-7.376	-9.248	-8.389

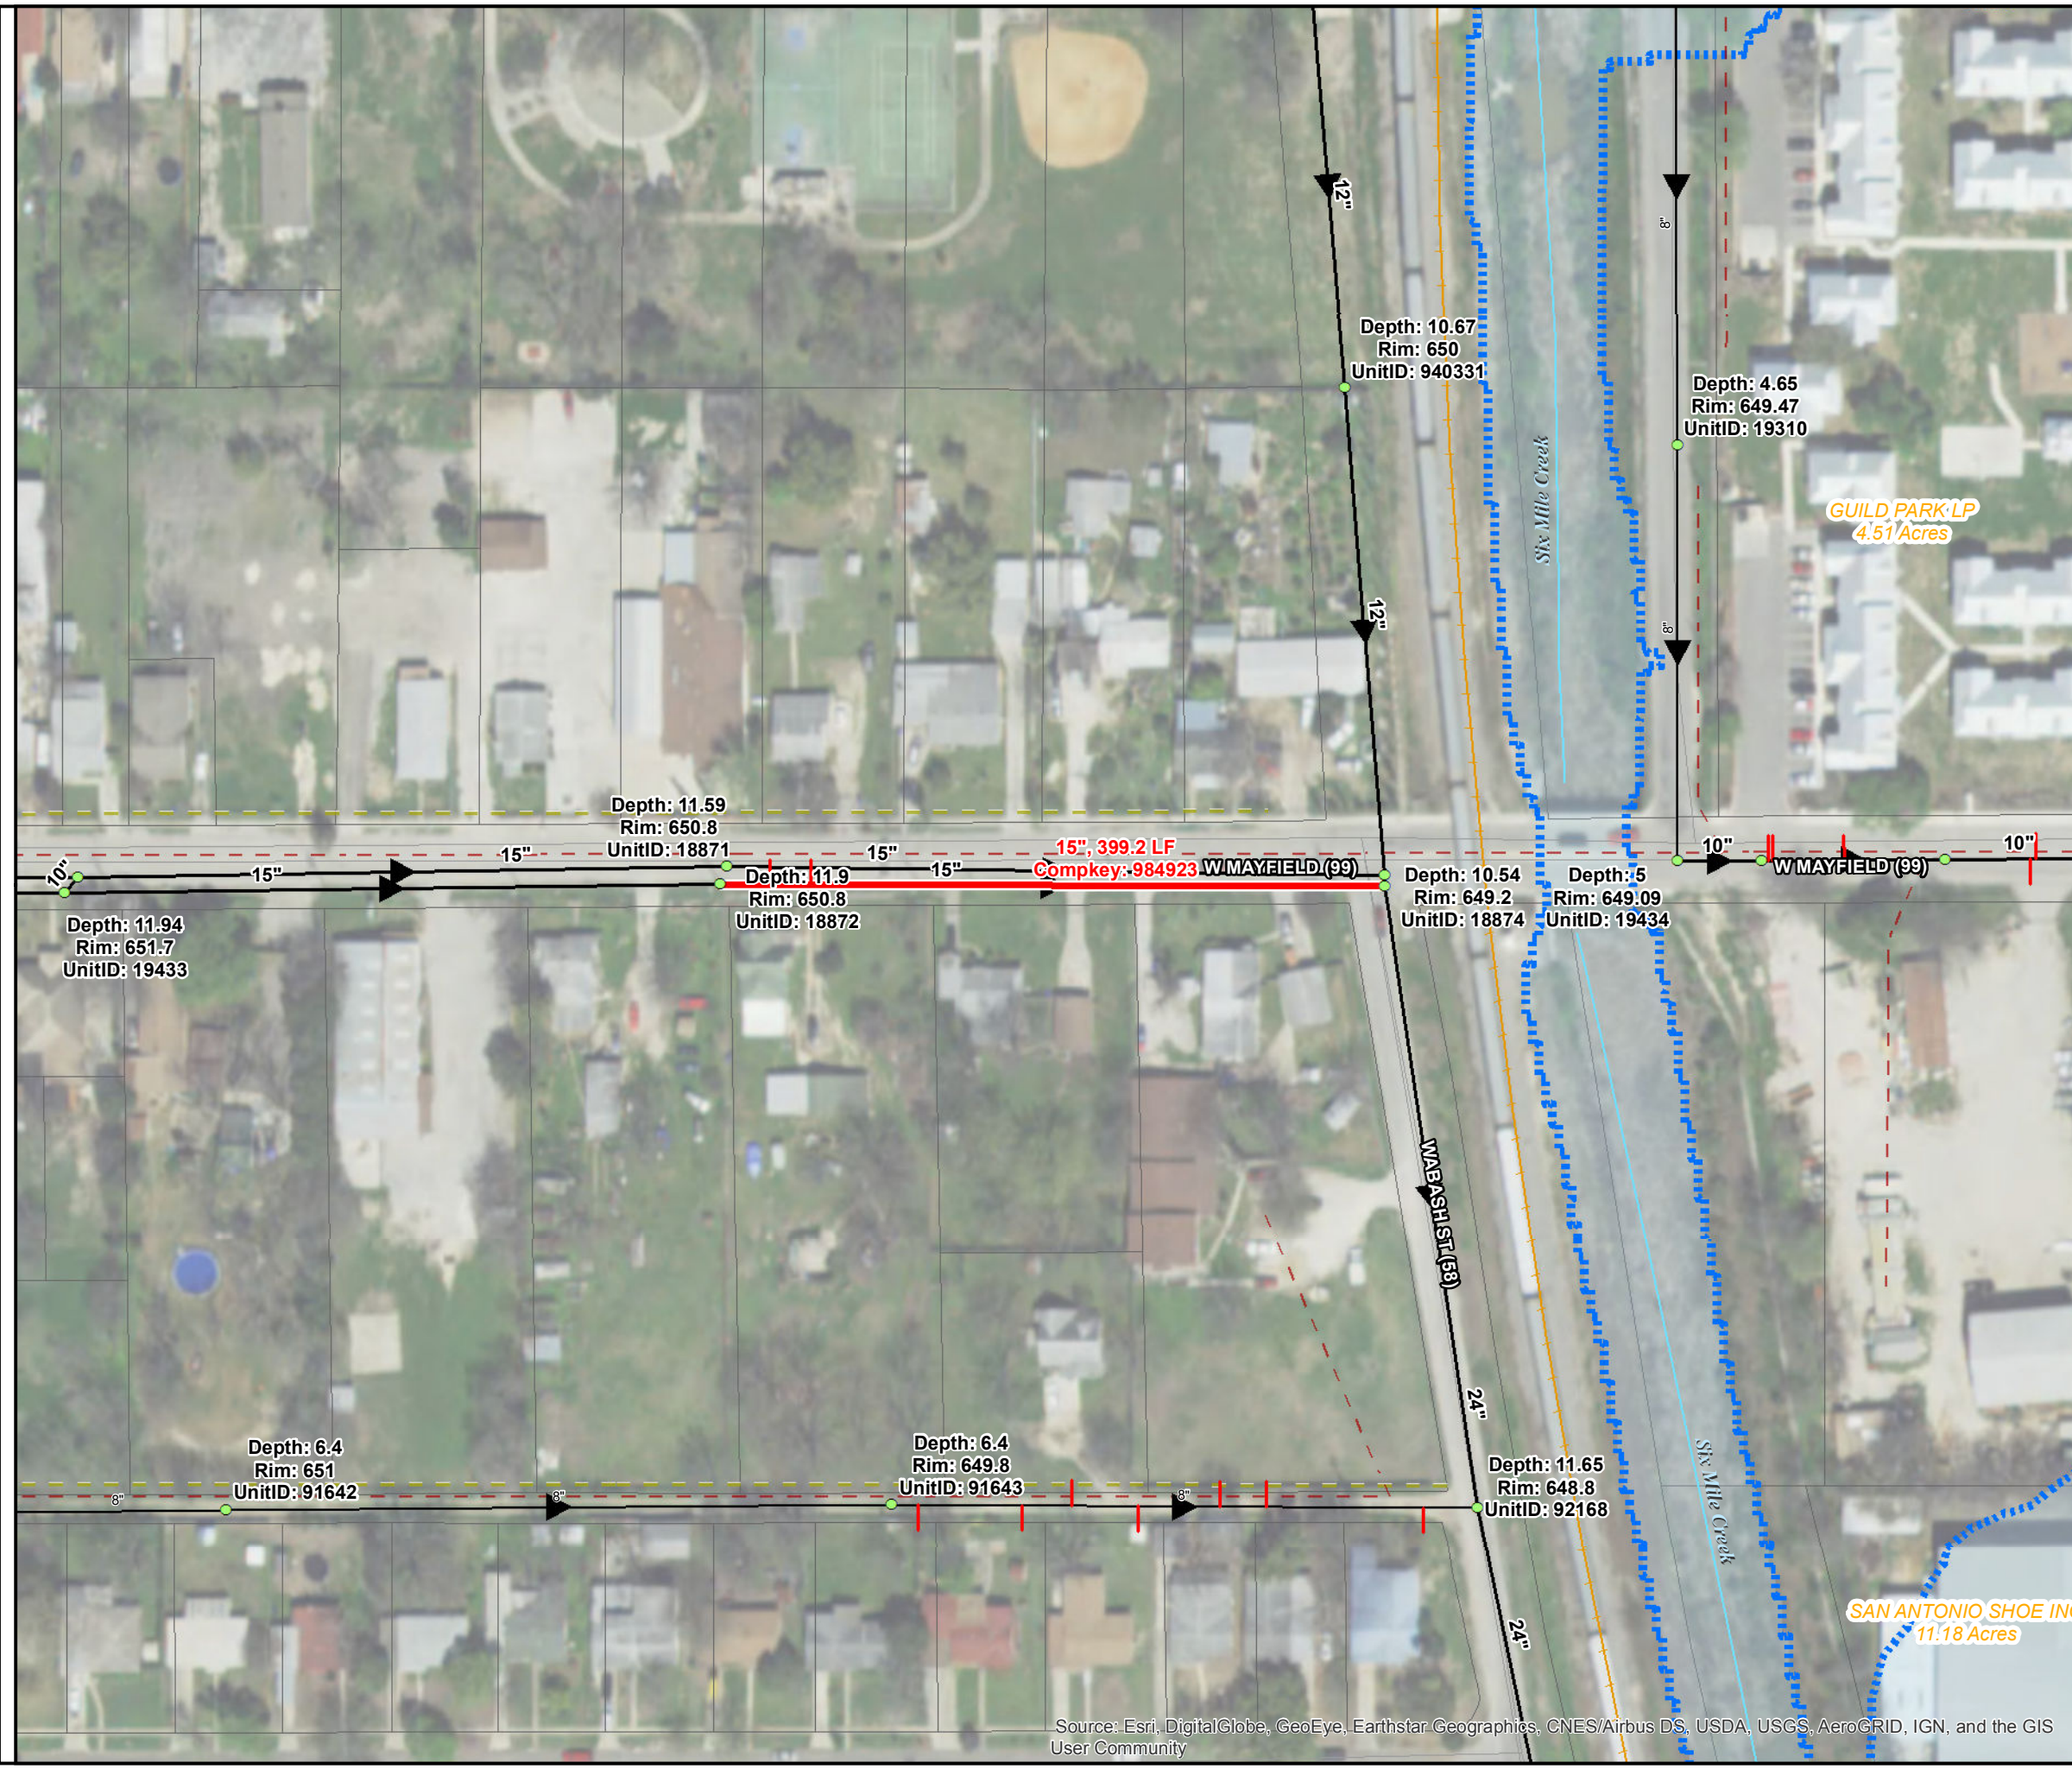
Title:	Compkey: 984923	
Project	SSO Basin Planning Consultant 30% Condition Small Diameter	
Date:	7/11/2018	Sheet C-8

LEGEND	
● Manhole	▶ 8" and Smaller Wastewater Line
— CIPP	▶ 10" and Larger Wastewater Line
- - CIPP & POINT REPAIR	— Water Main
— BORE	— Laterals
— PIPEBURST	— Road
- - PIPEBURST & POINT REPAIR	— Stream
— REPLACE OPEN-CUT	— 10-ft Contour
- - CPS Electric OH Primary	▭ Parcel
- - CPS Gas Distribution Main	▭ 100Yr Floodplains
— Additional Line	
● Potential Point Repair Location

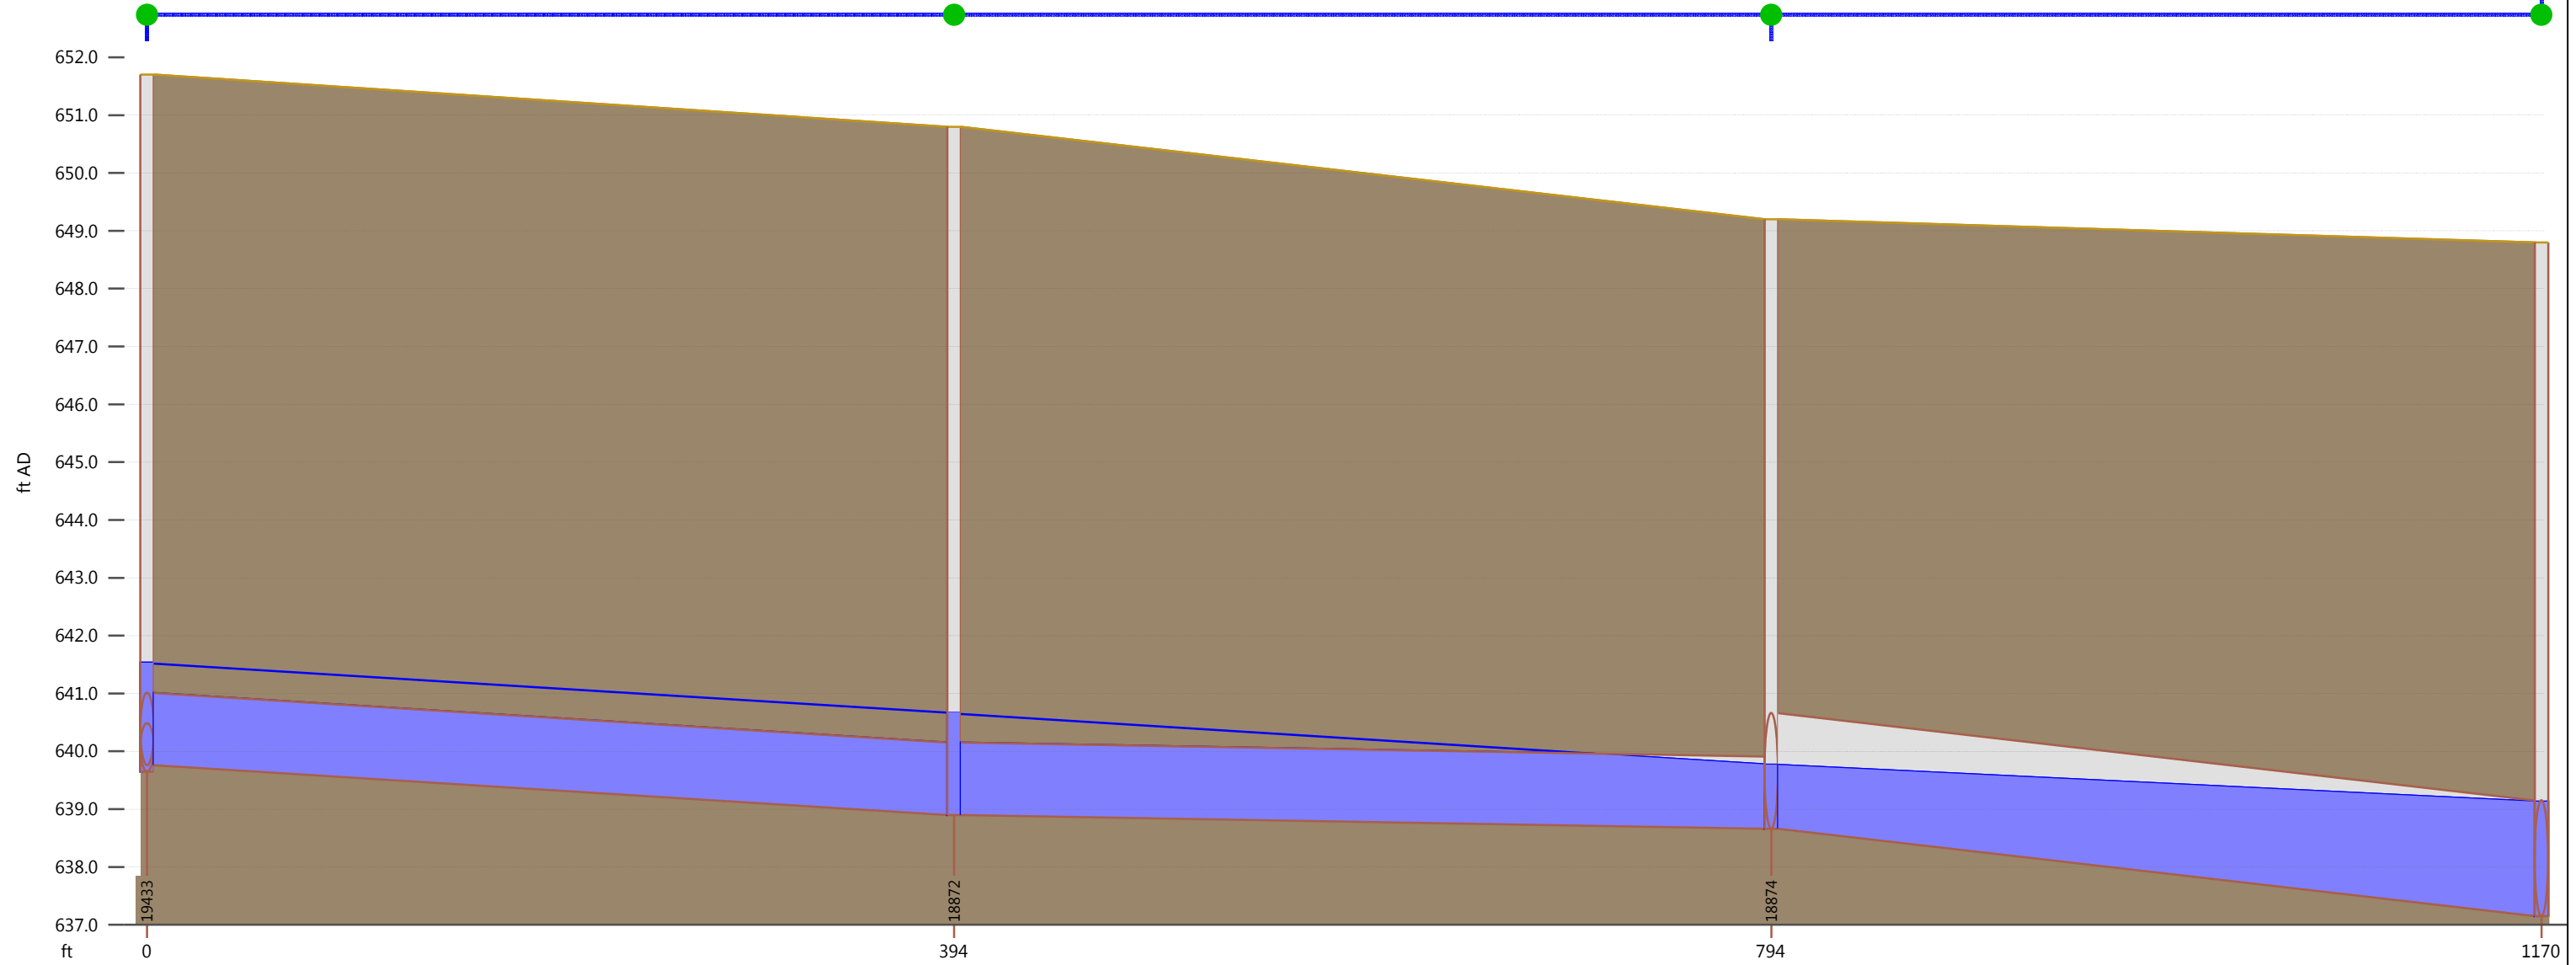
SAN ANTONIO WATER SYSTEM
 CONDITION 30% DESIGN
 PROFILE 9: COMPKEY ID 984923

Link	19433.1	18872.1	18874.1	
Asset ID		984923		
width (in)	15.0	15.0	24.0	
us inv (ft AD)	639.760	638.900	638.660	
ds inv (ft AD)	638.900	638.660	637.150	
grad (%)	0.218	0.060	0.401	
pfc (MGD)	1.95	1.02	9.26	
CC Project Area ID				
CC Alternative				
surc	1.00	2.00	0.99	
US flow (MGD)	1.9456	1.9516	4.8611	
US velocity (ft/s)	2.660	2.356	4.356	
Node	19433	18872	18874	92168
ground (ft AD)	651.700	650.800	649.200	648.800
flood dep (ft)	-10.163	-10.136	-9.431	-9.671
