Condition Remedial Measures Selection Large Diameter Open Cut 30% Design Package 2

Central Basin - 24" and Greater July 2018

Basin Planning Consultant for the Sanitary Sewer Overflow Reduction Program (SSORP) Team

FREESE AND NICHOLS, INC.

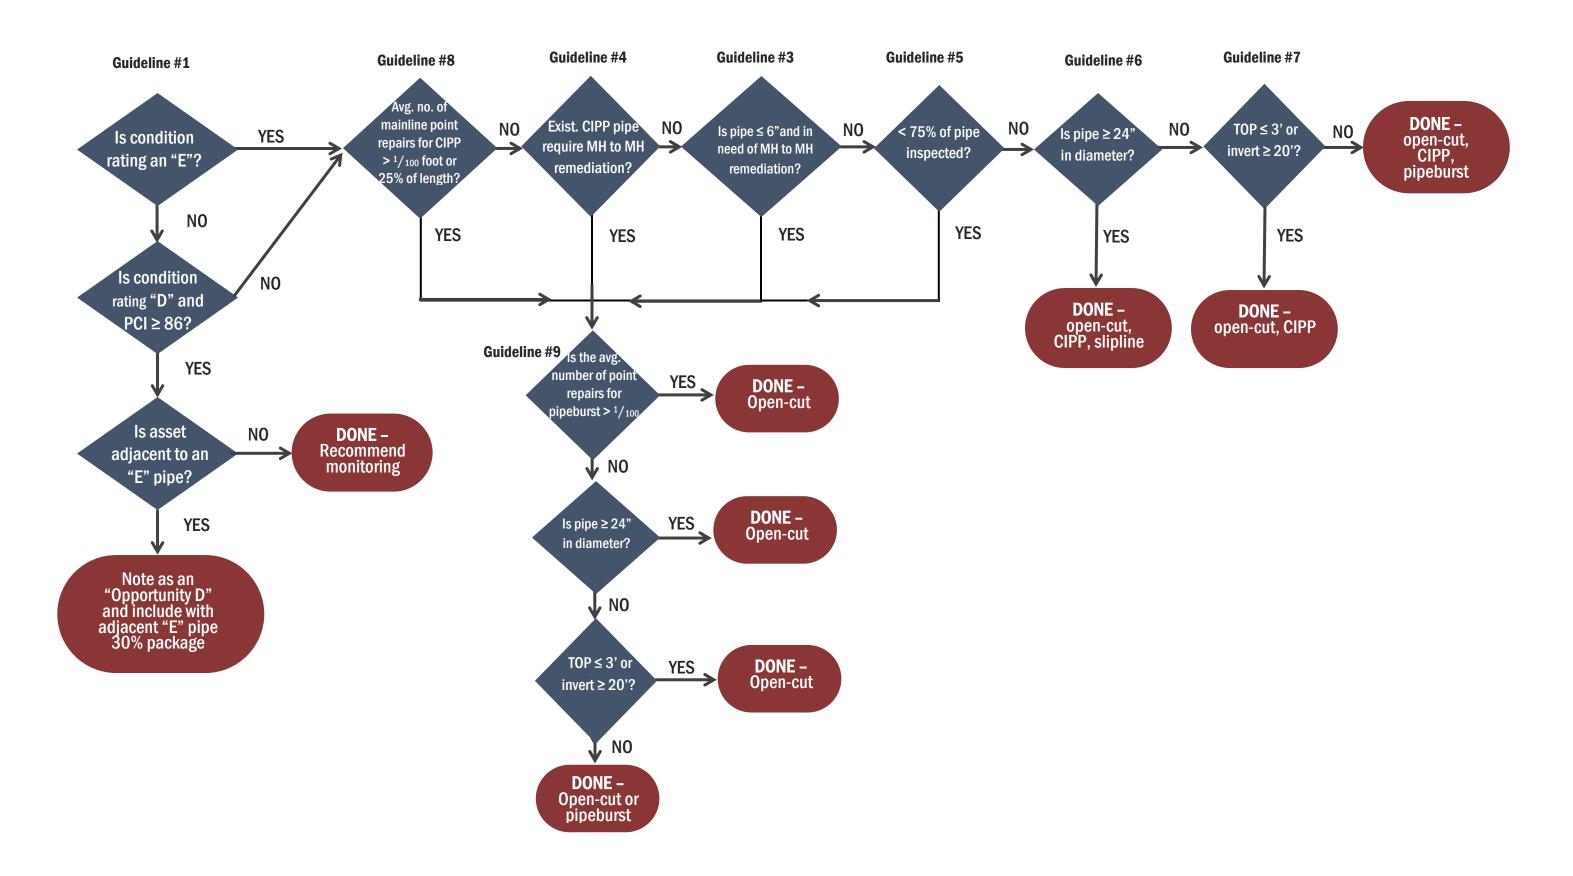
Figure 2-1 - Remedial Measure Flow Chart

FNI used the decision guidelines developed by SAWS in the *Guidelines TM* to develop a protocol with which to recommend a remedial measure. This protocol is shown in **Figure 2-1** as a flowchart (decision tree) resulting in a preferred remedial measure.

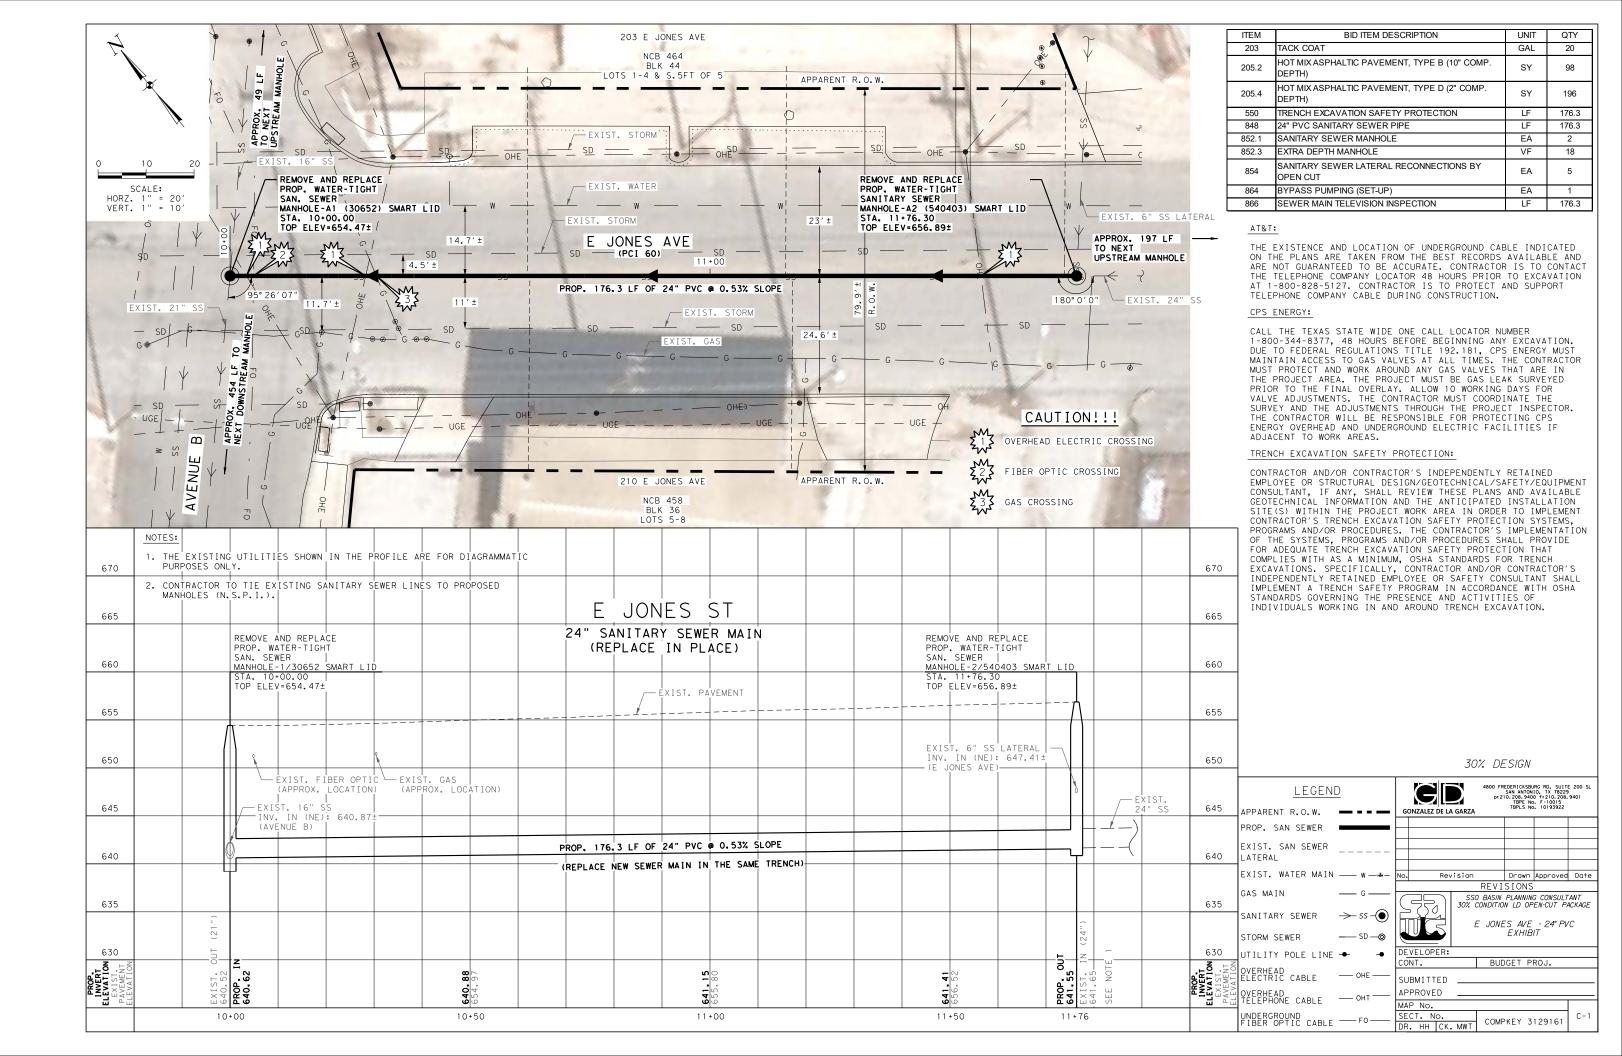
CompKey	31	.29161	Diameter	24	Upstream MH	_	540403	US Dep			VCP
Final Rehab	RFDI ΔC	E OPEN-CUT	Length (ft)	176.3	Downstream N	MH	30652	DS Dep	th 14	VerifiedCondition	E
			Length Surveyed	177	Siphon #					Condition (Consultant)	
Basin	CE	NTRAL	✓ 75% Televise	a	Sags	Yes					
										No of Point Repairs 0	Yes Point Repair Identified by a Professional
Construction Access	Yes - Green	Within in ROW of E Jo	ones Ave					Available Grade		No of Laterals 5	
								☐ Available Cover			
Operational Access	Yes - Green	Within in ROW of E Jo	ones Ave					☐ Large Trees			
								✓ Site Access by Combo T	ruck		
Jurisdictional Water	No - Green							☐ Crosses Creek, TxDOT F	Rd, or Bridge		
								✓ Large WTR Mains			
Existing Utilities	Yes - Red	Parallel water main						☐ Large Gas Mains			
Existing officies	res nea	r draner water man						Facement Deguired	0	By-Pass Pum	ping Info
Permit Coordination	Yes - Red	COSA - East Jones Ave						Easement Required (number of parcels)	0	By-Pass Info

Permit Coordination	res - Neu	COSA - East Jones Ave	е					NA		No parallel sewer mains	
Frederican d Consider	No. Consu]			
Endangered Species	No - Green									Peak Wet Weather (Model)	3.37
										Average Day (from Model)	0.07
In Karst Zones	No - Green	Within karst zone 5, a	an area that does not	contain karst sp	oecies				# IN	US Suction Manhole	30675
										DS Suction Manhole	30652
Critical Habitat	No - Green									By-Pass Length	373
Environmental Factors	No - Green									-	
										Street Repa	air Data
Hazardous Sites	Yes - Red	Entries in hazardous i		rch resulted in	finding:					Street Width	46
		Low risk: 2 LPSTs (1 si	t)							Trench Repair	10' Wide
										Quantity - of Street Repair (LF)	177
Archeological Sites	Yes - Red	Segment 3129161 is I Lone Star Brewery loo								PCI	60
		River acequia and one				position of	the mistoric				
Geomorphology Issues	No - Green									30% Package Number	2

deomorphology issues	No - Green									Reason Selected for 30%	Other E
Control pinel Findings	Van Dad	Challan and make			ah awaa atian Da					Base or Additional	Base Pipe
Geotechnical Findings	Yes - Red	Shallow groundwater may be required.	r, sumps may be requ	rea auring tren	ich excavation. Ro	ock excava	tion equipment			Not Orignially Assigned to BPC	<u>·</u>
		,								Low Income Area	No
										On CPMS Project	0

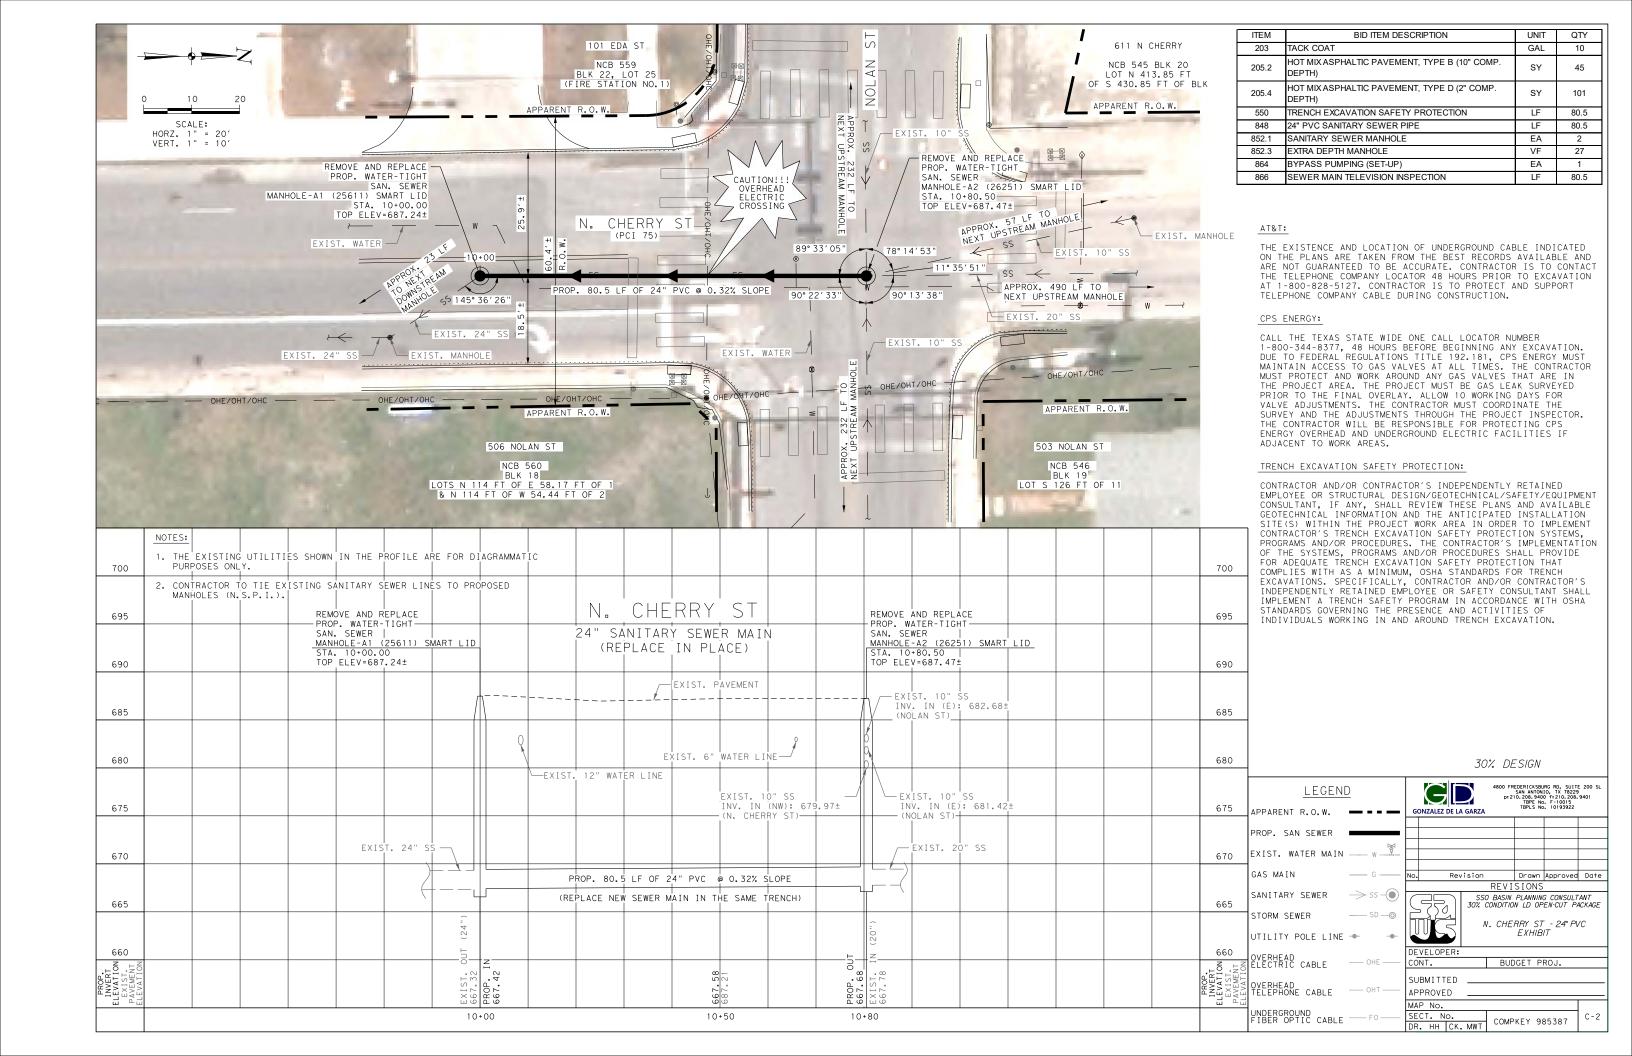
CompKey	9	85387	Diameter	24	Upstream MH	26251	US Depth	20	Material	VCP				
			Length (ft)	80.5	Downstream MH	25611	DS Depth	20	VerifiedCondition	Е				
Final Rehab		E OPEN-CUT	Length Surveyed	. 67	Siphon #		Condition (Consultant)							
Basin	CE	ENTRAL	✓ 75% Televised	d	Sags									
						No of Point Repairs O Yes Point Repair Identified by a Professional								
Construction Access	Yes - Green	Within ROW of North	h Cherry				Available Grade		No of Laterals	0				
							Available Cover							
Operational Access	Yes - Green	Within ROW of North	h Cherry				☐ Large Trees ☑ Site Access by Combo Truck ☐ Crosses Creek, TxDOT Rd, or Bridge							
Jurisdictional Water	No - Green					✓ Large WTR Mains	гышде							
							☐ Large Gas Mains							
Existing Utilities	Yes - Red	Parallel water main							Rv_D	ass Pumping Inf	fo			
							Easement Required (number of parcels)	0		ass rumping im				
Permit Coordination	Yes - Red	COSA - North Cherry					NA		By-Pass Info No parallel sewer mains

No. Croon]							
Endangered Species	No - Green								Peak Wet Weather (M	odel)	3.26			
In Karst Zones	No - Green	Within karst zone 5	an areas that does not	have kars	t snacias		Average Day (from Model) US Suction Manhole							
III Karst Zones	No - Green	Within Raist Zone 3, 6	an areas that does not	. Have Kars	t species									
Critical Habitat	No - Green						DS Suction Manhole				25601			
Circlear riabitat	No Green							i i	By-Pass Length		883			
Environmental Factors	No - Green								·					
	no orcen								Str	eet Repair Data	1			
Hazardous Sites	Yes - Red	Entries in hazardous	material database sea	rch resulte	ed in finding: Low risk: 1 IHWC	A/APAR, 1 site		N						
		with 1 LPST, 1 GWCC			Ü				Street Width Trench Repair		Wide			
		High risk: 1 BF						V	Quantity - of Street Rep		81			
Archeological Sites	Yes - Red Segment 985387 is located parallel along the outer boundaries of the Dignowity Hill Local Historic District and in close proximity to a plotted section of the San Antonio Valley acequia.						THE SA		PCI		75

District and in close p	oroximity to a protica .	30001011011	the Jan Antonio Valley account	u.								
Geomorphology Issues	No - Green								30% Package Number		1			
φ του ση									Reason Selected for 30%	6 Oth	ner E			
Geotechnical Findings	Yes - Red	Shallow groundwater	r, sumps may be requi	red during	trench excavation. Rock excav	vation equipment			Base or Additional	Base	e Pipe			
U		may be required.	, , ,	0					Not Orignially Assigned	to BPC				
									Low Income Area		No			
									On CPMS Project		0

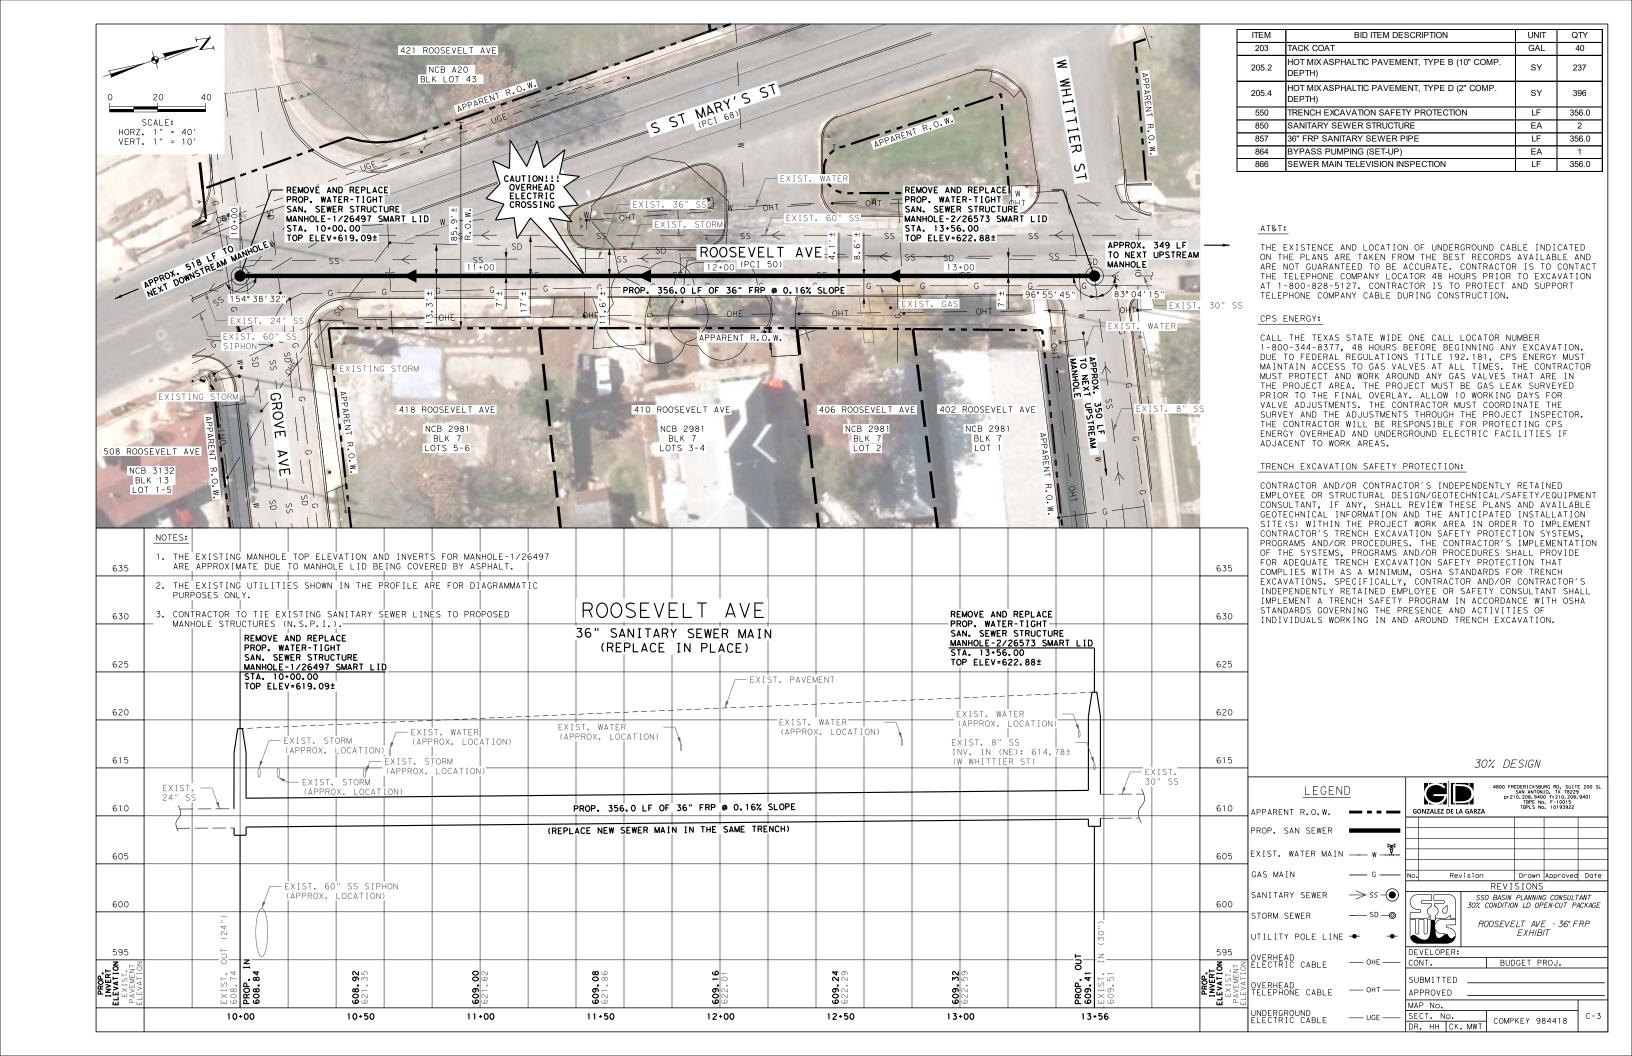
CompKey	9	84418	Diameter	36	Upstream MH		26573	US Depth	13	Material		CT
Final Rehab	REPLAC	E OPEN-CUT	Length (ft) Length Surveyed	356 380	Downstream M	H	26497	DS Depth	12	VerifiedCondition Condition (Consultant)		E
	CENTRAL		✓ 75% Televised		Siphon #					Condition (Consultant)		
Basin	CE	INIKAL			Sags	No				No of Point Repairs	0	Yes Point Repair Identified by a
Construction Access	Yes - Green	Within ROW of Roos	evelt Ave					Available Grade		No of Laterals	0	Professional
								☐ Available Cover				
Operational Access	Yes - Green	Within ROW of Roos	evelt Ave					☐ Large Trees				
								✓ Site Access by Combo Truck				
Jurisdictional Water	No - Green							Crosses Creek, TxDOT Rd, or	Bridge			
								✓ Large WTR Mains				
Existing Utilities	Yes - Red	Two parallel sewer m	nains, water main, gas ı	main, storm	sewer			✓ Large Gas Mains				
								Easement Required 0		Ву-Р	ass Pumpi	ng Info
Permit Coordination	Yes - Red	COSA - Roosevelt Ave	e					(number of parcels)		By-Pass Info

NA		parallel 36" sewer mai	า	
Endangered Species	No - Green										1 1)	
										Peak Wet Weather (M	-	9.01
In Karst Zones	No - Green	Within karst zone 5,	an area that does not h	ave karst sp	ecies				N	Average Day (from Mo US Suction Manhole	uei)	0.02 27638
										DS Suction Manhole		24424
Critical Habitat	No - Green								V	By-Pass Length		720
										by 1 dos zengtii		720
Environmental Factors	No - Green											
										Str	eet Repai	Data Data
Hazardous Sites	Yes - Red		material database sear	ch resulted i	n finding: Low risk: 1	LPST, 1 SEMS	; High			Street Width		28
		risk: 1 IHWCA, etc.								Trench Repair		10' Wide
						15		1111		Quantity - of Street Rep	air (LF)	356
Archeological Sites	Yes - Red		cated parallel along the Parkway District and t			_				PCI		50
		these districts at its s	•			,	enginery mass					
Geomorphology Issues	No - Green									30% Package Number		2
, J.									· · · · · · · · · · · · · · · · · · ·	Reason Selected for 30%	S E U	nder Roads BPC

Geotechnical Findings	Yes - Red Shallow groundwater, sumps may be required during trench excavation. Rock excavation equipment may be required.						equipment			Base or Additional		Base Pipe
										Not Orignially Assigned	to BPC	V
										Low Income Area		No
										On CPMS Project		0

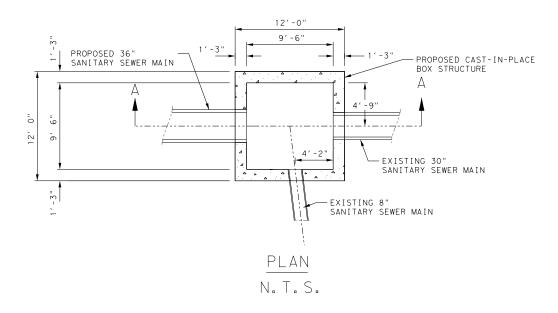
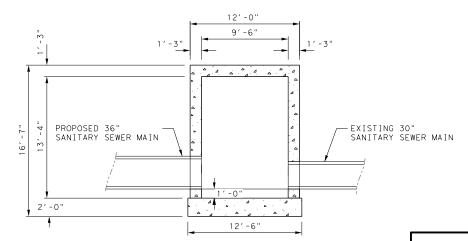
MANHOLE STRUCTURE 2

SECTION A-A
N.T.S.
