CONDITION REMEDIATION ALTERNATIVES ANALYSIS

Project Scoping Report

Central Sewershed Package 9 (Airport)

PREPARED FOR: San Antonio Water System

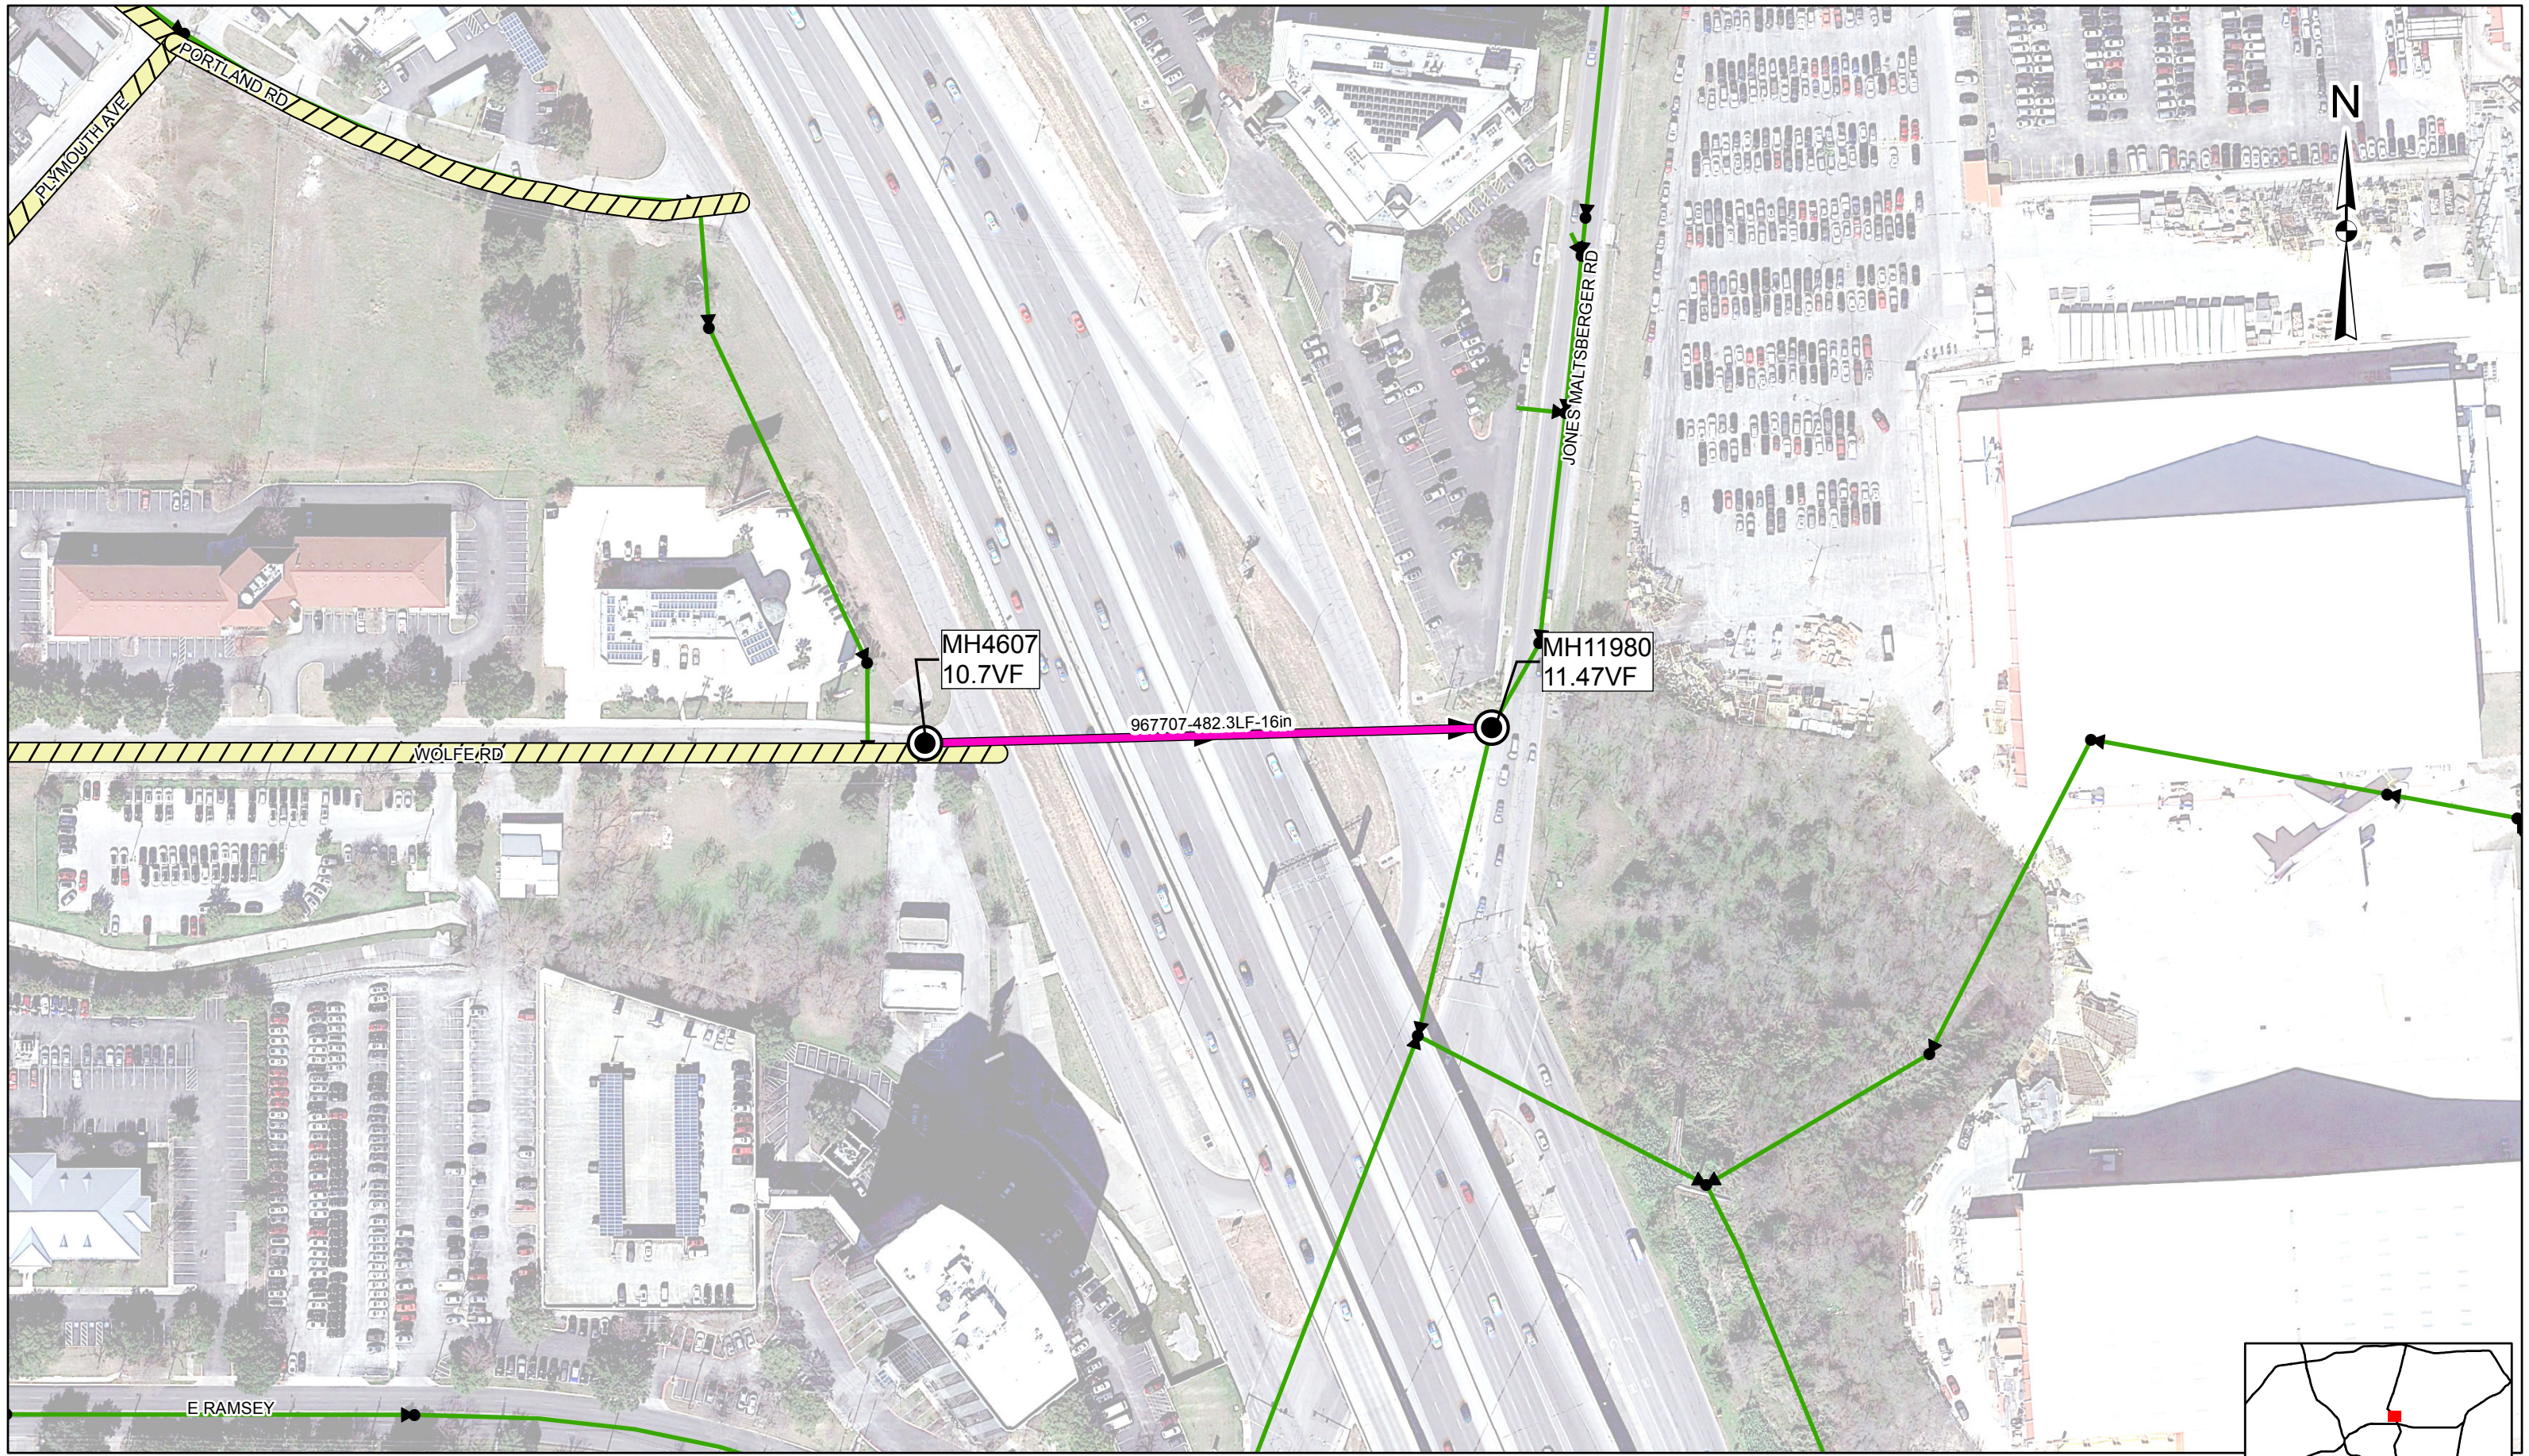
Central Sewershed Package 9 Airport Rehab Package

MHs in Scope

5 Year IMP Street Maintenance

Proposed CIPP

2017 - 2022 Bond Projects

Proposed Replacement

Table 5-1 provides detailed information, the preliminary remediation method, as well as the reason behind each method chosen for each pipe segment included in this package. The location maps are provided in the Exhibits section of this report.

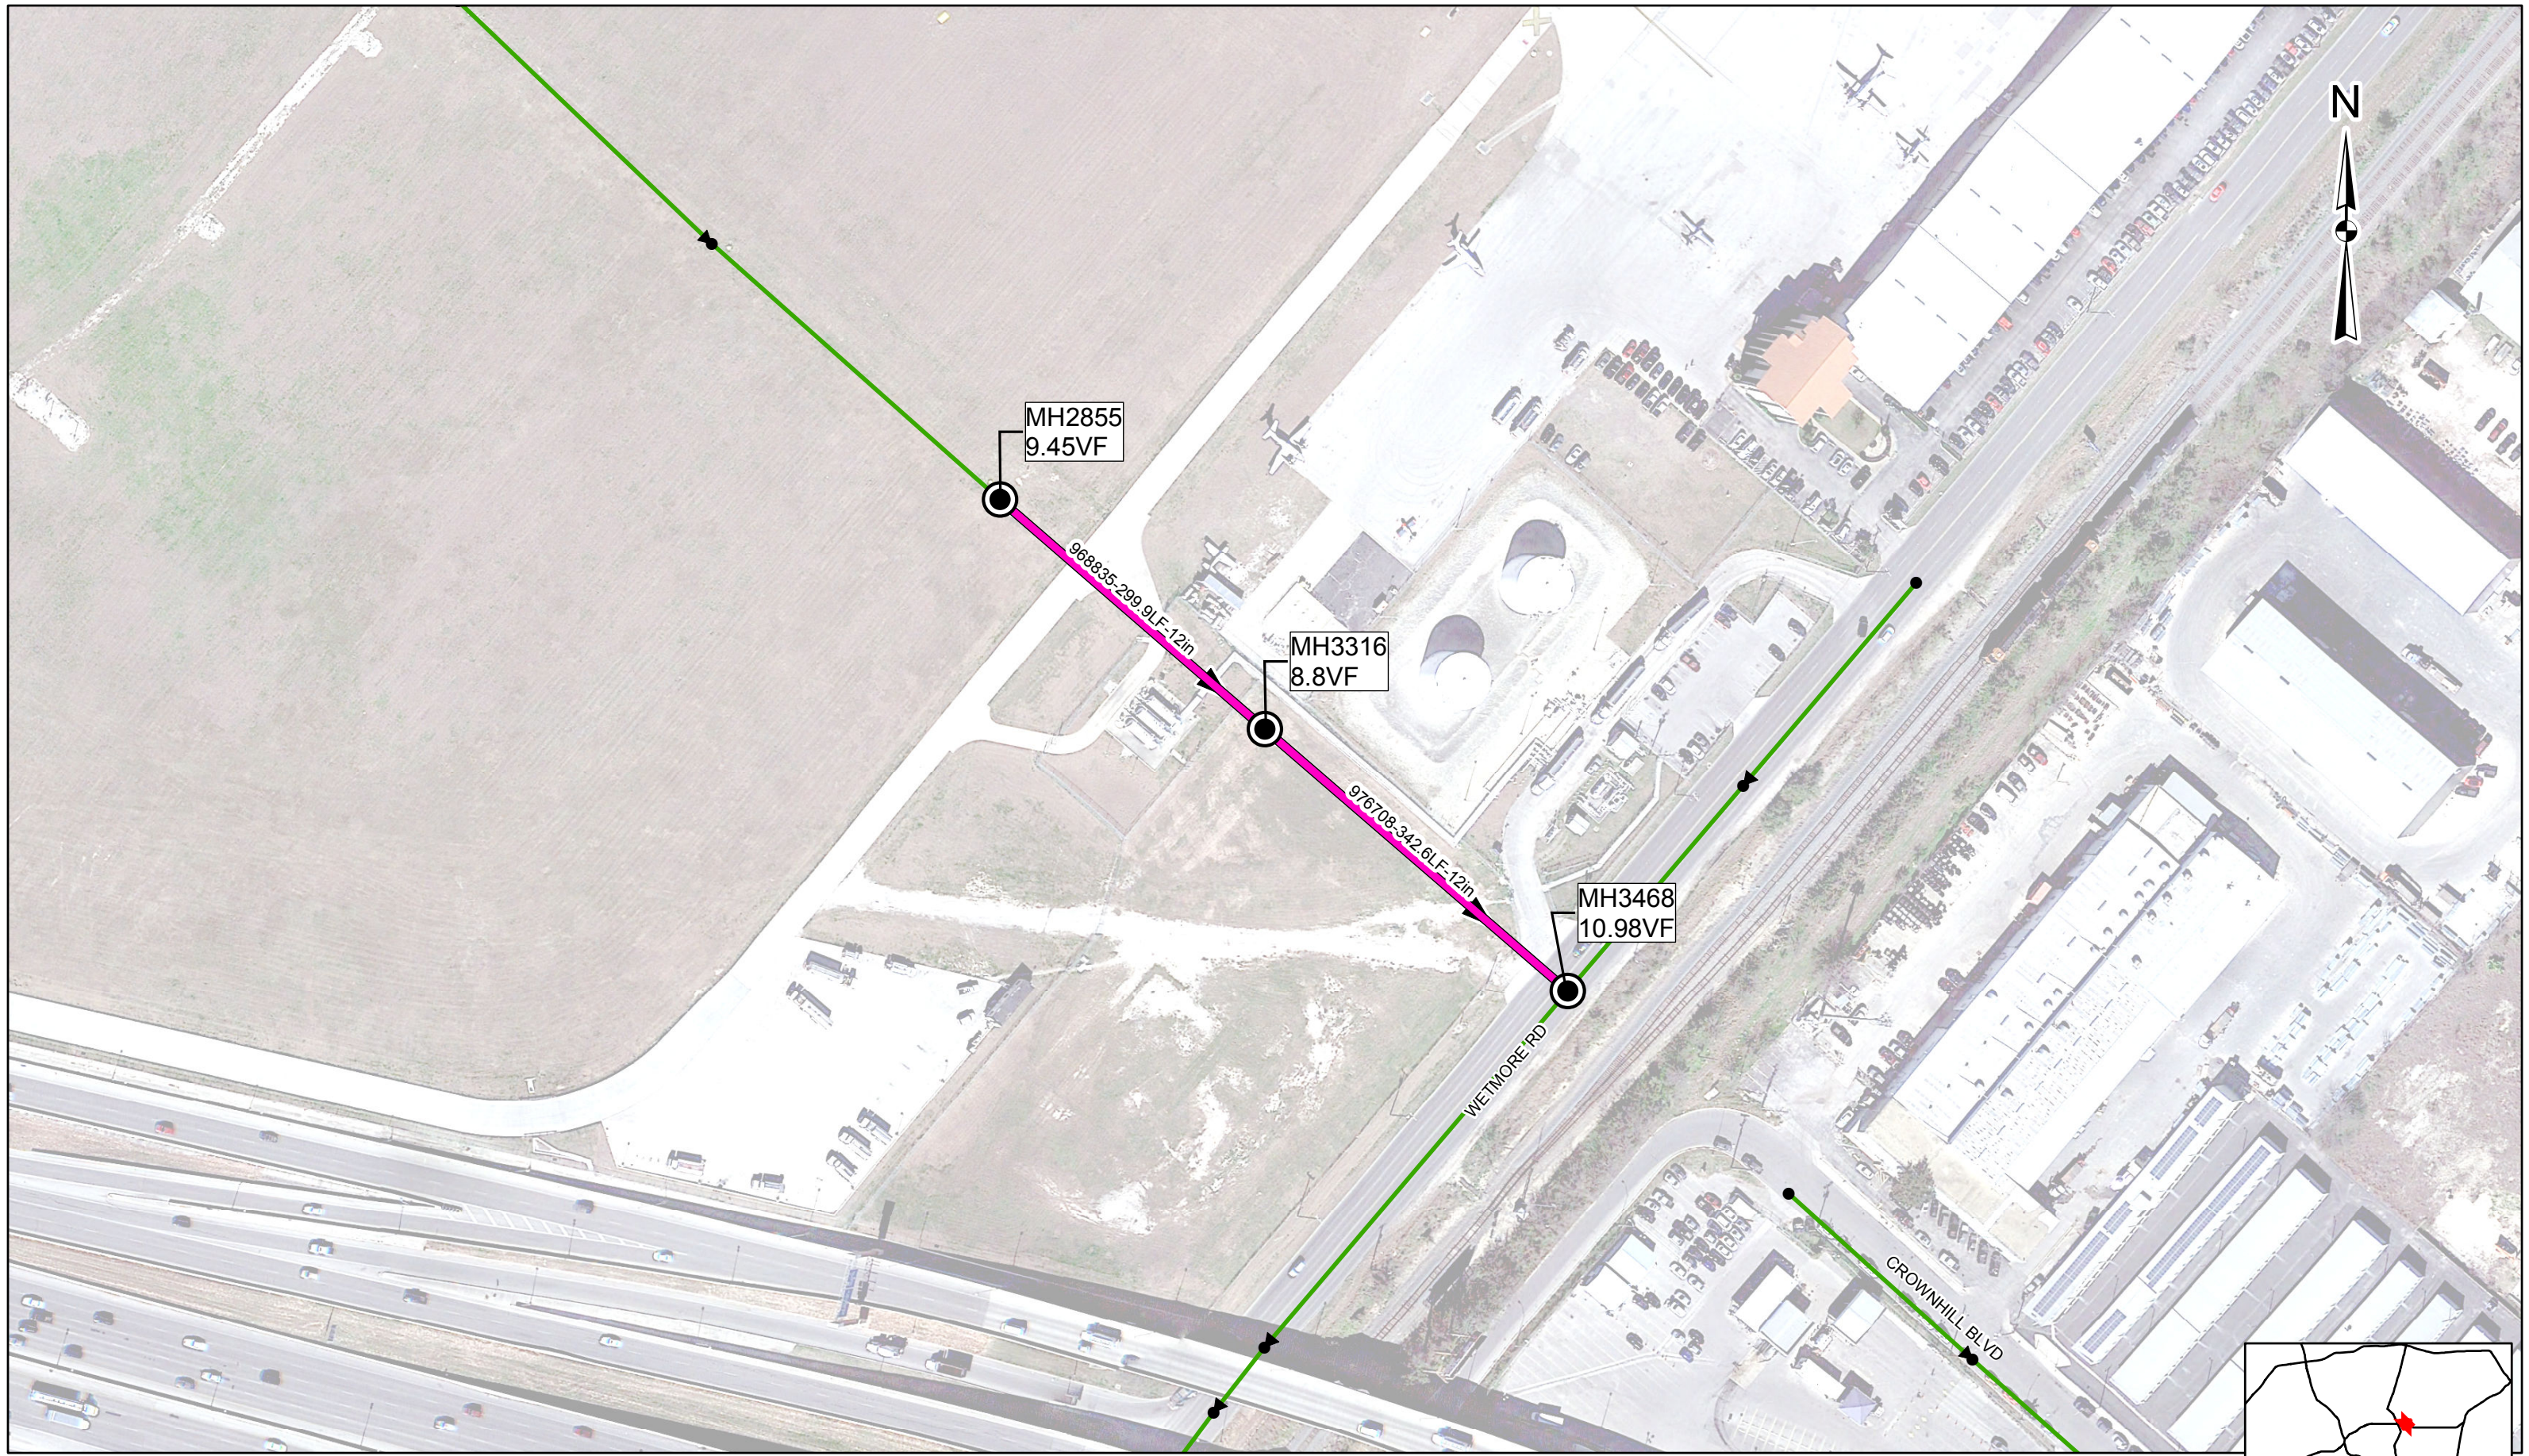
MHs in Scope		5 Year IMP Street Maintenance
	Proposed CIPP		2017 - 2022 Bond Projects
	Proposed Replacement

Central Sewershed Package 9 Airport Rehab Package

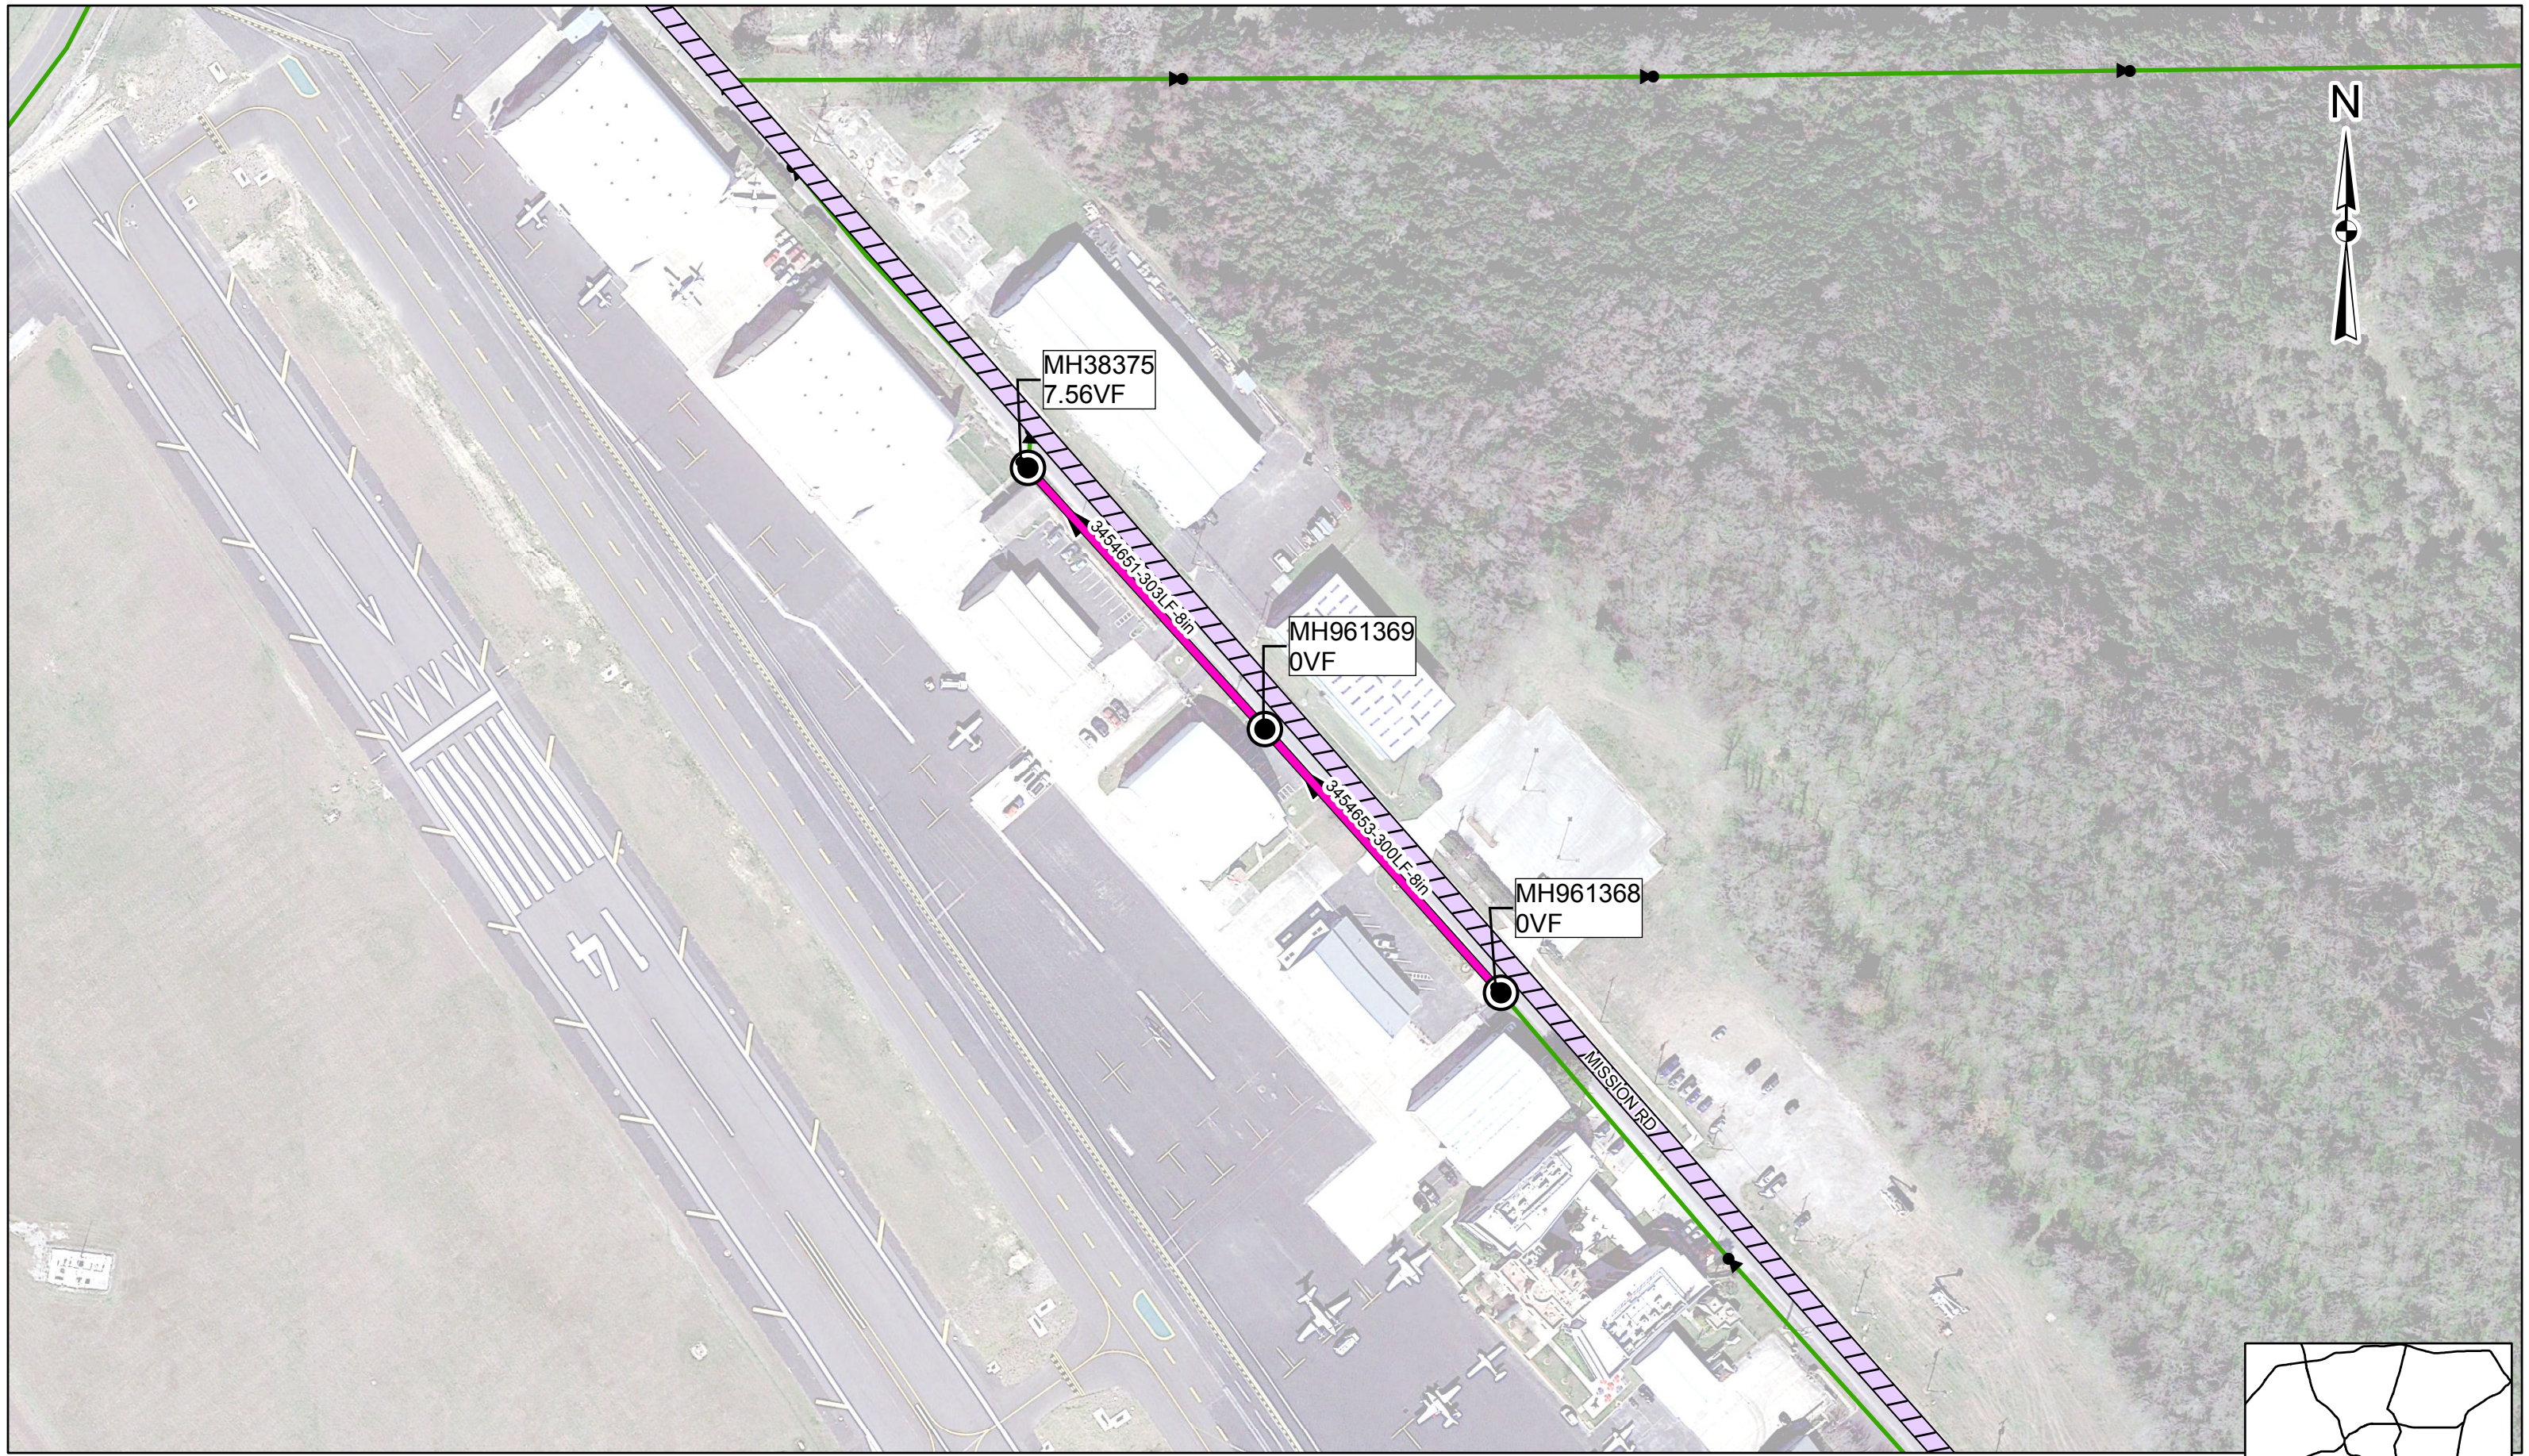
MHs in Scope		5 Year IMP Street Maintenance
	Proposed CIPP		2017 - 2022 Bond Projects
	Proposed Replacement

Central Sewershed Package 9 Airport Rehab Package
