CONDITION REMEDIATION ALTERNATIVES ANALYSIS

Project Scoping Report

Multiple Sewershed Package 15

PREPARED FOR: San Antonio Water System

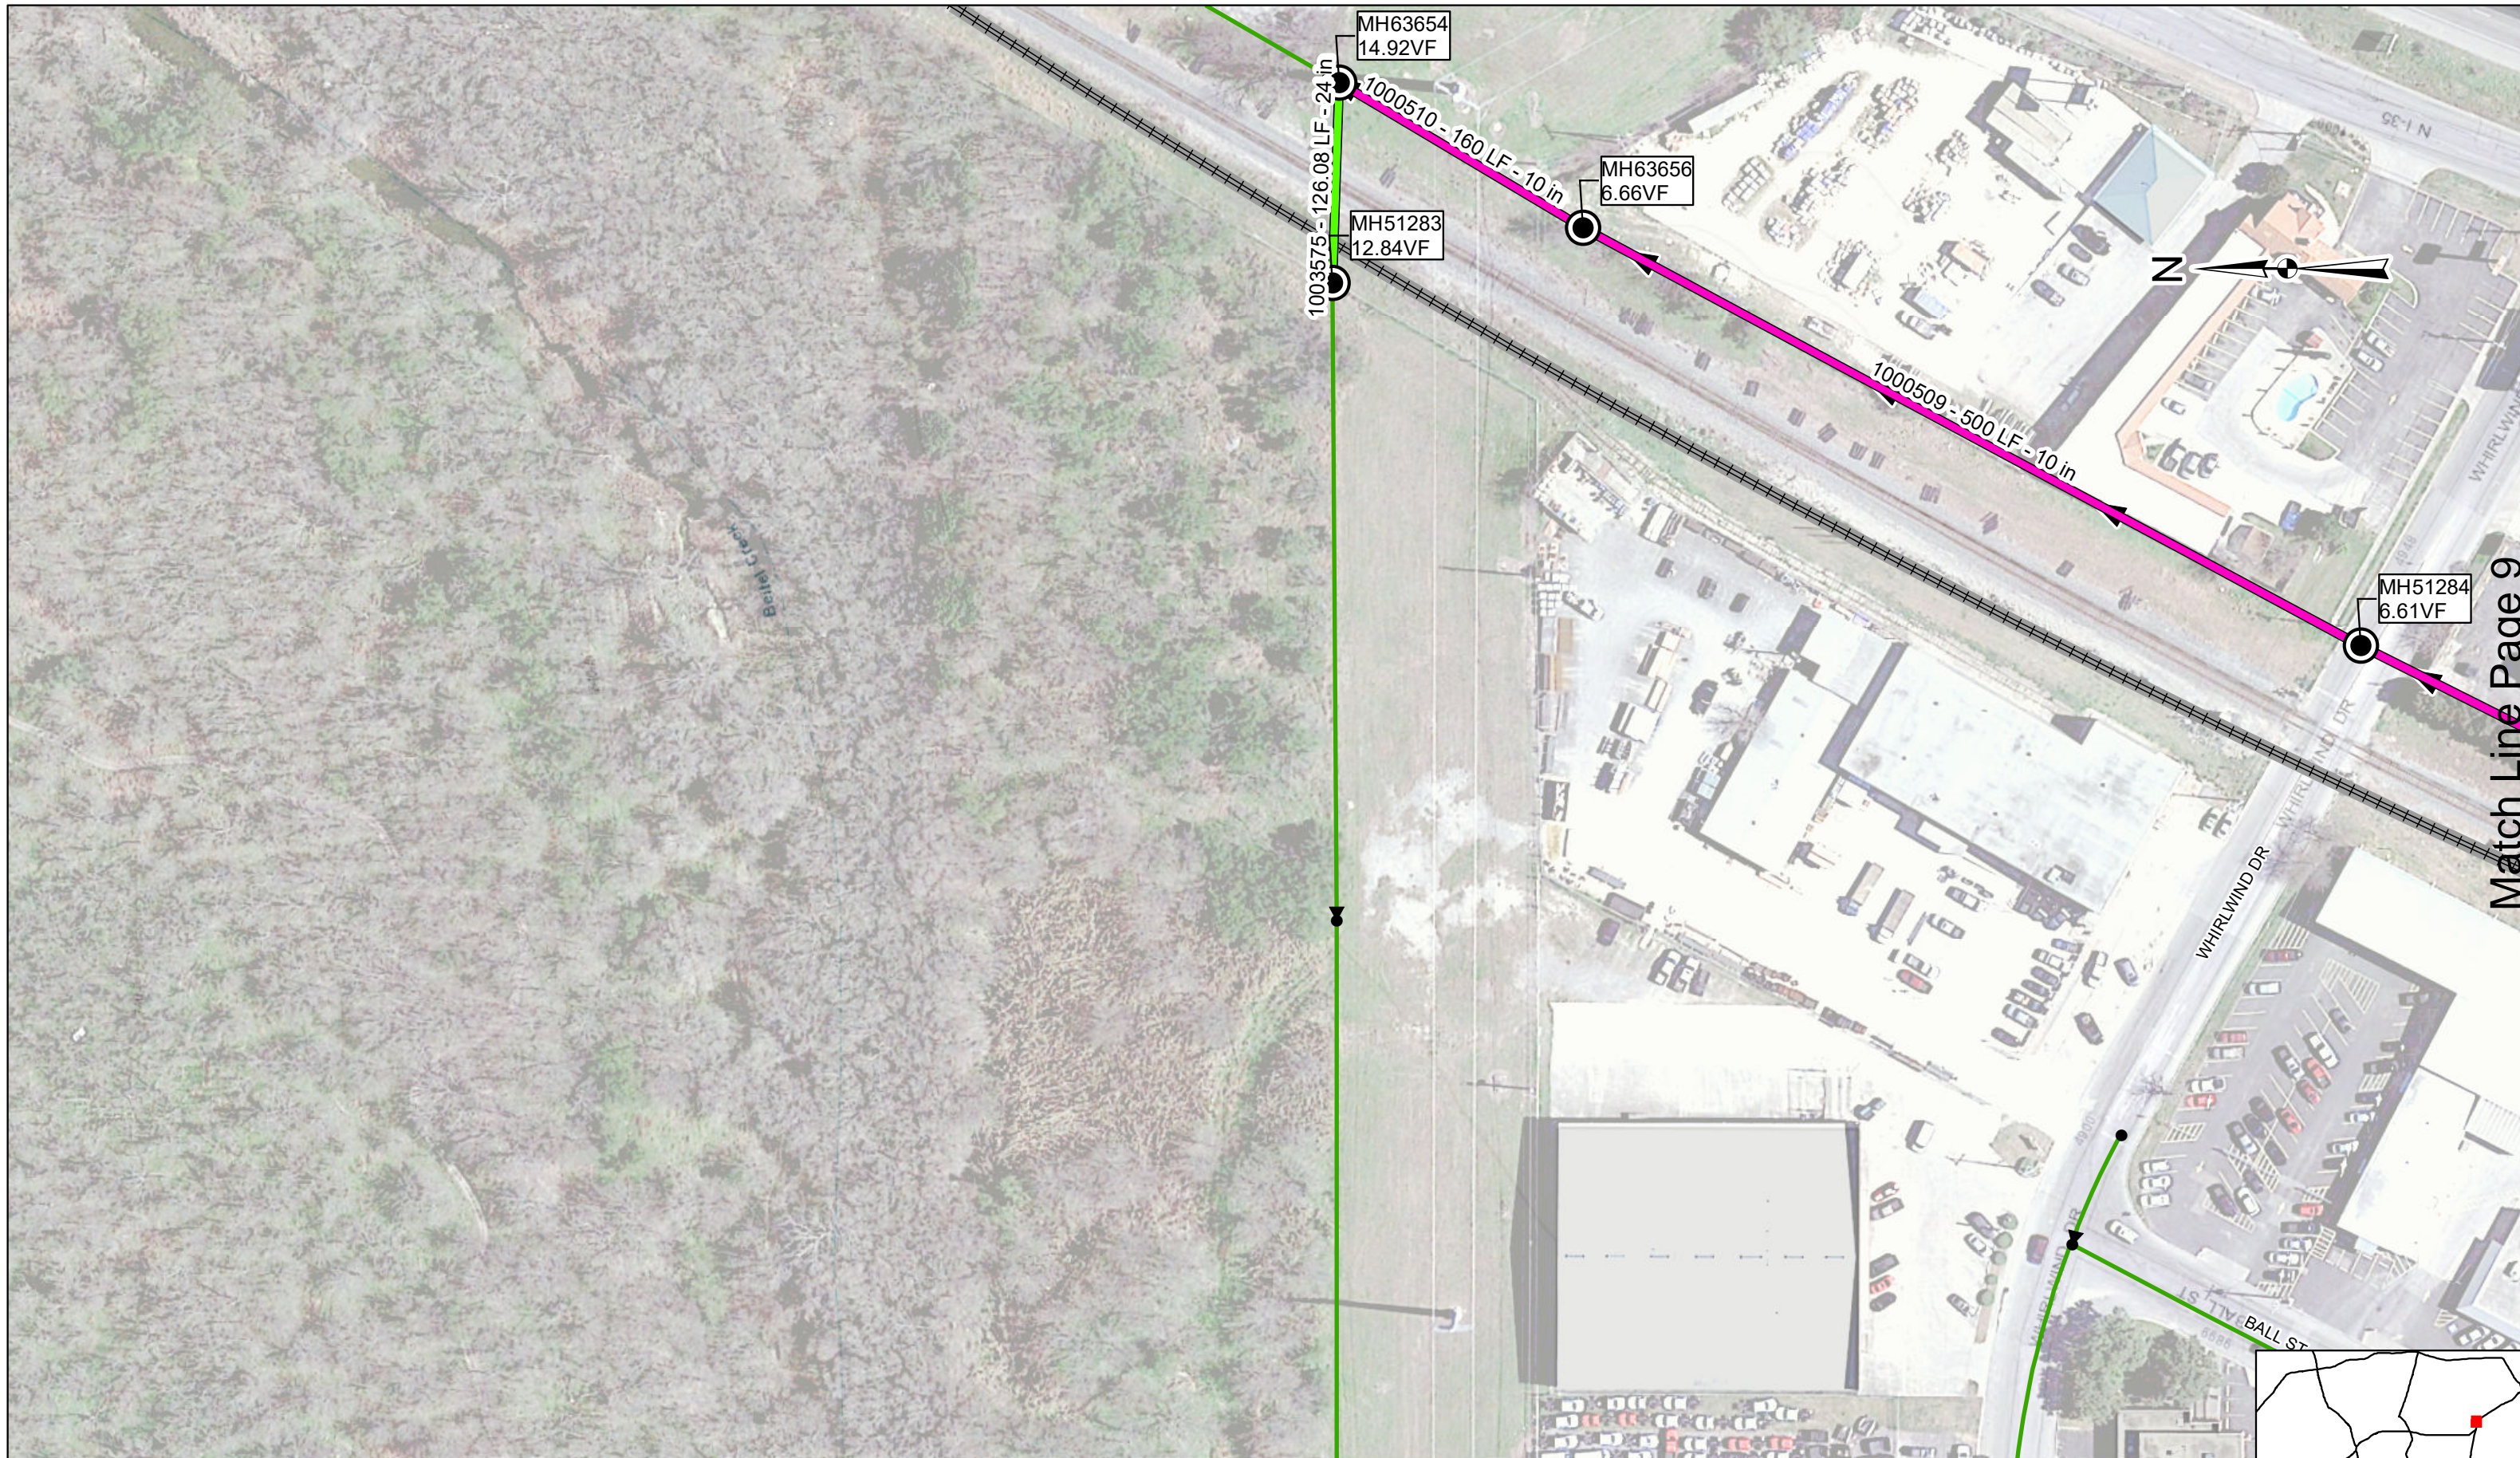
EXHIBITS: Detailed Map

Multiple Sewershed Package 15 UPRR

MHs in Scope		Proposed PB		Rail Roads
	Proposed CIPP		Proposed Replacement		5 Year IMP Street Maintenance
					2017-2022 Bond Projects

CoSA provides an ArcGIS layer of street projects throughout the City. **Table 3-1** below lists the pipes that are located near or within identified street projects. This information has also been overlaid into the detailed location maps provided in the Exhibits section. It is our understanding that the actual dates of the projects are subject to change. It is recommended that SAWS coordinate with CoSA to determine the timing of the street projects. Please note that pipes may be required to be moved into current IDIQ contracts to expedite the construction where street projects are forthcoming.
