13-4711 PLAN OF RECORD Job Completion Date: August 28, 2014

2013 SMALL DIA REHAB PROGRAM- PROJECT 8

DR. A.F.D. SAN ANTONIO WATER SYSTEM
 CIG. REV.
 BLK. MAP 159-596

REPLACEMENT & IMPROVEMENTS

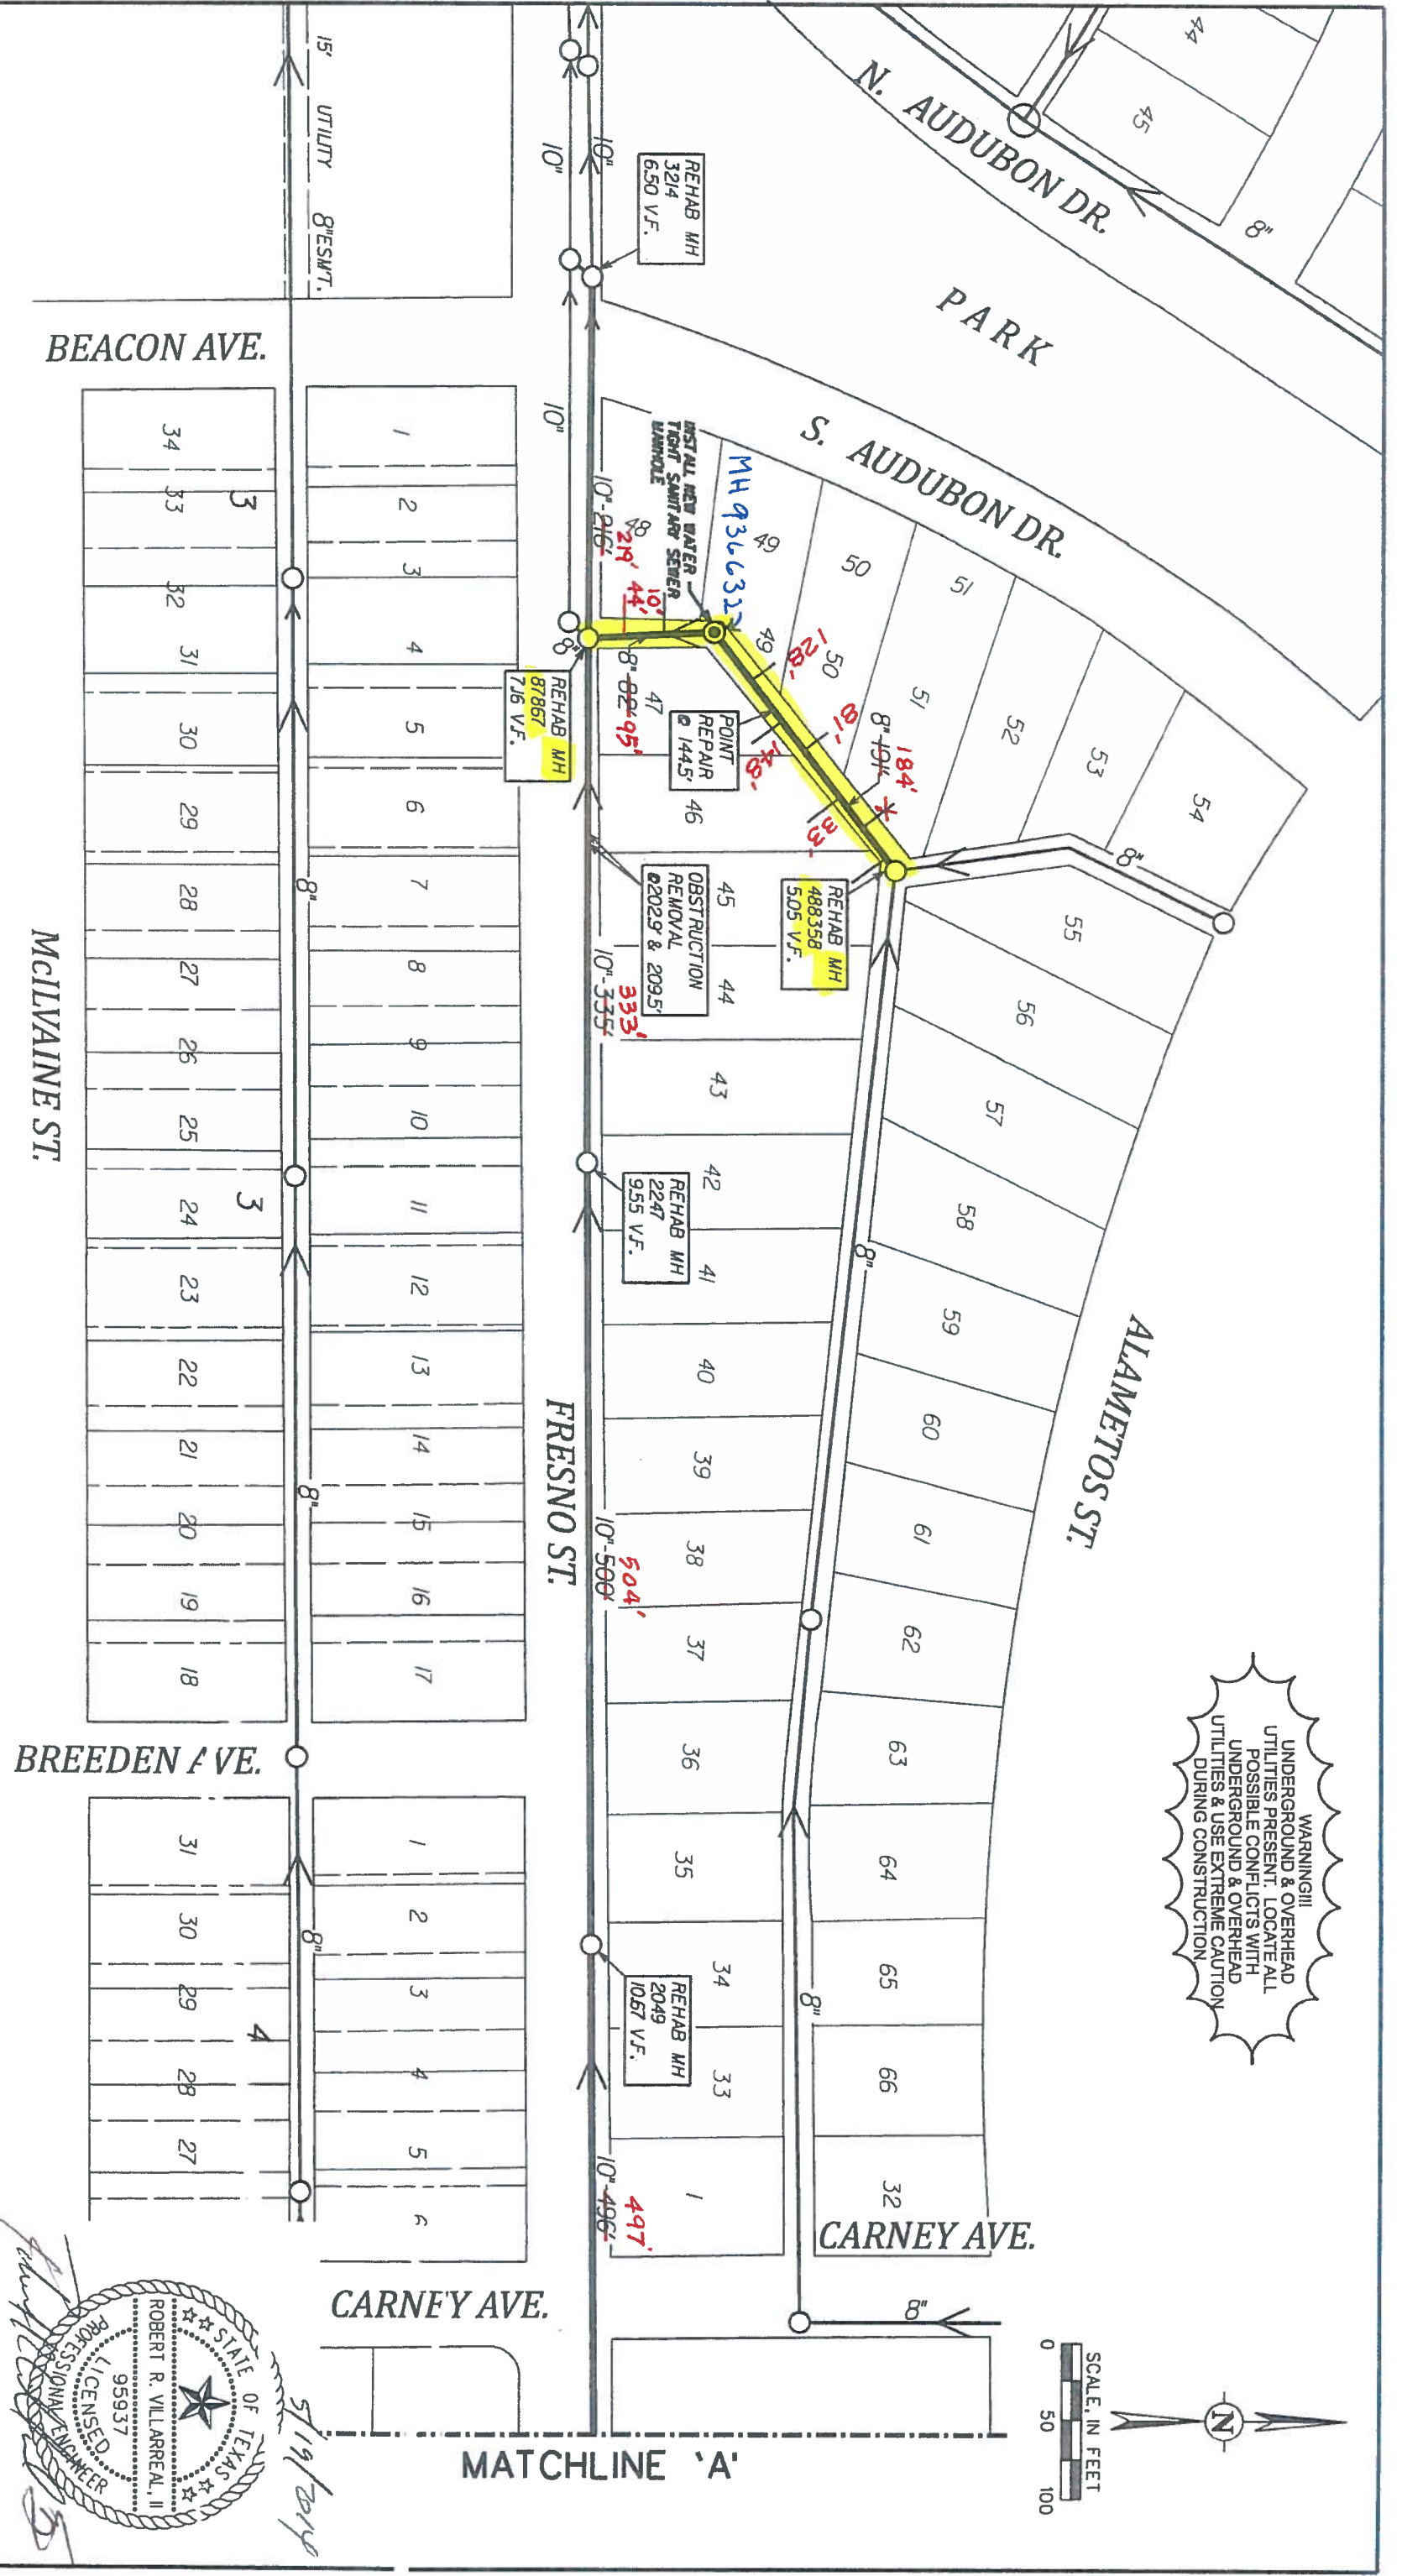
219 L.F. OF 8" PIPE
 273 L.F. OF 8" PIPE
 157 L.F. OF 10" PIPE
 1553

Note: Sewer laterals were reconnected not replaced

Note: Underlined lateral distance to manhole lateral is connected to main is not known for certain.

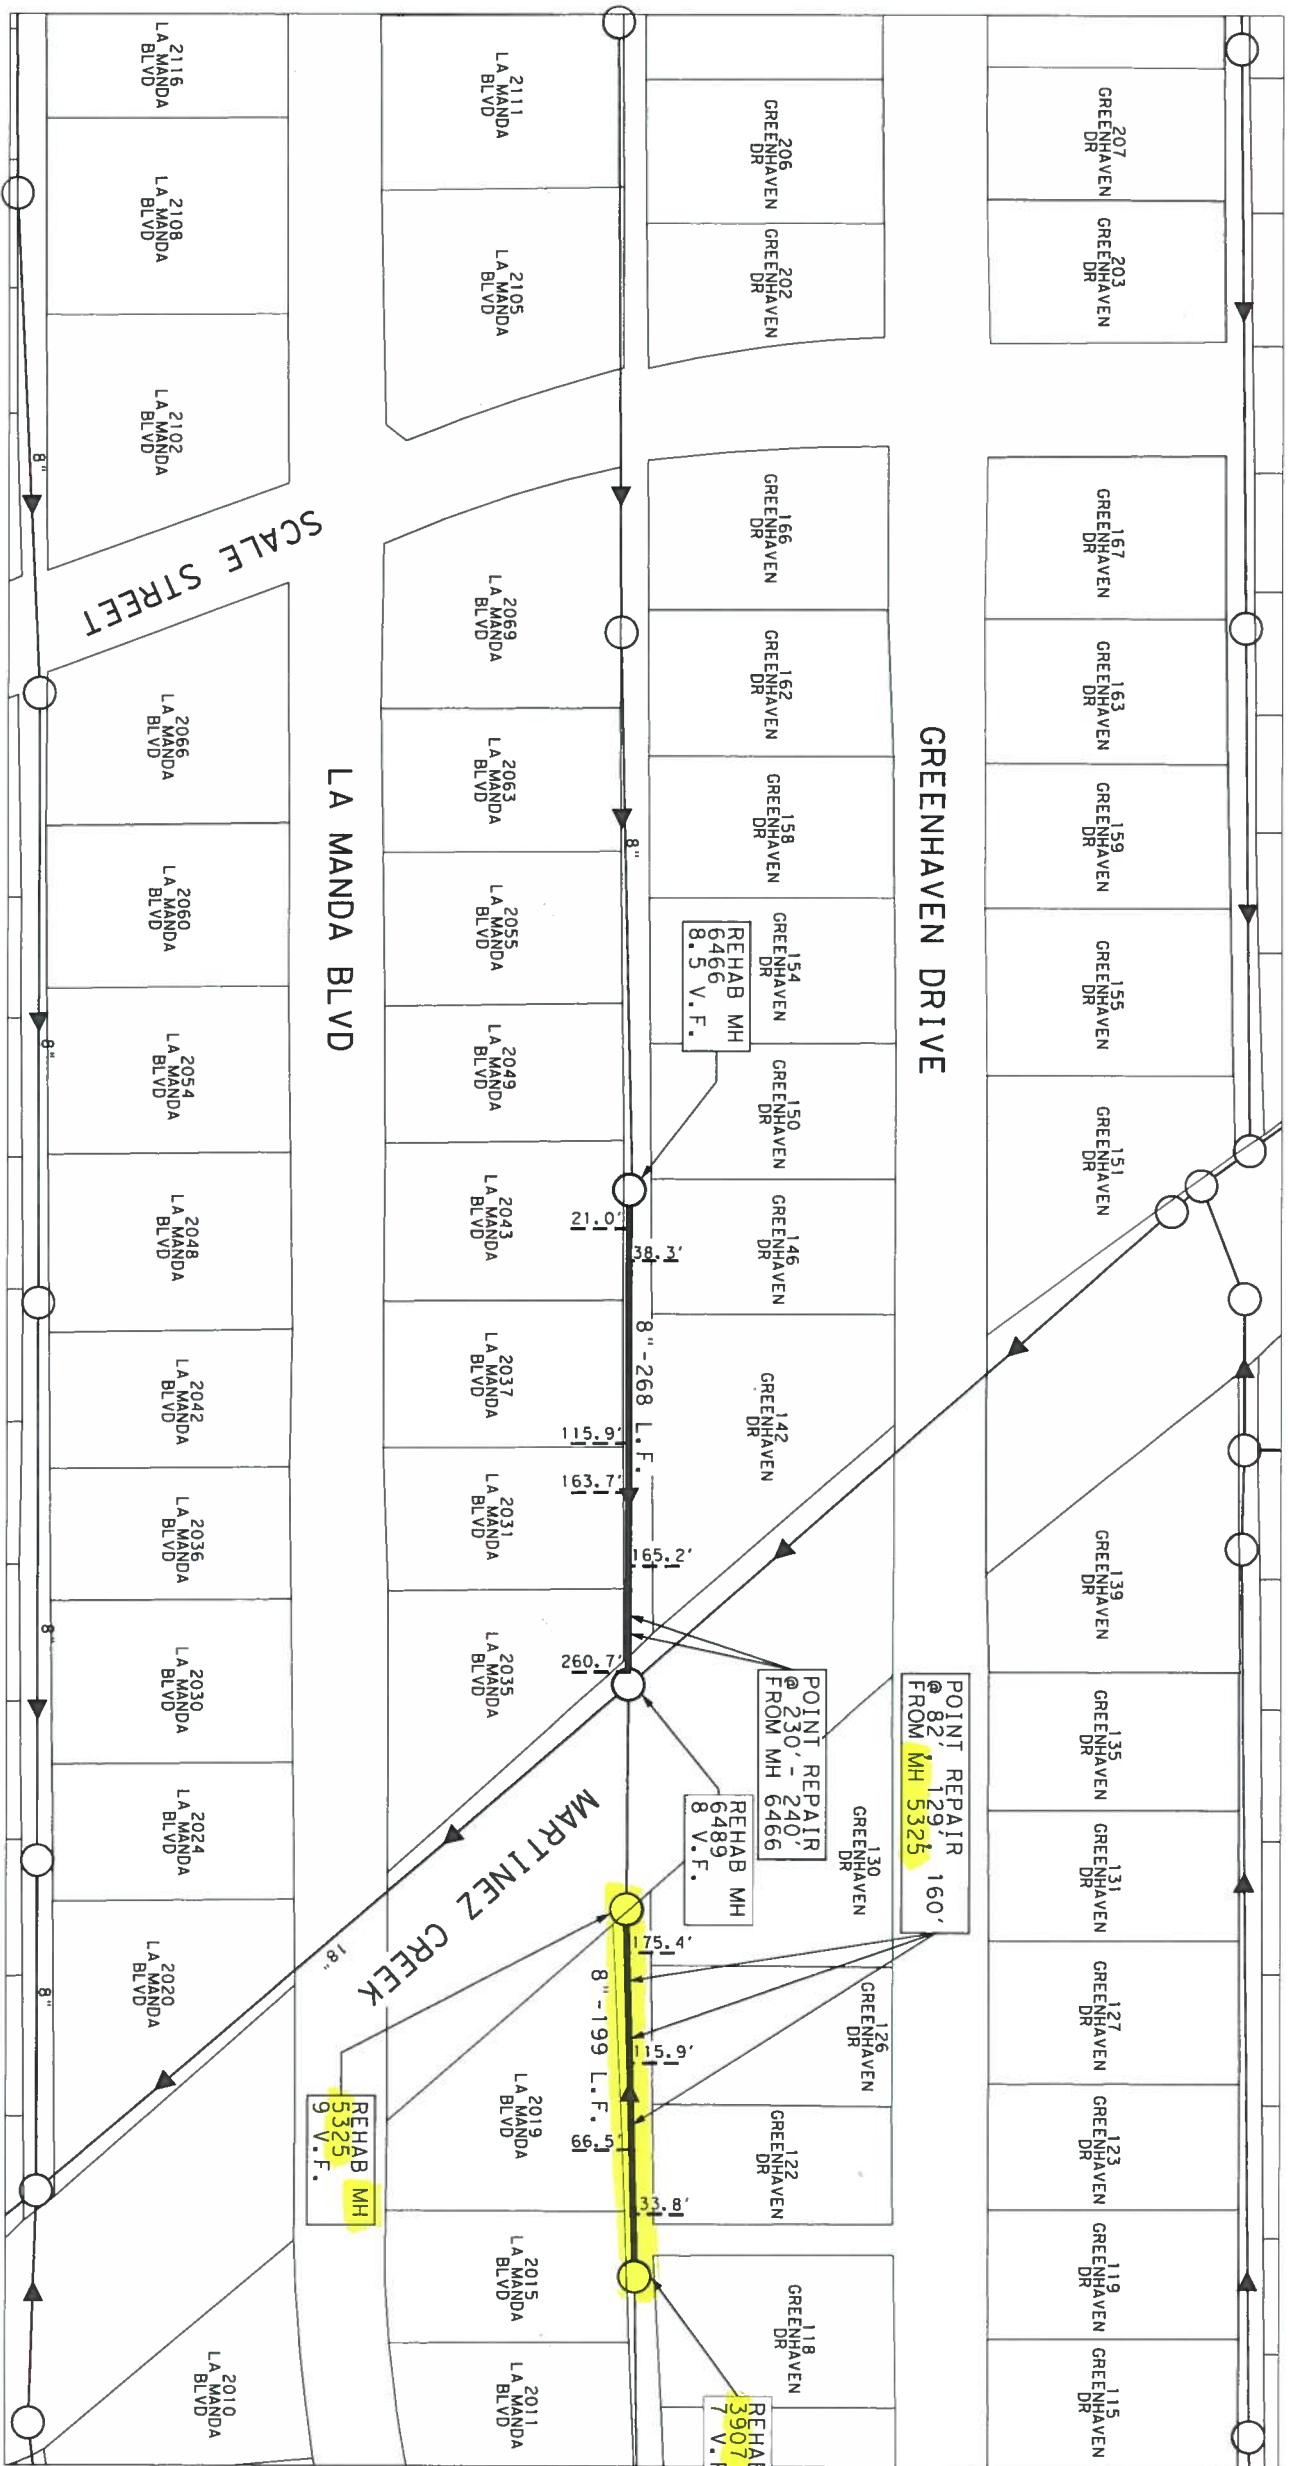
— PIPE BURSTING 467 L.F. OF 8" PIPE

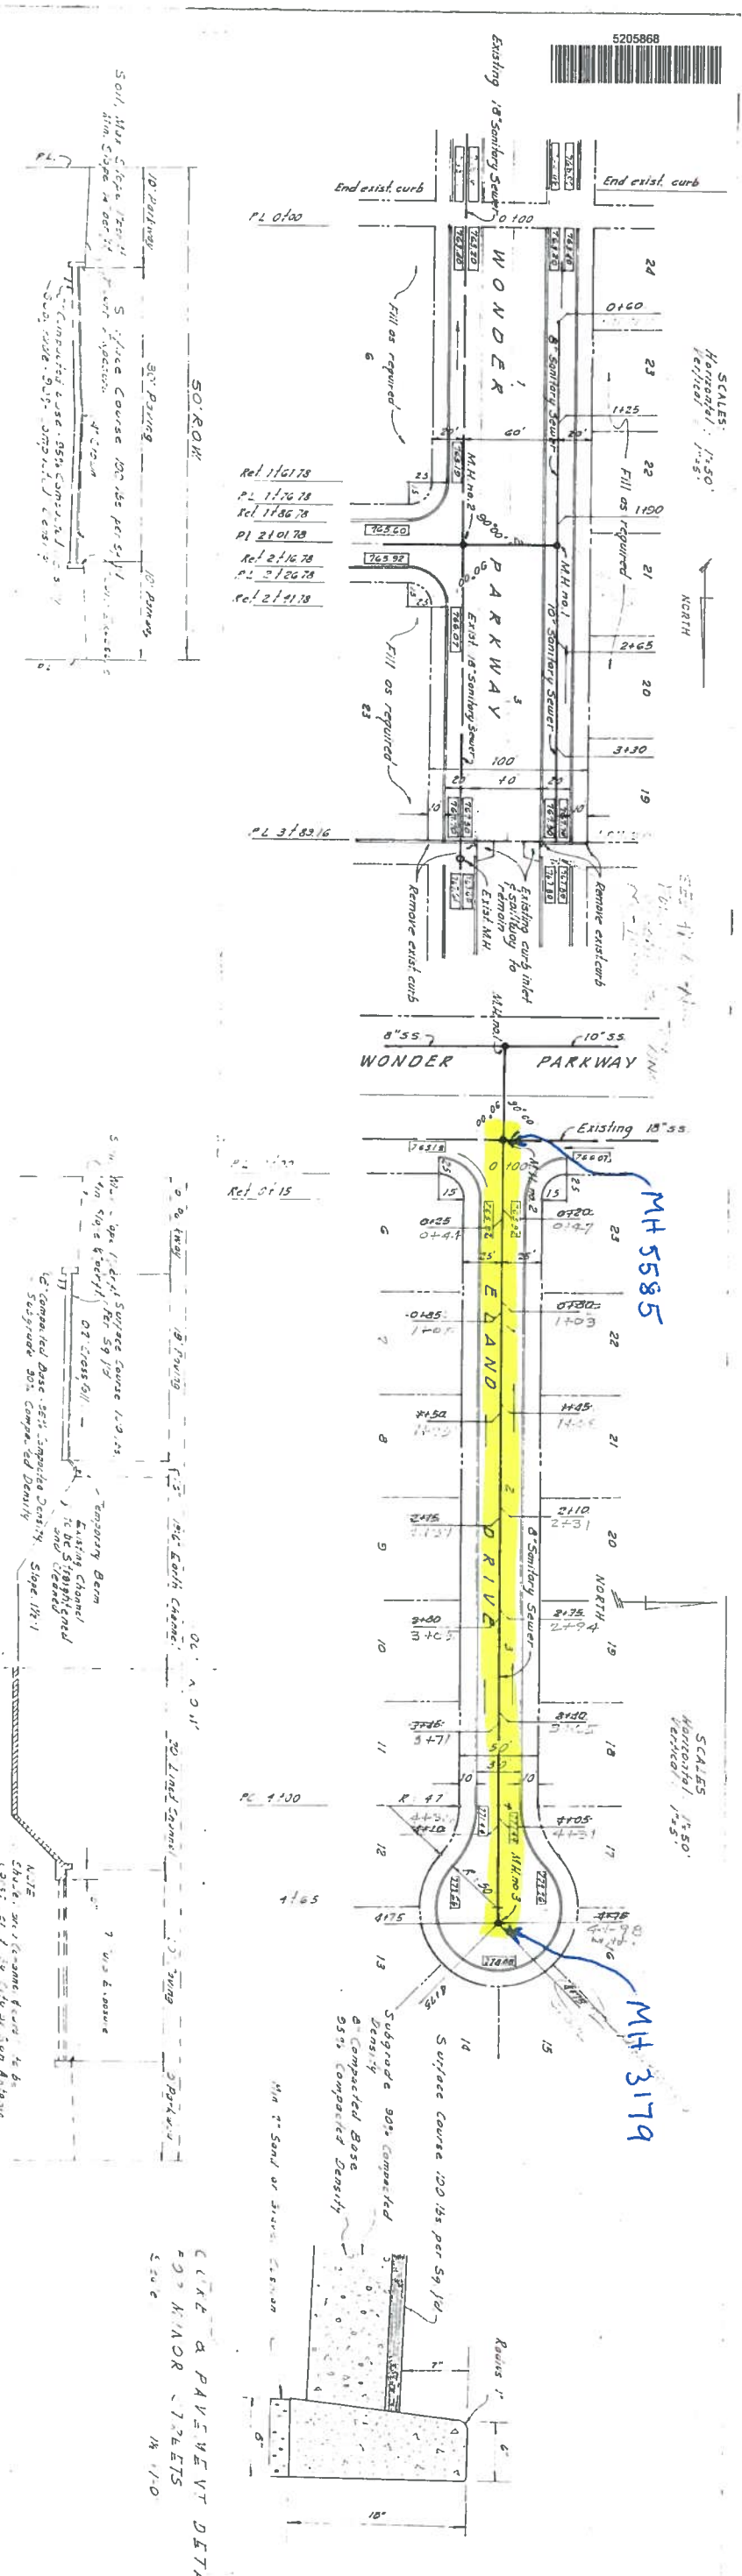
STREET PLAN & PROFILE
 WONDER PARKWAY
 SUPERVISOR

TYPICAL HALF SECTION SHOWING PAVING AND TEMPORARY CHANNEL

TYPICAL HALF SECTION SHOWING UPON ULTIMATE DRIVE IMPROVEMENT

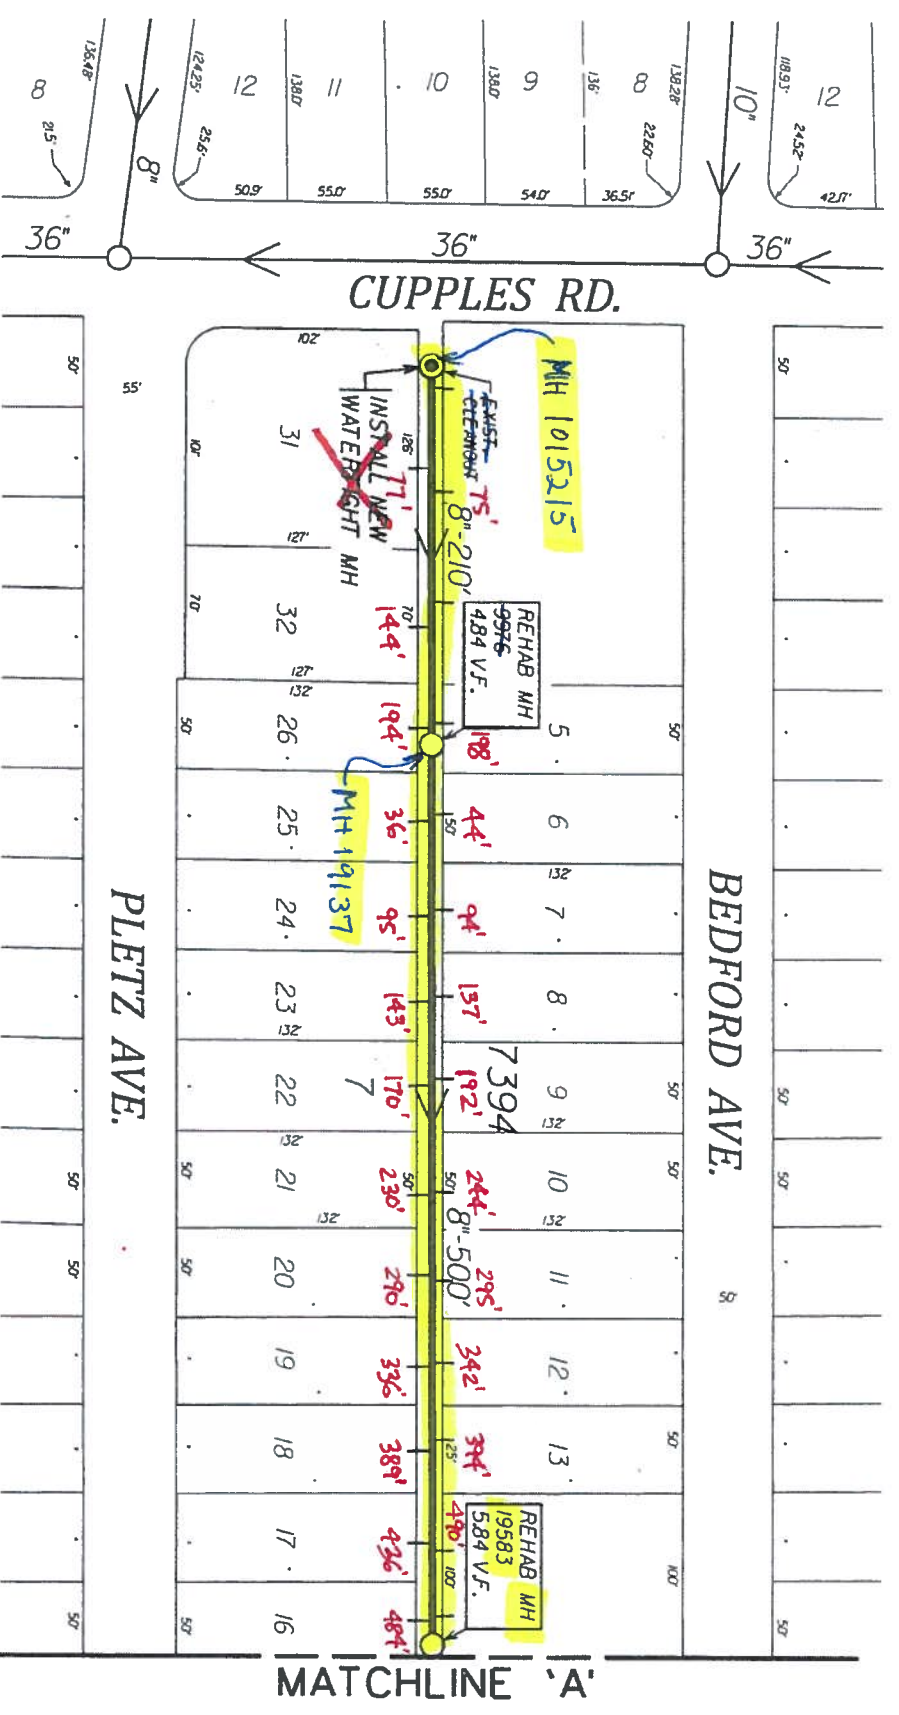
— PIPE BURST 710 L.F. OF 8" PIPE
