**GEOTECHNICAL STUDY**  
**SAWS WESTERN WATERSHED SEWER RELIEF LINE PROJECT**  
**PHASE I - QUINTANA ROAD TO SW LOOP 410**  
**SAN ANTONIO, TEXAS**

Report No. 04.10070157  
September 10, 2010

**Geotechnical Data Study  
SAWS Western Watershed Sewer Relief Line Project  
Phase I - Quintana Road to SW Loop 410  
San Antonio, Texas**

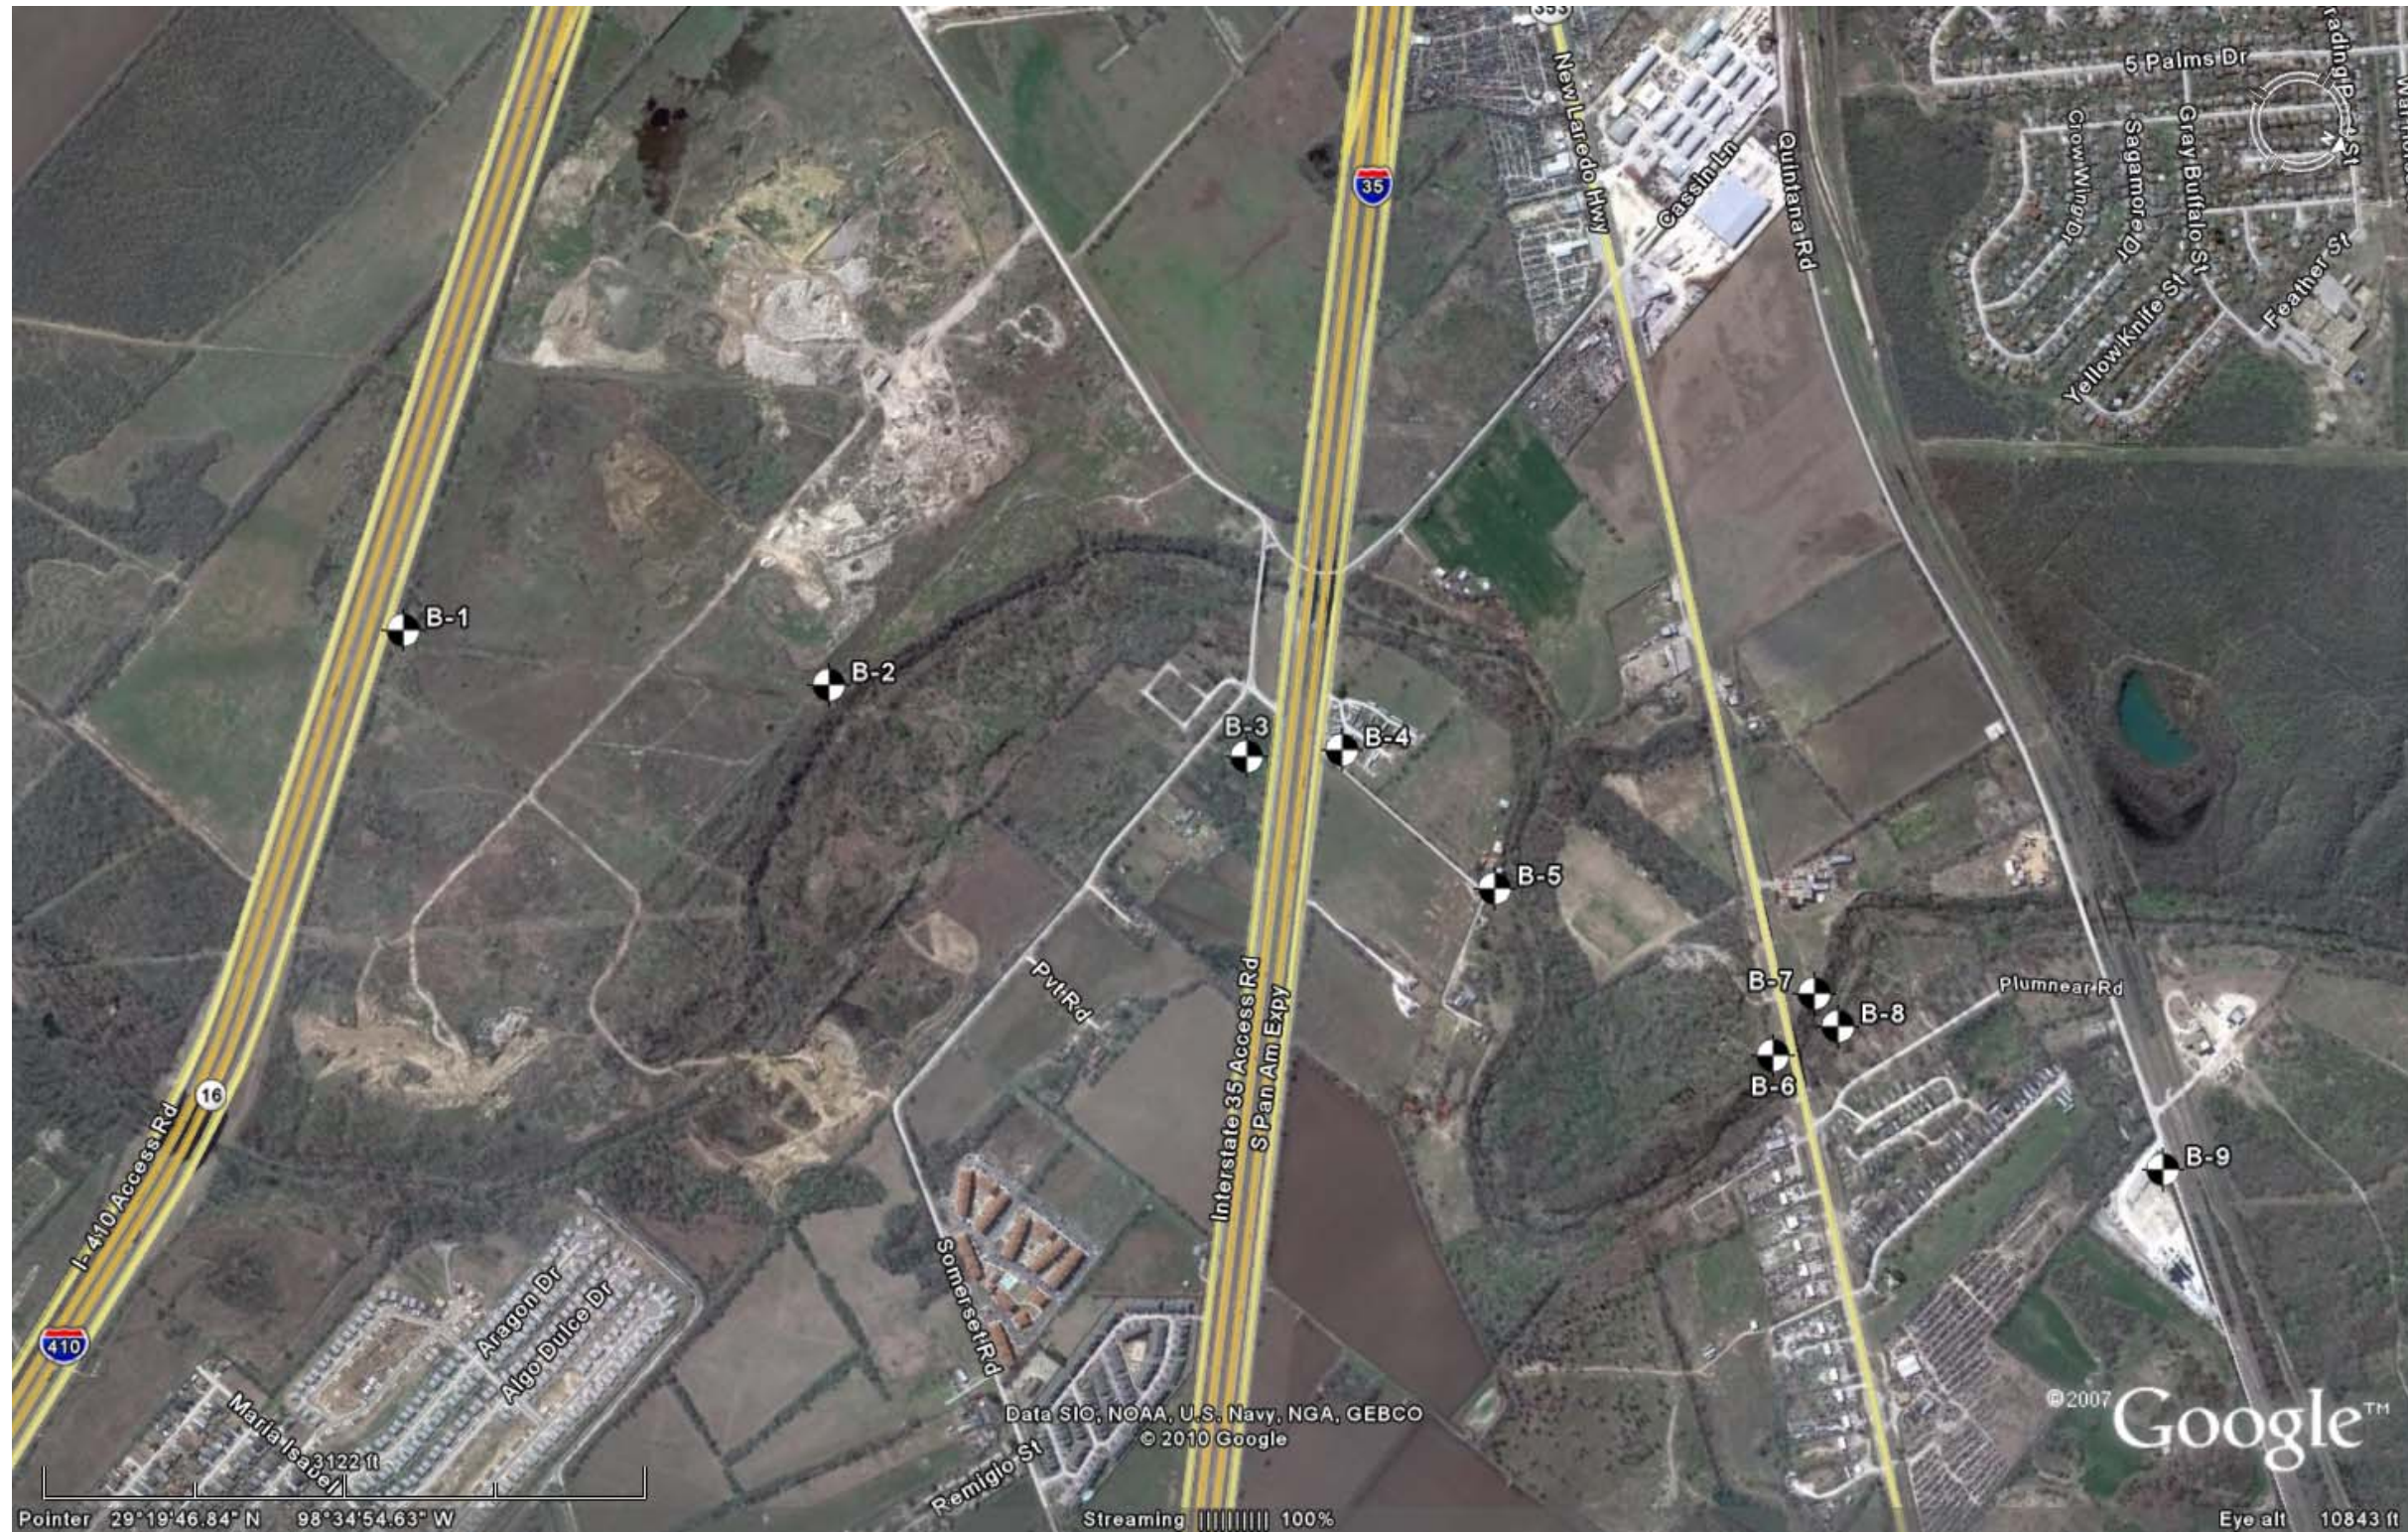
Plan of Borings  
SAWS Western Watershed Sewer Relief Line Project  
Phase I - Quintana Road to SW Loop 410  
San Antonio, Texas

The approximate locations of the borings are illustrated on a Plan of Borings, Plate 2. Boring locations shown on the Plan of Borings should be considered approximate. Surface elevations and coordinates were provided by Ford Engineering, Inc., site surveyor for the project, and are included on the boring logs.

As requested by CDM, Fugro performed nine borings, designated as Borings B-1 to B-9, along the pipeline alignment to depths ranging from 15 to 30 ft for this project. As indicated by CDM, the approximate boring locations and depths are presented on the following page.
