**RE: Olmos Basin Central Watershed Sewer Relief Line (C-3) Project: Geotechnical Data Study
Reach 1 Through Reach 3 Geotechnical Report
SAWS Job No. 08-2512
WESTON WO# 10412.015.001**

**GEOTECHNICAL DATA STUDY
REACH 1 THROUGH REACH 3
OLMOS BASIN CENTRAL WATERSHED SEWER LINE RELIEF
SAN ANTONIO WATER SYSTEM
SAN ANTONIO, TEXAS**

**Geotechnical Data Study
Reach 1 through Reach 3
Olmos Basin Central Watershed Sewer Relief Line
San Antonio Water System
San Antonio, Texas**

**GEOTECHNICAL DATA STUDY
REACH 4
OLMOS BASIN CENTRAL WATERSHED SEWER LINE RELIEF
SAN ANTONIO WATER SYSTEM
SAN ANTONIO, TEXAS**

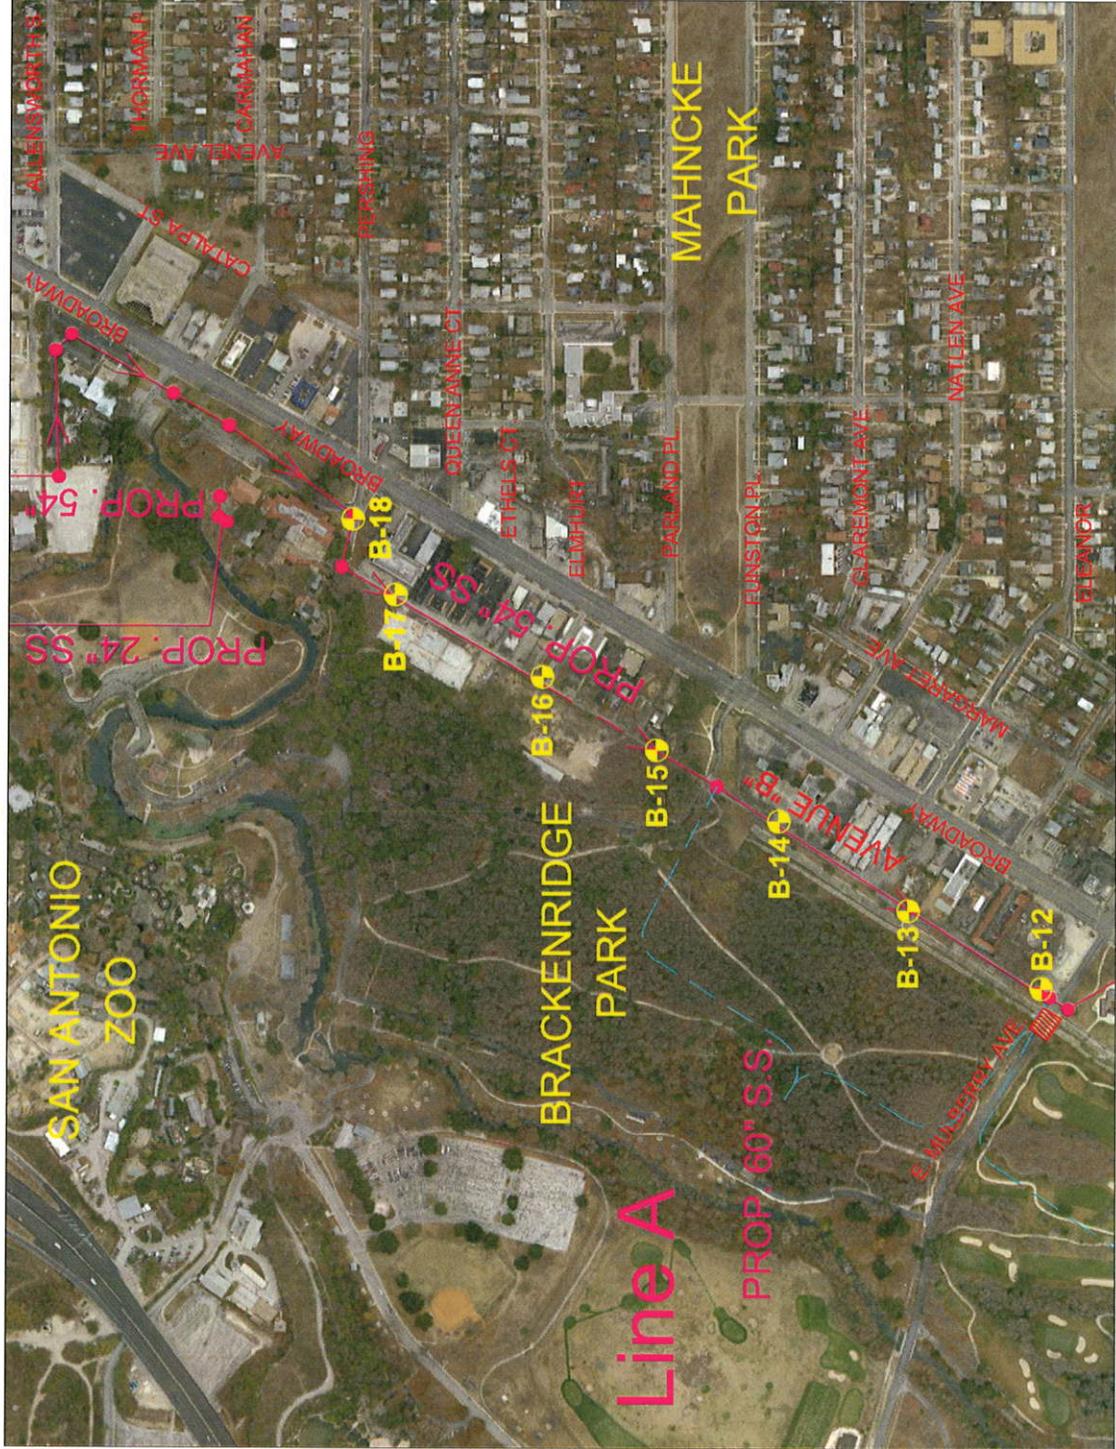
PLATE 2b

PLAN OF BORINGS
 Reach 1 Through Reach 3
 Olmos Basin Central Watershed Sewer Relief Line
 San Antonio Water System
 San Antonio, Texas

Stratigraphy. Subsurface conditions at the site can be understood by a thorough review of the eighteen boring logs presented on Plates 3 through 20. A brief summary of the subsurface conditions is provided in the following paragraphs.

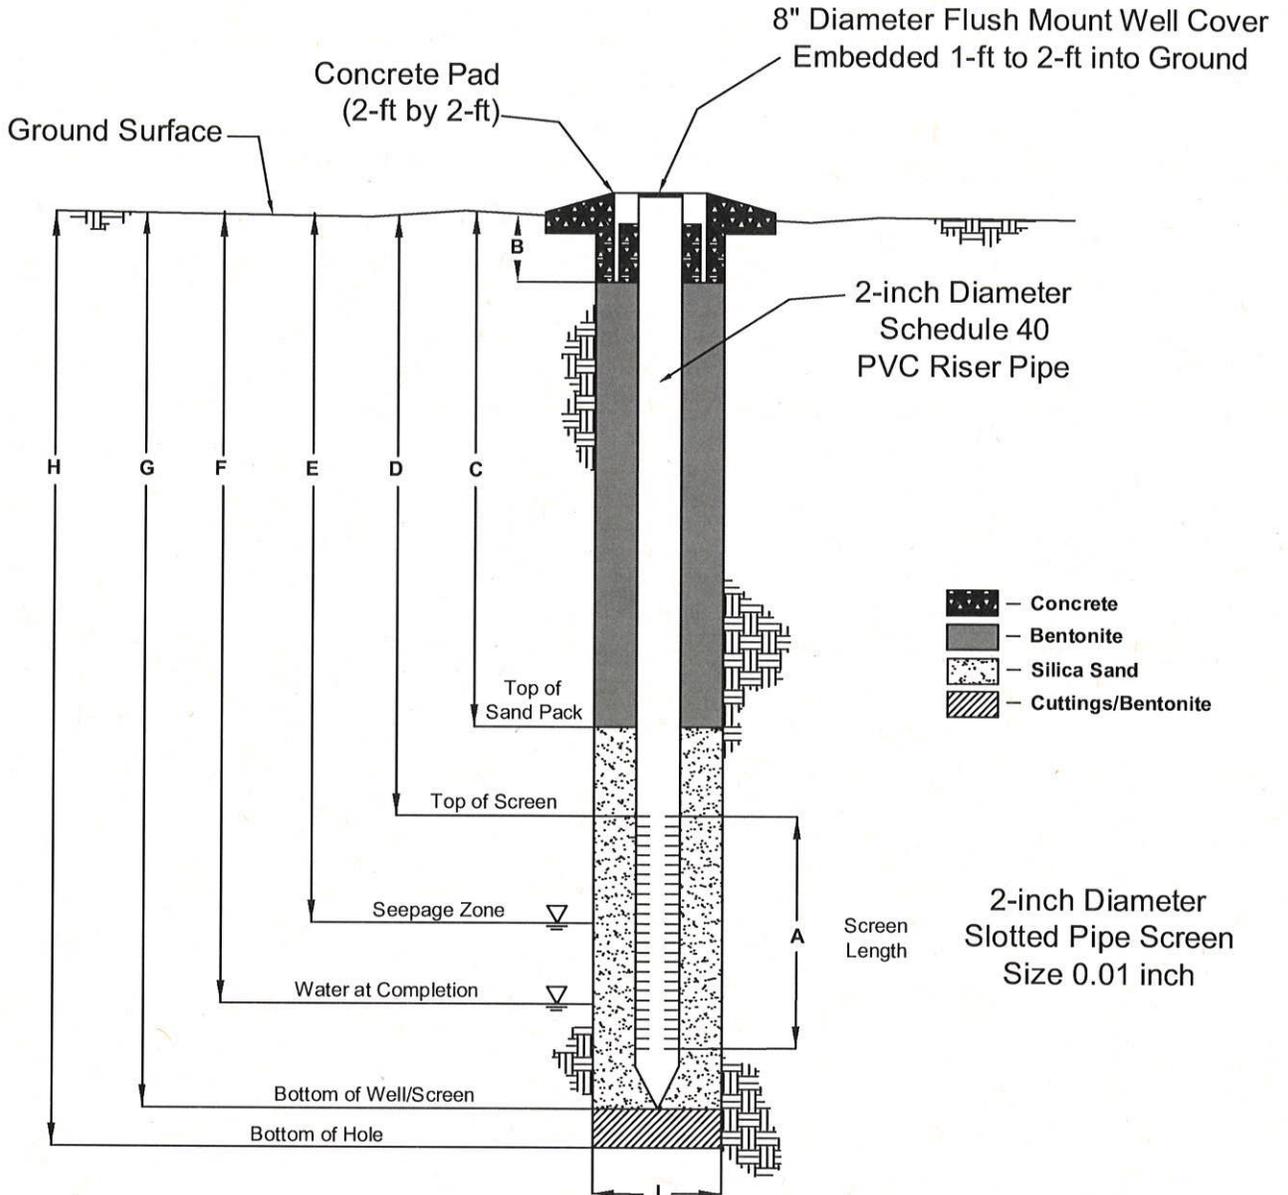
Piezometer Number: P @ B-3

Installation Date: October 4, 2010

Field Measurements:

A: 10' C: 8.5' E: N/A G: 20.5' I: 7.5"

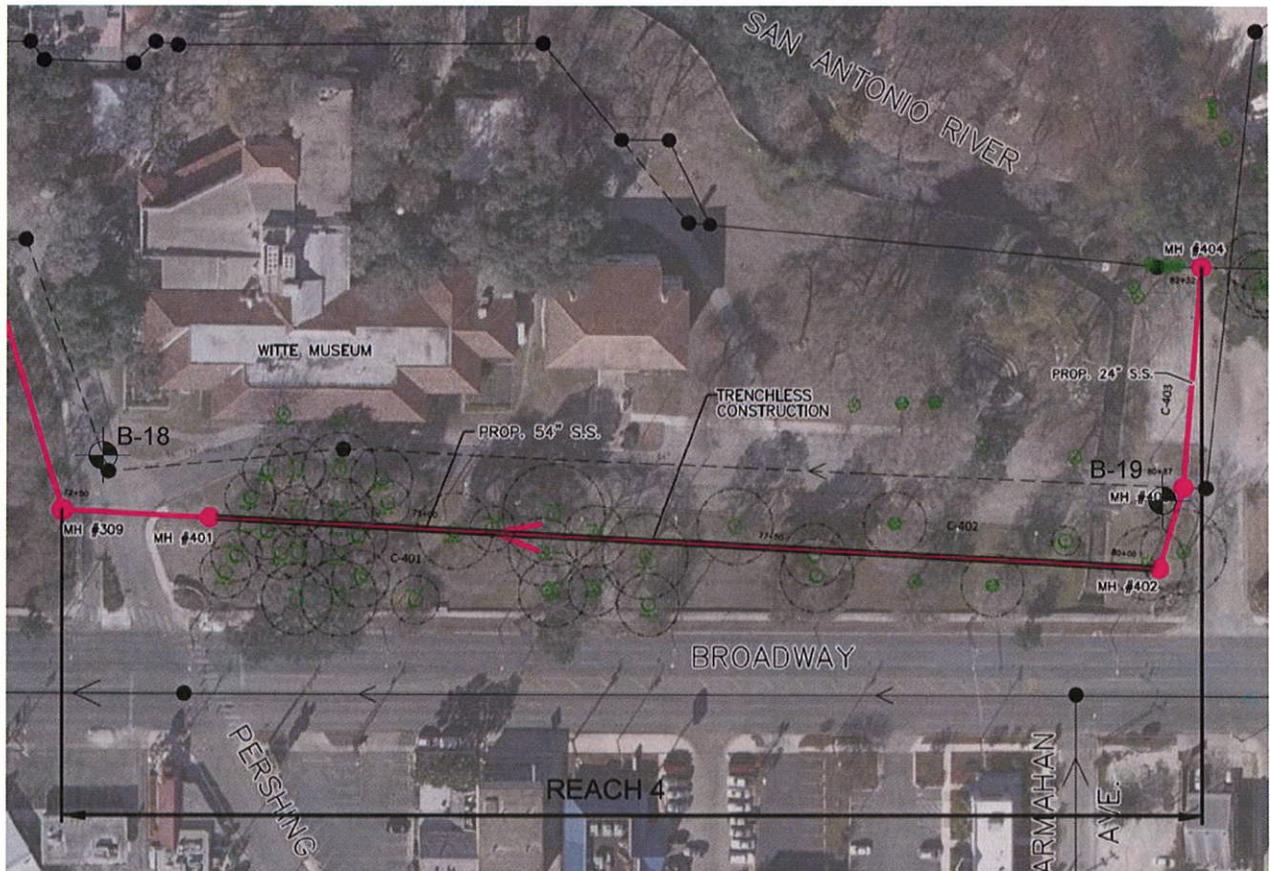
Note: Boring B-18 drilled for geotechnical study for Reach 1 through 3.

BORING PLAN
Reach 4
Olmos Basin Central Watershed Sewer Relief Line
San Antonio Water System
San Antonio, Texas

Stratigraphy. Subsurface conditions at the boring location can be understood by a thorough review of the boring log, B-19, presented on Plate 3. A brief summary of the subsurface conditions for encountered at boring B-19 is provided in the following paragraphs.
