Geotechnical Data Report

Mitchell Lake Wetland Project

San Antonio, Texas

Arias Project No. 2017-698

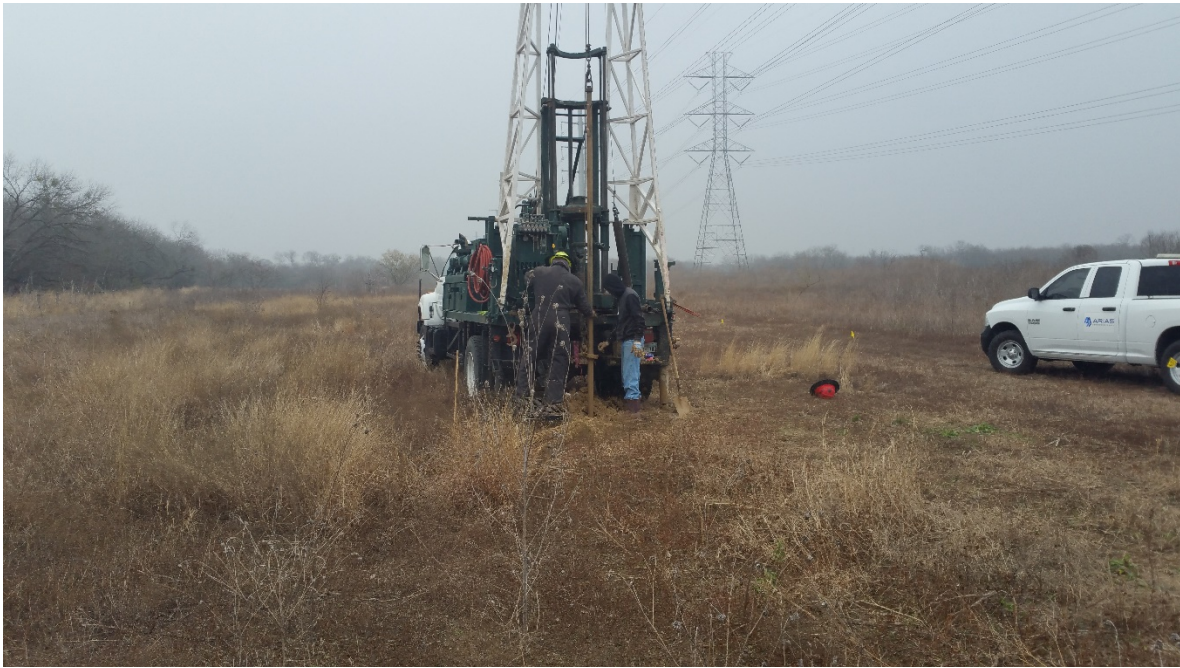
Photo 1 – View looking at Boring 103 drilling operations.

Detailed descriptions of subsurface conditions encountered in the borings are presented on the *Boring Logs* included in Appendix B. Sample type and interval are included on the individual soil boring logs at the respective sample depth. An Arias representative visually logged each recovered sample and selected representative samples for laboratory testing. *Site Photographs* of the drilling operation are presented in Appendix A, Figure 3.

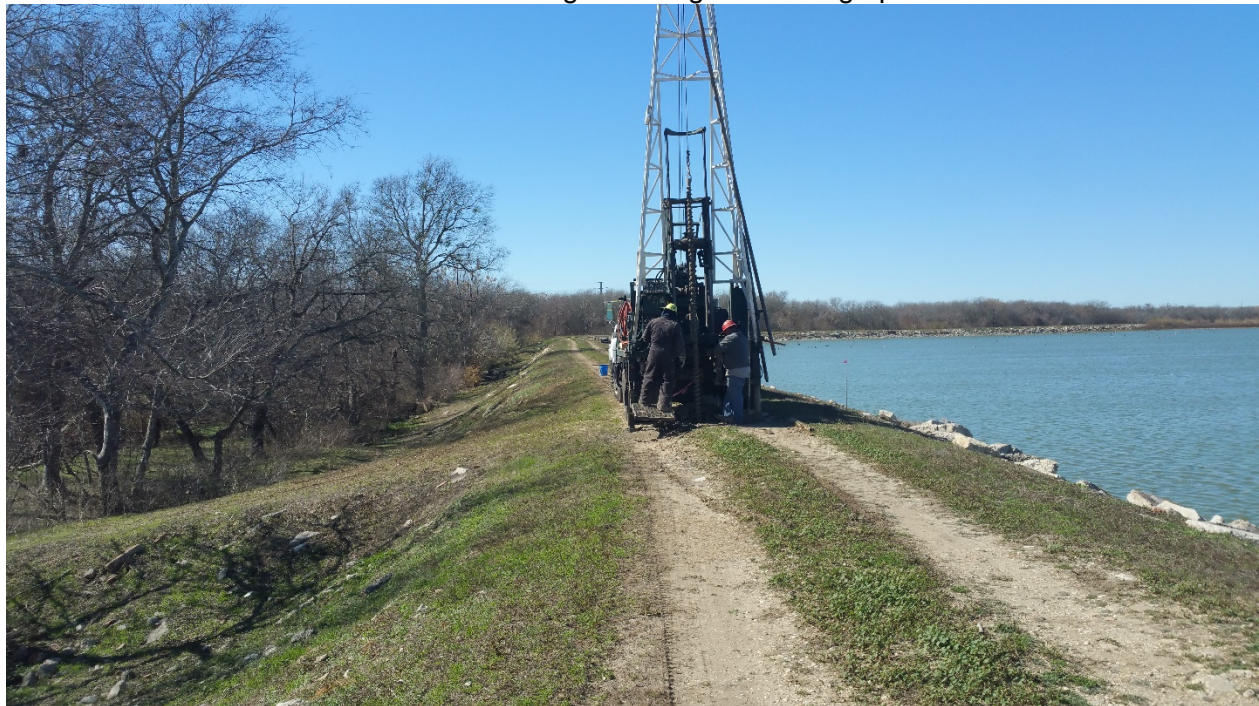
Photo 2 – View looking at Boring 105 drilling operations.

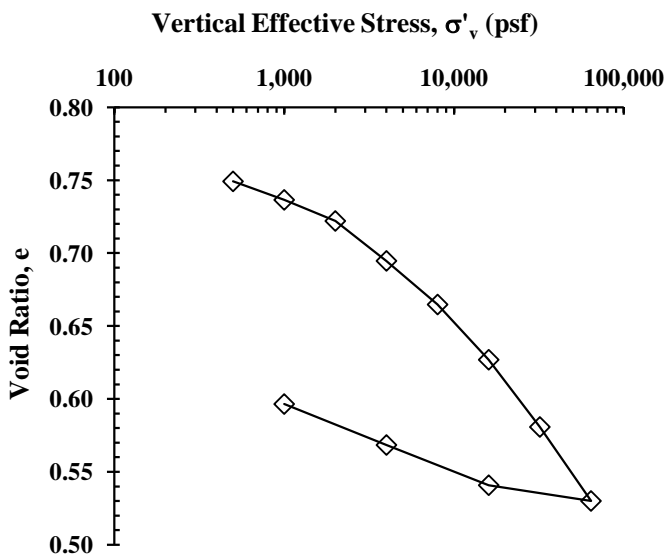
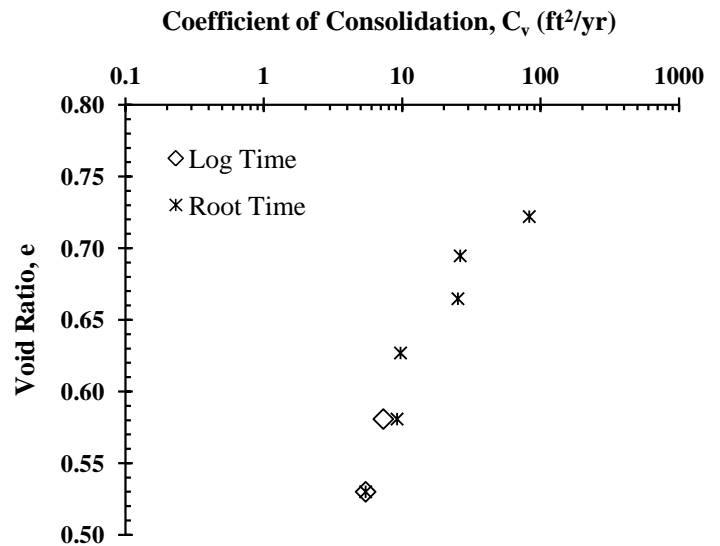
σ'_v (psf)	e	Strain, ϵ (%)	C_v (ft ² /year)	
			Log Time	Root Time
Initial	0.790	0.0	-	-
500	0.749	2.3	-	-
1,000	0.736	3.0	-	-
2,000	0.722	3.8	-	83
4,000	0.695	5.3	-	26
8,000	0.665	7.0	-	25
16,000	0.627	9.1	-	9.7
32,000	0.581	11.7	7.3	9.2
64,000	0.530	14.5	5.4	5.4
16,000	0.541	13.9	-	-
4,000	0.568	12.4	-	-
1,000	0.596	10.8	-	-

The undisturbed specimen was provided by the client. The specimen was trimmed using a trimming turntable and mounted. The specimen was inundated with tap water during testing. Coefficient of Consolidation was determined using the Log Time and Root Time Methods. A specific gravity of 2.75 was assumed for weight-volume calculations. Calculations include machine deflections measured at each loading step. The preconsolidation pressure was determined using the Casagrande construction technique.

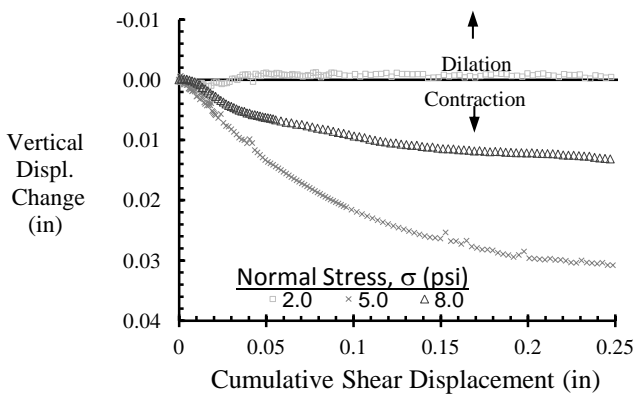
TRI Log#: 36618.1
 Test Method: ASTM D3080

Sample Number		1	2	3
Initial Condition	Diameter, in	2.50	2.50	2.50
	Height, in (before consol)	1.00	1.00	1.00
	Water Content, %	13.0	12.9	12.7
	Saturation, %	56.1	50.8	53.7
	Dry Density, pcf	102.5	98.9	101.7
	Void Ratio	0.61	0.67	0.63
Post-Consol	Height, in (prior to shear)	1.00	1.00	1.00
	Dry Density, pcf	102.5	99.2	102.0
	Void Ratio	0.61	0.67	0.62
Displacement rate (in/min)		1.0E-04	1.0E-04	1.0E-04
Final Water Content, %		24.5	23.8	22.8
Peak	Normal Stress, σ' (psi)	2.05	5.56	8.24
	Shear Stress, τ (psi)	2.31	3.89	5.59
	Displacement (in)	0.05	0.19	0.06
	ϕ'_d , degrees	27.7		
	c'_d , psi	1.2		
0.25 Inches	Normal Stress, σ' (psi)	2.28	5.71	9.15
	Shear Stress, τ (psi)	1.74	3.74	6.48
	Secant Friction Angle, Degrees	37.4	33.2	35.3
	ϕ'_d , degrees	34.6		
	c'_d , psi	0.0

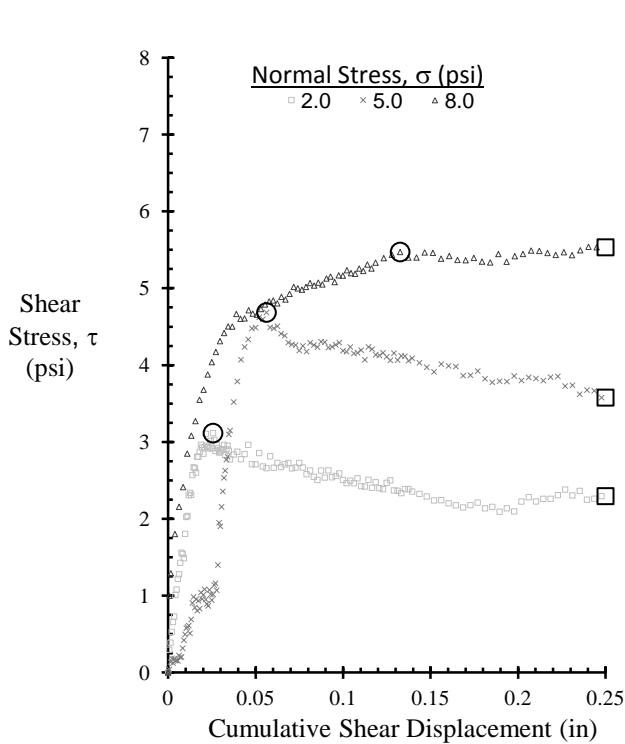
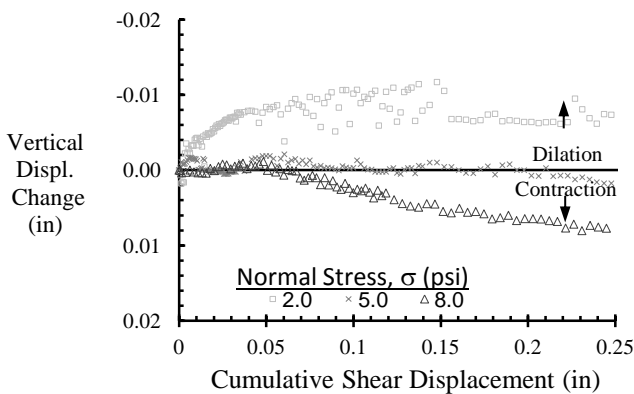
TRI Log#: 36618.2
 Test Method: ASTM D3080

Sample Number		1	2	3
Initial Condition	Diameter, in	2.50	2.50	2.50
	Height, in (before consol)	1.00	1.00	1.00
	Water Content, %	14.4	14.4	14.3
	Saturation, %	64.3	69.3	67.9
	Dry Density, pcf	103.8	106.7	106.1
	Void Ratio	0.59	0.55	0.56
Post-Consol	Height, in (prior to shear)	1.00	1.00	1.00
	Dry Density, pcf	103.8	106.7	106.1
	Void Ratio	0.59	0.55	0.56
Displacement rate (in/min)		1.0E-04	1.0E-04	1.0E-04
Final Water Content, %		23.6	25.5	24.5
Peak	Normal Stress, σ' (psi)	2.01	5.58	9.10
	Shear Stress, τ (psi)	3.12	4.68	5.47
	Displacement (in)	0.03	0.06	0.13
	ϕ'_d , degrees	18.4		
	c'_d , psi	2.6		
0.25 Inches	Normal Stress, σ' (psi)	2.26	5.84	9.15
	Shear Stress, τ (psi)	2.30	3.58	5.53
	Secant Friction Angle, Degrees	45.5	31.5	31.2
	ϕ'_d , degrees	25.1		
	c'_d , psi	1.1

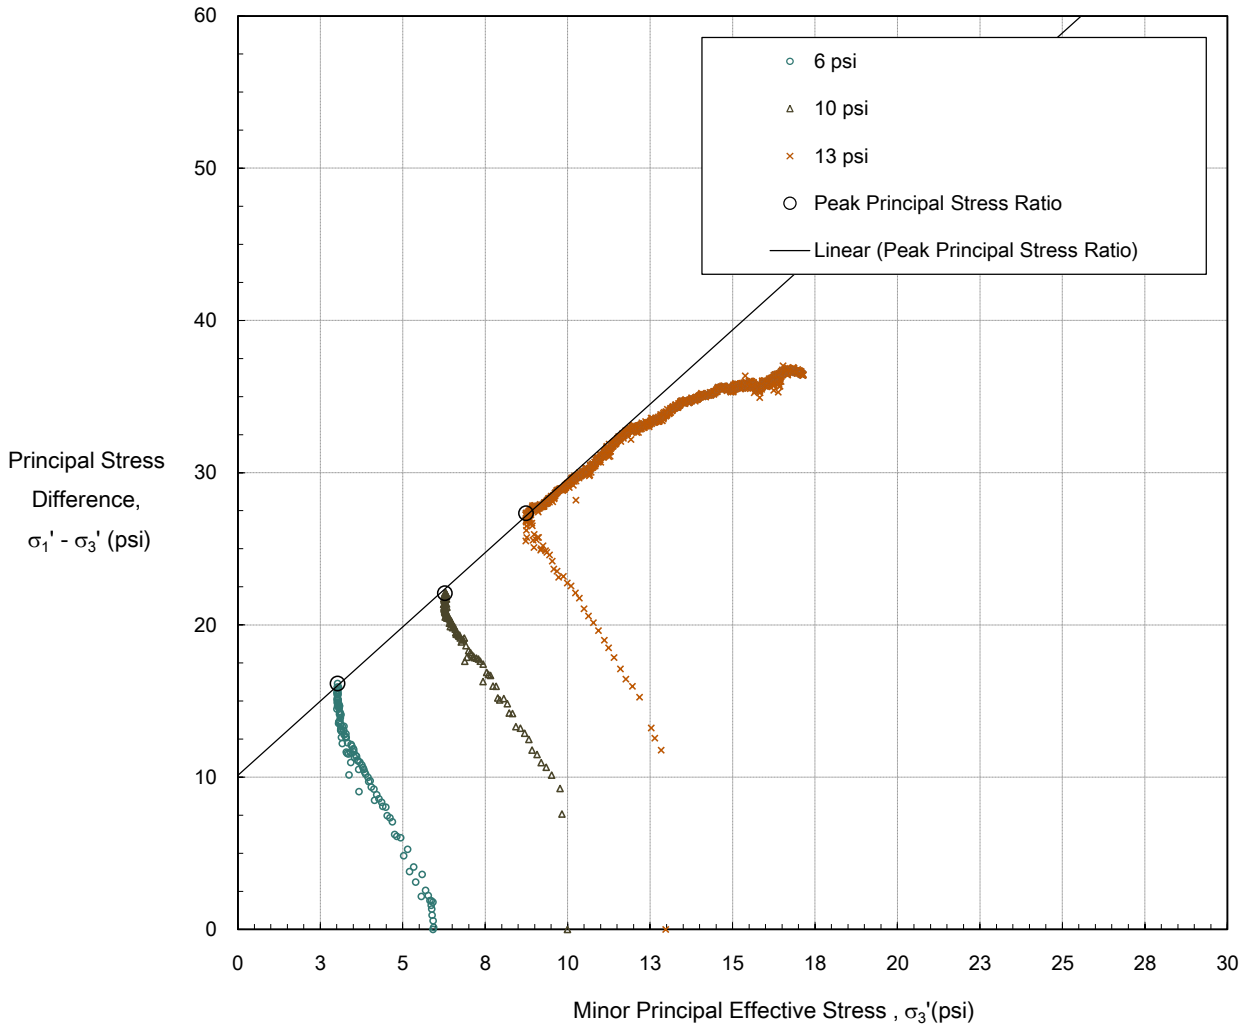
Modified Mohr-Coulomb

Failure Criterion: Peak Principal Stress	Difference, $(\sigma_1' - \sigma_3')_{max}$	Ratio, $(\sigma_1' / \sigma_3')_{max}$
Effective Friction Angle (deg)	-	29.6
Effective Cohesion (psi)	-	2.9
