MITCHELL LAKE DAM IMPROVEMENTS PRELIMINARY ENGINEERING REPORT

NOVEMBER 2020

FREESE AND NICHOLS, INC.
Texas Professional Engineering Firm No. F-2144
9601 McAllister Freeway, Suite 1008
San Antonio, Texas 78216

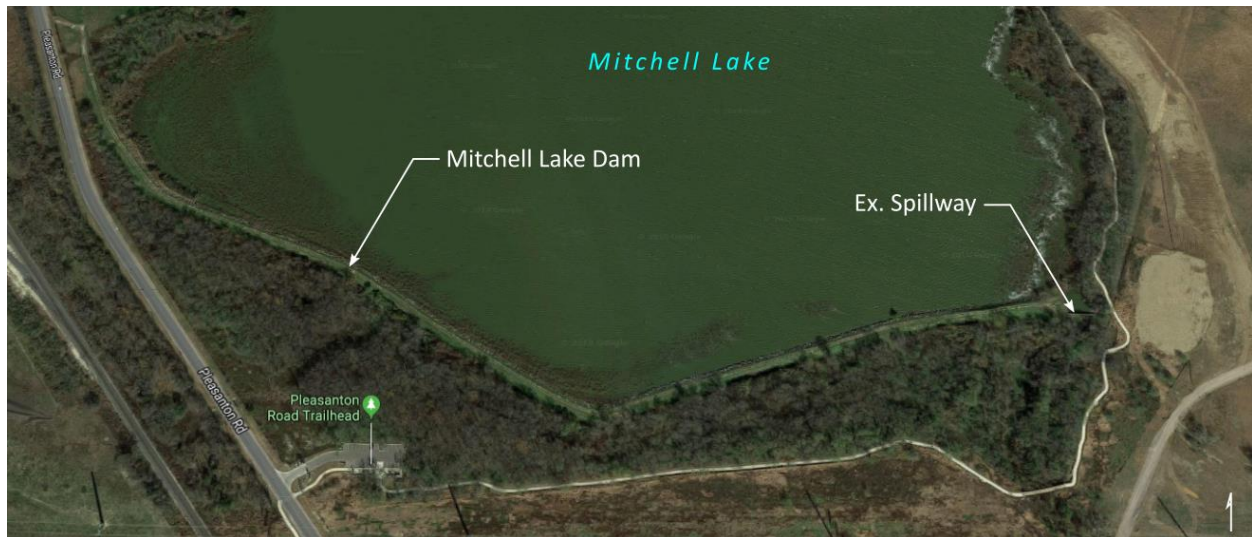
Figure 1.1: Overview of Mitchell Lake Dam

Mitchell Lake Dam (TX01453) is located in south San Antonio, Texas in Bexar County. The dam was originally constructed in 1901 and consists of an earthen embankment and a spillway at the left abutment. The embankment is approximately 3,200 feet long with a maximum height of approximately 20 feet. The crest width is approximately 15 feet with side slopes ranging from approximately 2:1 (H:V) to 3:1. The crest elevation varies between approximately 526.0 feet and 528.5 feet, although the majority of the embankment has a crest elevation of around 528.0 feet. Figure 1.1 shows an aerial photo of the dam.
